# **CHARACTERIZING AND INSPECTING FOR PROGRESSIVE EPOXY DEBONDING IN BONDED INSULATED RAIL JOINTS**

**09-1793**

Submitted for consideration for presentation and publication  
88<sup>th</sup> Annual Meeting of the Transportation Research Board  
Washington, DC – January 2009

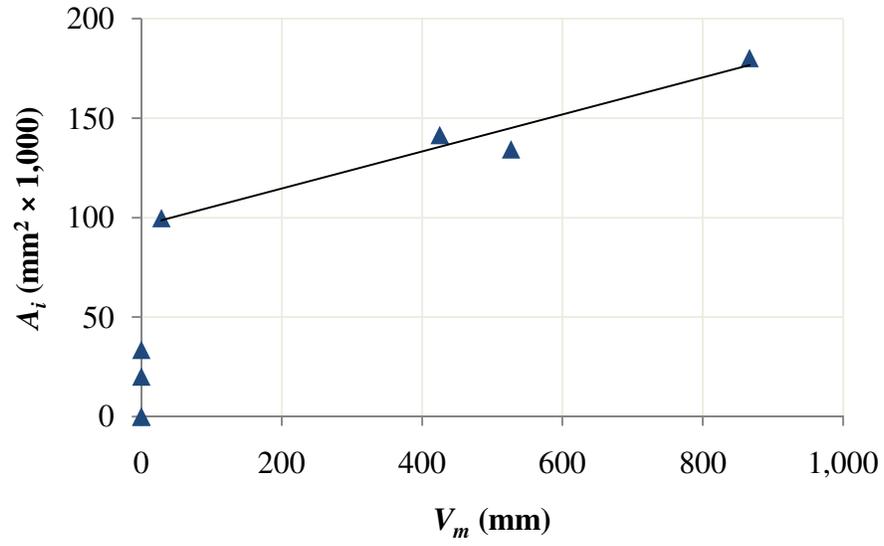
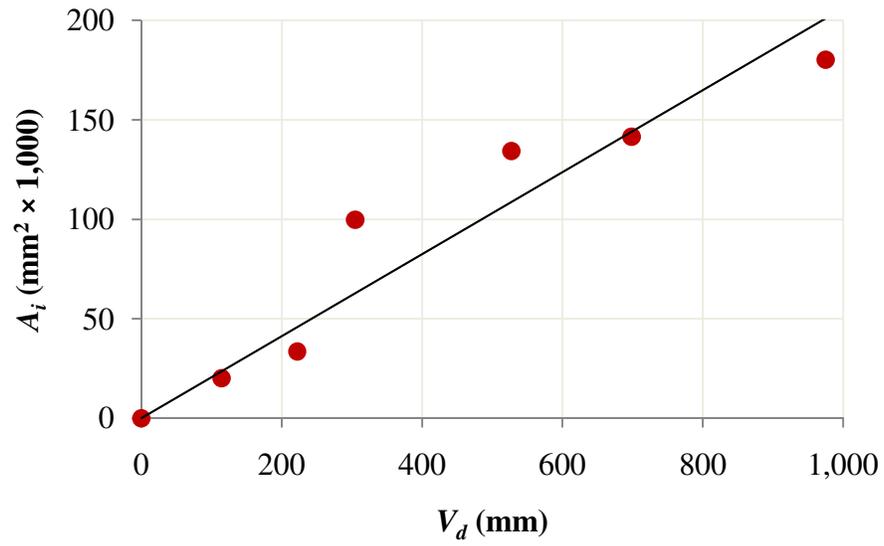
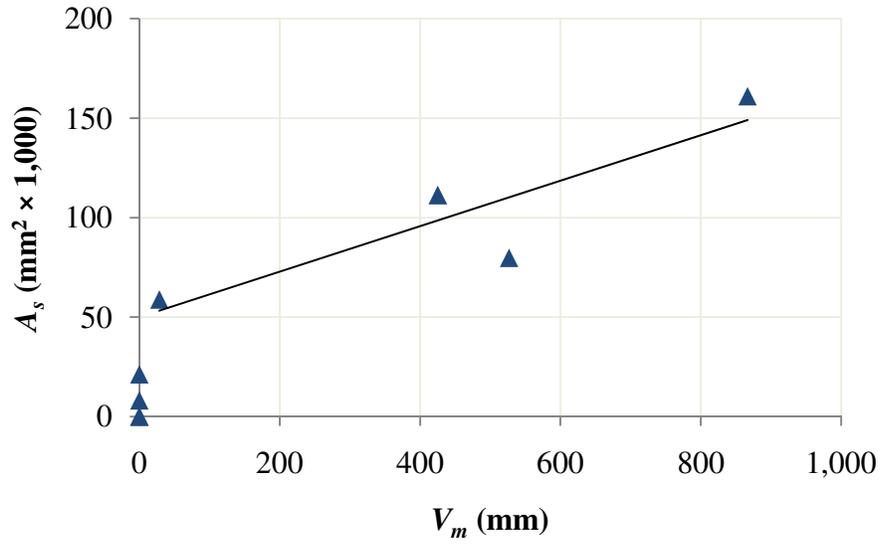
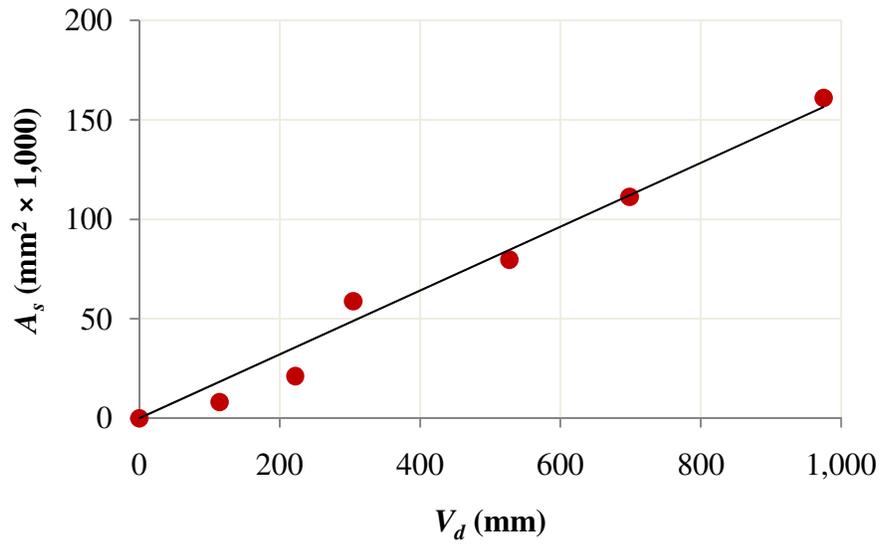
**Figure 5: Actual debonding versus visual inspection metrics for control and test specimens.**  
(a)  $A_i$  versus  $V_m$ . (b)  $A_i$  versus  $V_d$ . (c)  $A_s$  versus  $V_m$ . (d)  $A_s$  versus  $V_d$ .

$V_m$  and  $V_d$  were computed for a whole joint by summing the length of missing, or missing and loose, top insulator edge on each of the four interfaces of that joint. Plotting these measurements versus the debonded area of each interface revealed a strong correlation (Figure 5). The relationship between  $V_d$  and debonding appears linear over the whole range of measurements; a straight line, constrained to pass through the origin, was fit to these data.  $V_m$  was complicated by the fact that several joints with measurable debonding have  $V_m = 0$ . It does appear that  $V_m$  has some relationship with debonding when it is non-zero, but the correlation is not as strong as for  $V_d$ . Therefore, it appears that  $V_d$  is a more useful indicator of debonded area than  $V_m$ .

The purpose of visual inspection is to estimate debonding from the visual metrics, and so a goal of this statistical analysis was to develop confidence intervals for that estimate. Because  $V_d$  appears to be the more useful metric, the error analysis only included estimates of  $A_i$  and  $A_s$  that are based on  $V_d$ , not  $V_m$ . The debonded area was estimated by multiplying  $V_d$  times the slope of the regression line in Figure 5. It is reasonable to assume that the residuals of the estimate are independent and normally distributed, so that a confidence interval can be estimated using the Student-t distribution with 7 degrees of freedom (Table 3). The results show that  $V_d$  allows for  $A_s$  to be estimated more accurately than  $A_i$ .

$V_d$  correlates well with the Strict debonded area  $A_s$  and, to a lesser extent, the Inclusive debonded area  $A_i$ . One millimeter of missing or loose top edge corresponded to 201 mm<sup>2</sup> of  $A_i$  and 159 mm<sup>2</sup> of  $A_s$ . These relations allow the debonded areas  $A_i$  and  $A_s$  to be estimated to within  $\pm 28,000$  mm<sup>2</sup> and  $\pm 12,000$  mm<sup>2</sup> respectively.
