Rail Yard Case Study: Aging Subsurface Infrastructure and Environmental Issues

2015 Railroad Environmental Conference October 27 & 28, 2015

Stuart Boykin, CSX Transportation Mike Feamster, Ramboll Environ Tobias Parker, Ramboll Environ

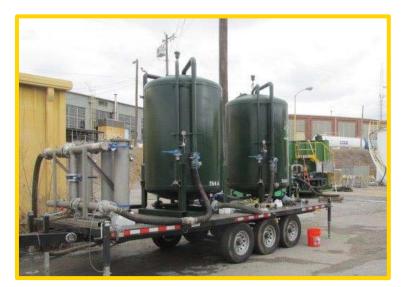
The only pipe to city sewer was inoperable

Divert flow away from collapsed pipe

Sanitary wastewater- collected in frac

tanks; discharge to city

WWTF effluent-diverted to stormwater treatment plant; discharge to NPDES outfall

> Installed tertiary treatment at WWTF

Flushed stormwater treatment plant upstream piping

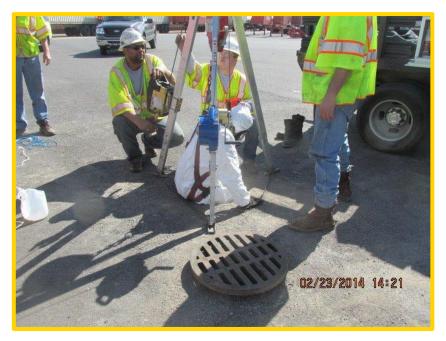
- Large drainage area covering non-CSXT properties
 - Hundreds of acres
 - Numerous adjacent Industrial property owners
- Inaccurate/incomplete documentation and maps
- Confined space
- Active rail lines
- Infrastructure limitations
- Significant depths
 - Limited to no accessibility

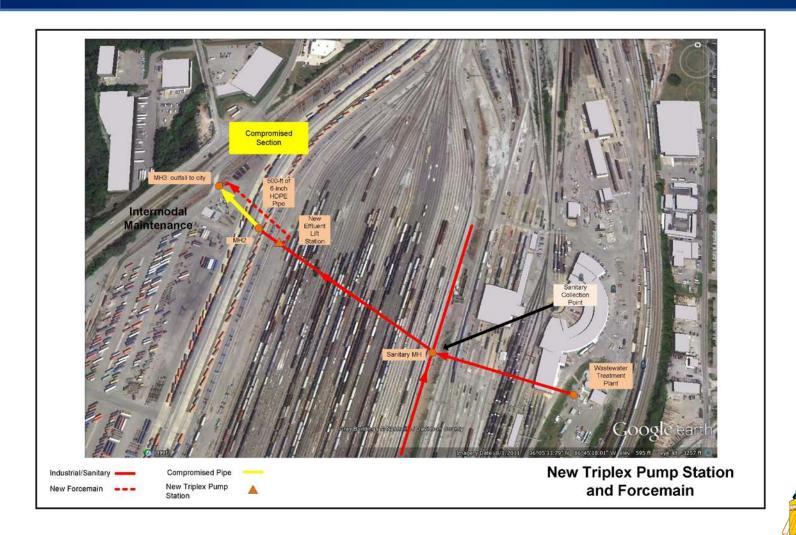
Long Term Solution: Remote Location

- Compromised pipe 50-ft deep under active tracks
- Pump station location
 - Near compromised pipe
 - Remote from WWTF
 - Accessible for construction and maintenance
- Remote location challenges:
 - Independent power and controls
 - Telemetry for remote monitoring and controls
 - Redundant (Fail Safe) pump, power and controls

Installed triplex pump station:

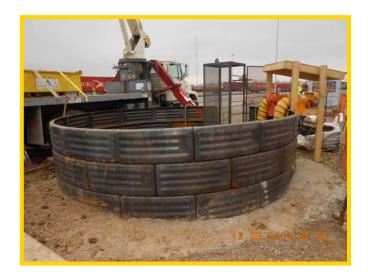
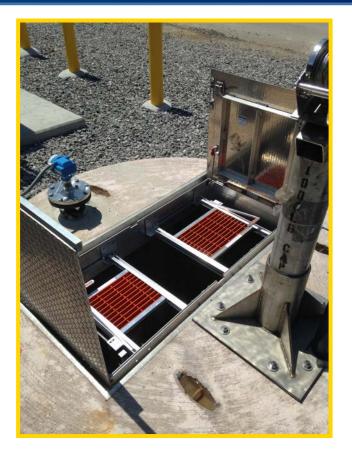
Long Term Solution: Construction Challenges

- Personnel Safety
 - Caged access
 - Fall protection
- Non-Traditional Installation

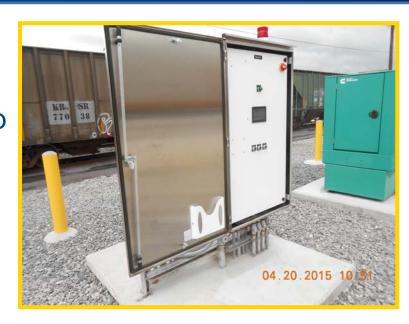
Long Term Solution: Operational Challenges

- Fully automated PLC with alarms
- Fail safes
 - Triplex pump station (installed backup pump)
 - Emergency generator
 - Primary radar level control with backup float switches
 - PLC fails then backup float switches
- Communications
 - Cellular telemetry for remote access
- Accessibility
 - Active Rail Yard; (~50 feet between track and access road)
