#### Use of Ground Penetrating Radar (GPR) to Locate Contaminant Beneath Railroad Track

Jim Hyslip – HyGround Engineering Christopher Oakes – Norfolk Southern Russell McDaniel – Norfolk Southern Kenneth Battyanyi - WSP

> Railroad Environmental Conference University of Illinois, Urbana-Champaign 28 - 29 October, 2014

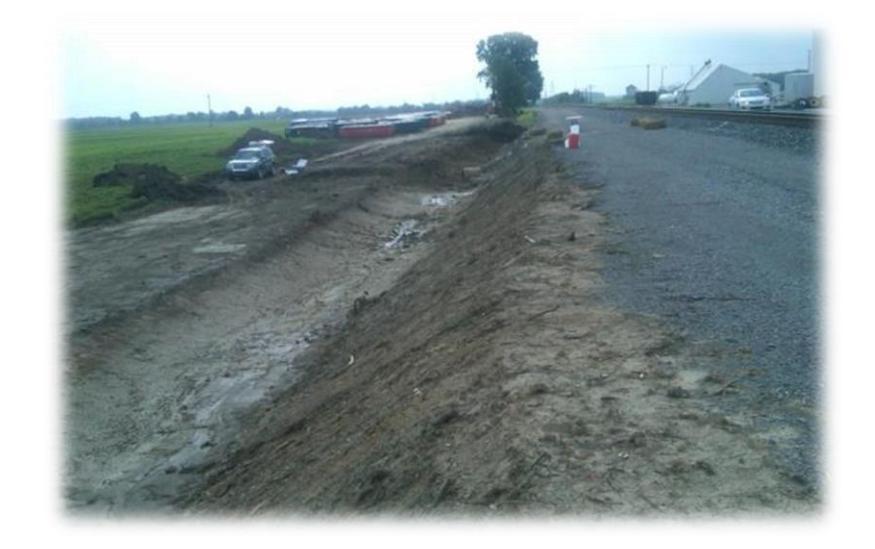
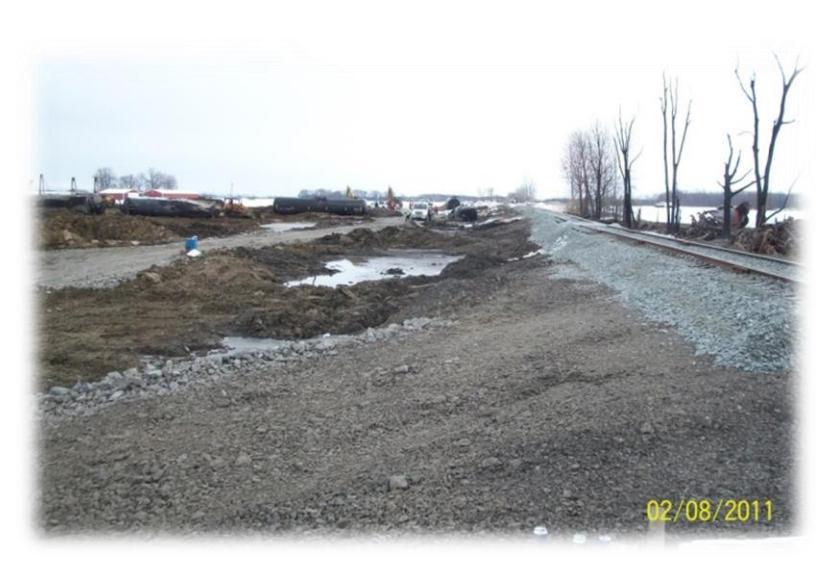
### **Release and Site Characteristics**

- > Denatured Ethanol
  - No Regulatory Standard for Ethanol
  - 2% 5% Natural Gasoline (Low octane)
  - Contains BTEX which are the regulated compounds
- Geology
  - Elevated track bed with perched water
  - Below track bed is a 35 foot clay later about 10 feet below grade
  - True groundwater is over 50 feet
