Concrete Ties – The Amtrak Experience

Alfred J. Cloutier
Assistant Deputy Chief Engineer - Track

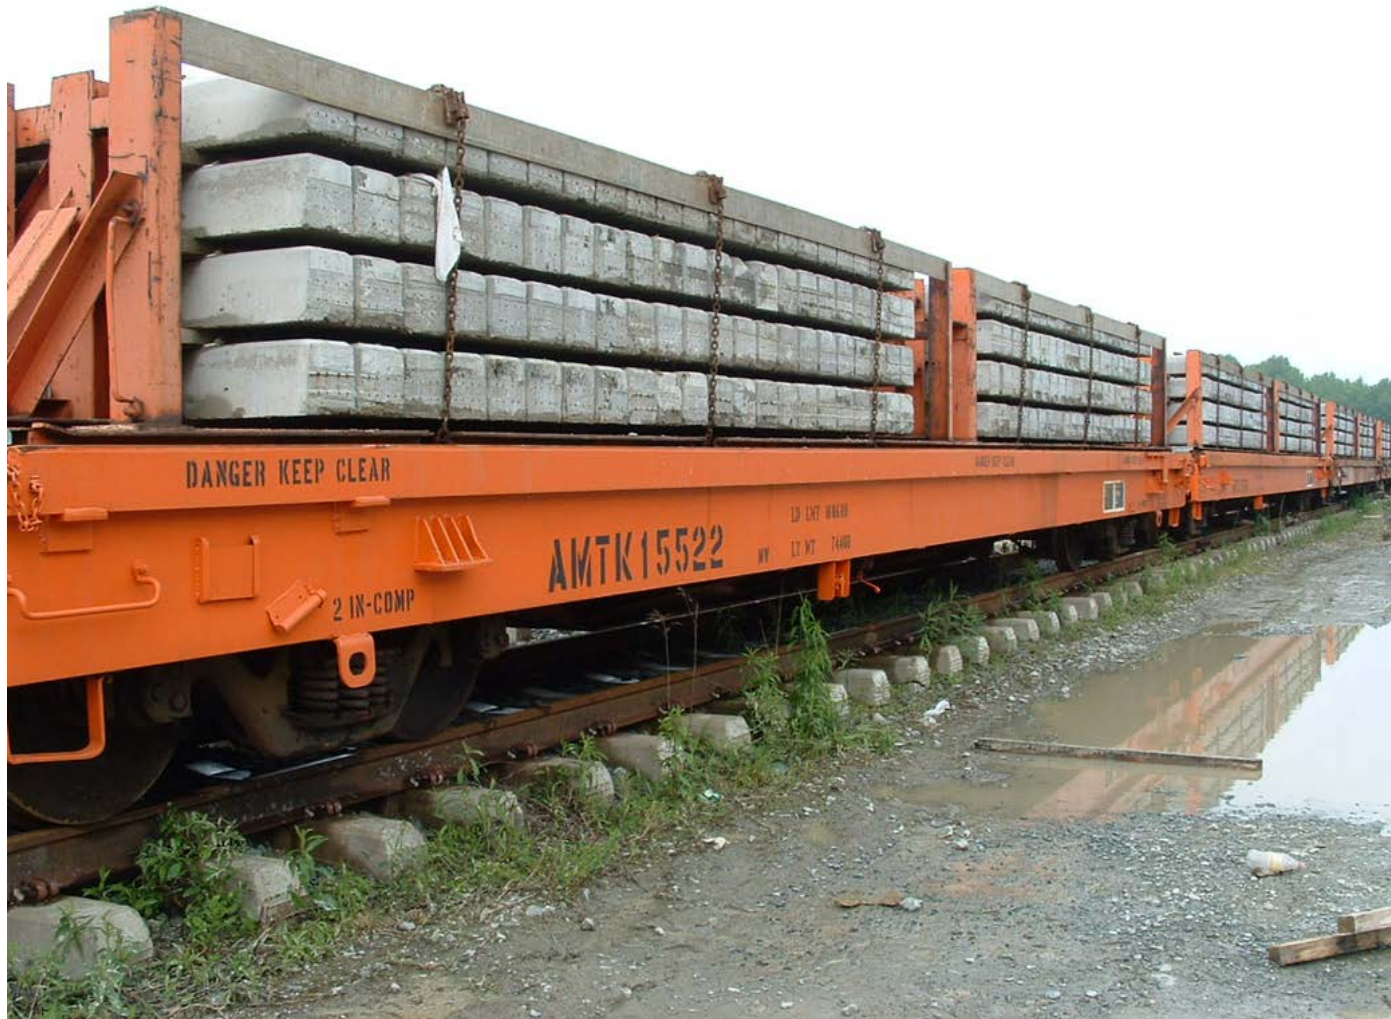
Initial Appearance of ASR/DEF
