REPORT NO. FRA/TTC-80/02

CONCRETE AND WOOD TIE TRACK PERFORMANCE THROUGH 150 MILLION GROSS TONS

MARCH 1980

INTERIM REPORT

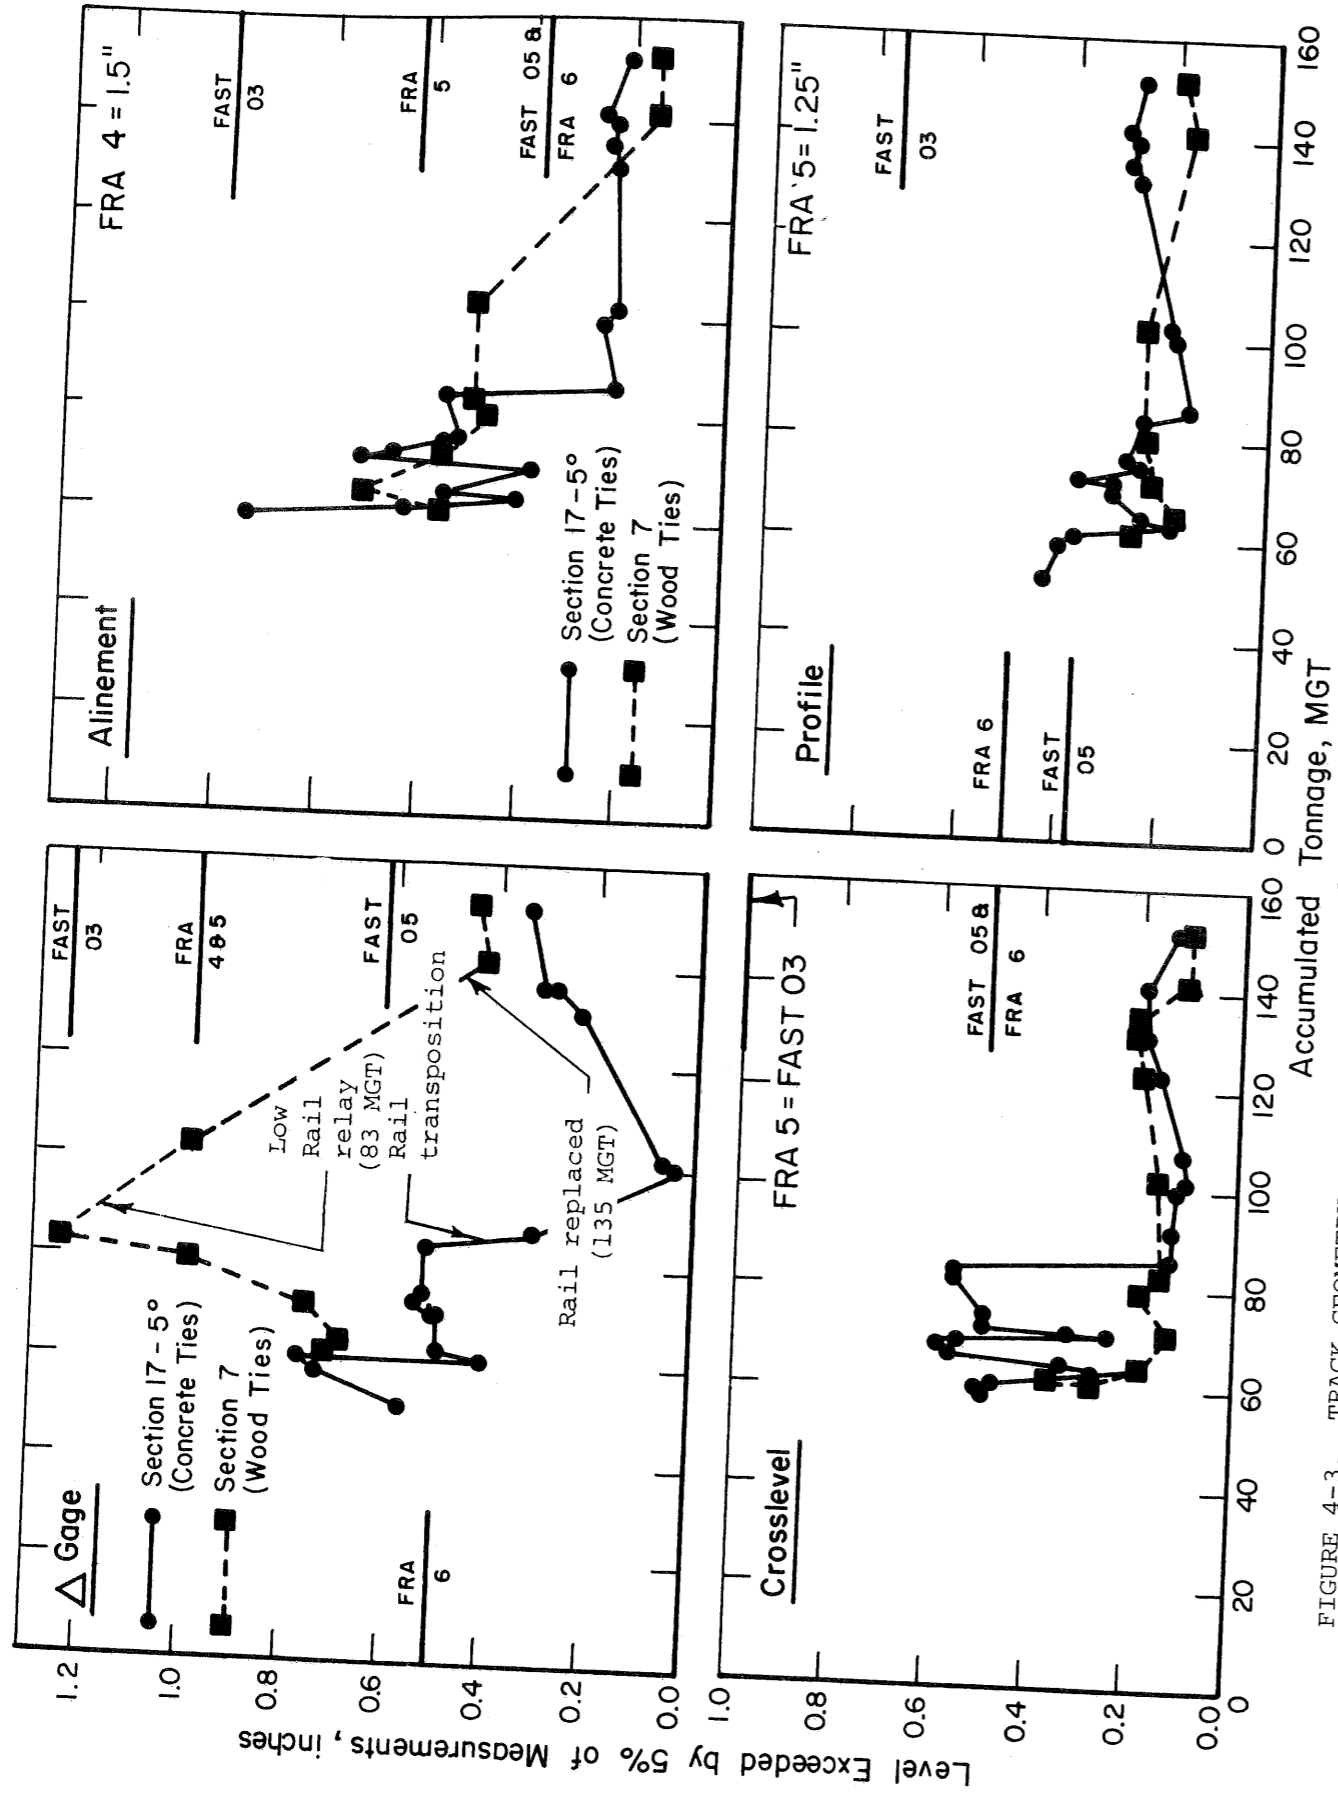
FIGURE 4-3. TRACK GEOMETRY ERRORS VS MGT ON 5° CURVES OF CONCRETE AND WOOD TIE TRACK.

The data consist of the amplitudes of track geometry errors which were exceeded by 5% of the measurements and are plotted vs. MGT. In Figure 4-3 it can be seen that the retention of track geometry is approximately equivalent between concrete and wood tie track on the 5° curve, with the exception of rapid growth in gage widening on wood tie track prior to an initial rail transposition at 32 MGT (not shown) and continuing to the low rail change at 83 MGT. The tangent track performance data shown in figure 4-4 contain no major differences between concrete and wood tie segments, and the geometry appears to be quite stable up to 150 MGT of service.

In summary, track geometry retention of the concrete and wood tie track was approximately equal through 150 MGT except for the high rate of gage widening in the wood tie, Section 07 track.

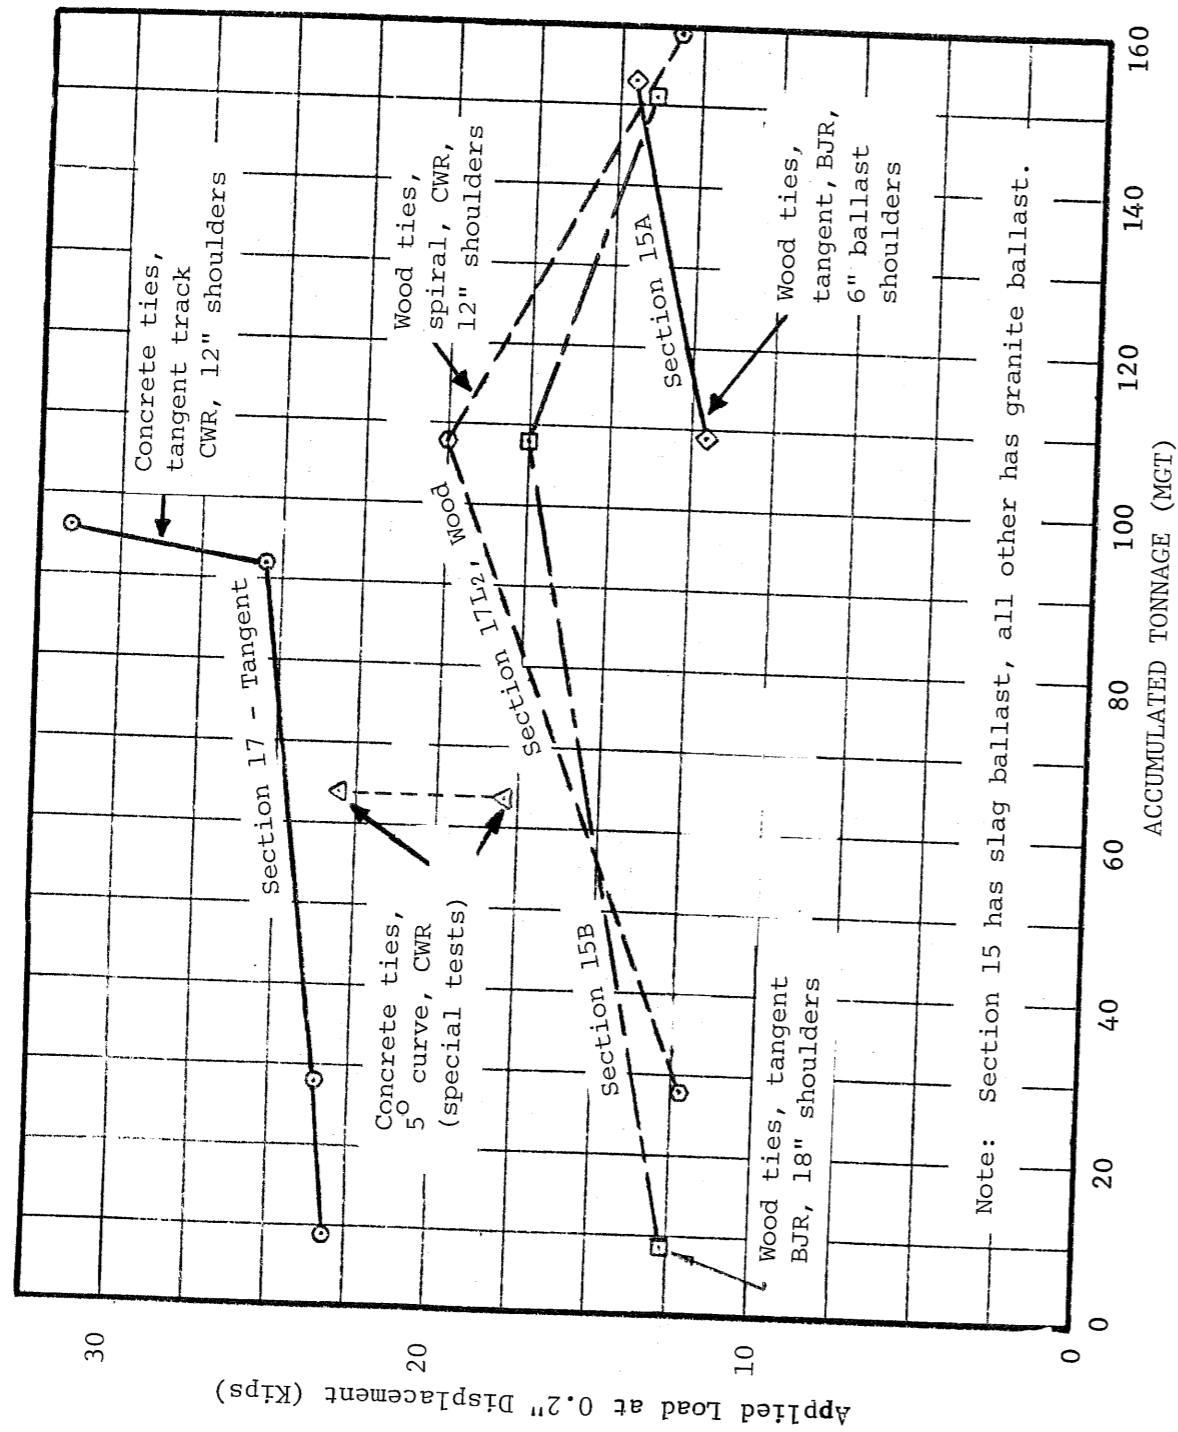
FIGURE 4-6. APPLIED LATERAL LOAD AT 0.2" DISPLACEMENT FROM HORIZONTAL TRACK STIFFNESS TESTS FOR SECTIONS OF CONCRETE AND WOOD TIE TRACK.

To compare performance in the different test segments vs. MGT, the load developed at 0.2" of centerpoint rail displacement is shown for each test in figure 4-6. A general increase in load at about the same rate occurs for both concrete and wood tie track up to about 100 MGT. Approximately 50% higher lateral resistance loads were developed on the concrete tie track than on the wood tie track.

Also shown on figure 4-6 are the results of two tests conducted on the same day at the same site in the concrete tie 5° curve. These were special tests conducted after the lateral track buckle that occurred at 61 MGT and are the only tests conducted on curved track.

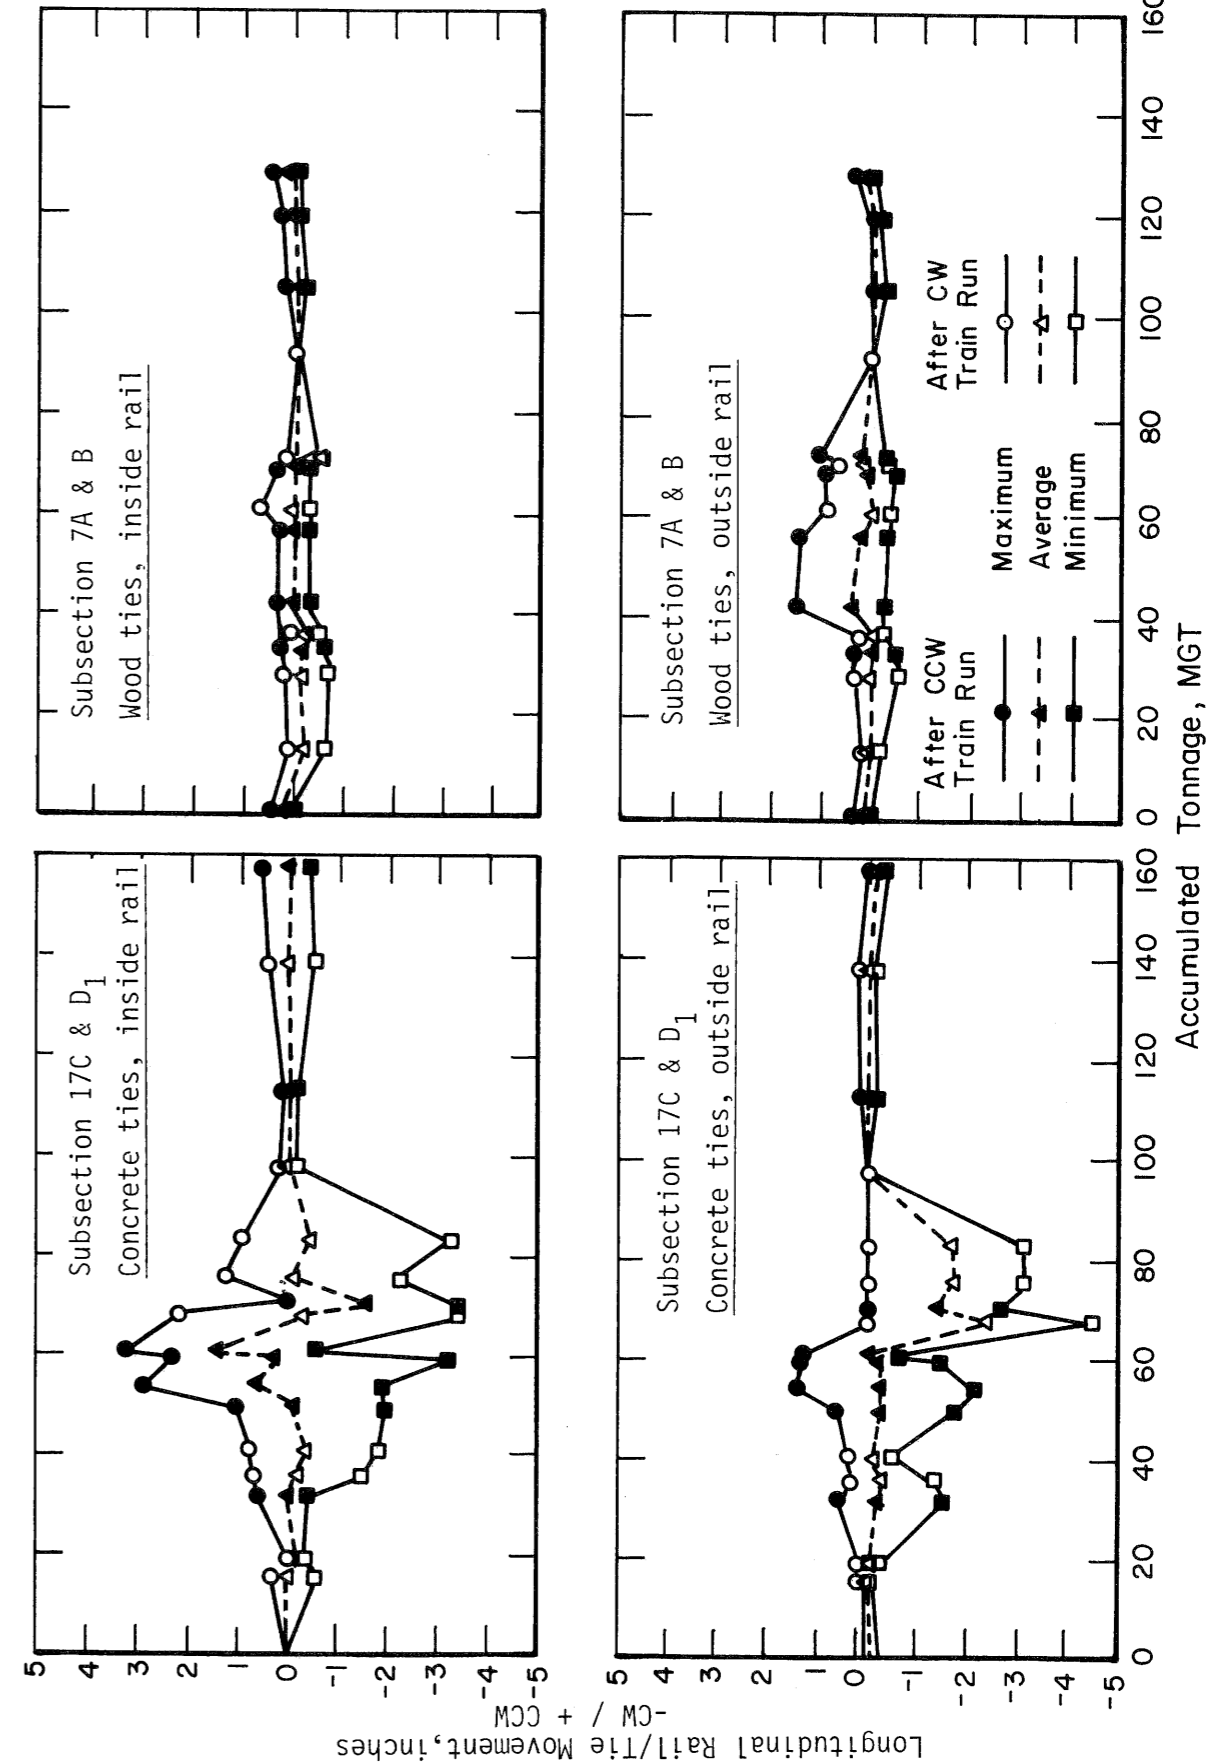
FIGURE 4-12. RAIL CREEP ON 5° CURVE SEGMENTS OF CONCRETE AND WOOD TIE TRACK.

- a. Creep in subsections 17C and 17D was substantial between 20 and 80 MGT, a period that also included frequent repetitions of maintenance affecting ballast compaction (as will be shown later),
- b. Section 17 creep reached a peak during the track buckle at 61 MGT,
- c. Substantial stabilization took place in Section 17 during a period of about 20 MGT after the track buckle,
- d. In Section 17 the creep markings were "rezeroed" following the rail transposition at 84 MGT; no significant rail creep was found from then to 150 MGT, and
- e. Rail creep was not substantial in either the tangent section of concrete tie track or the tangent or curved sections of wood tie track.

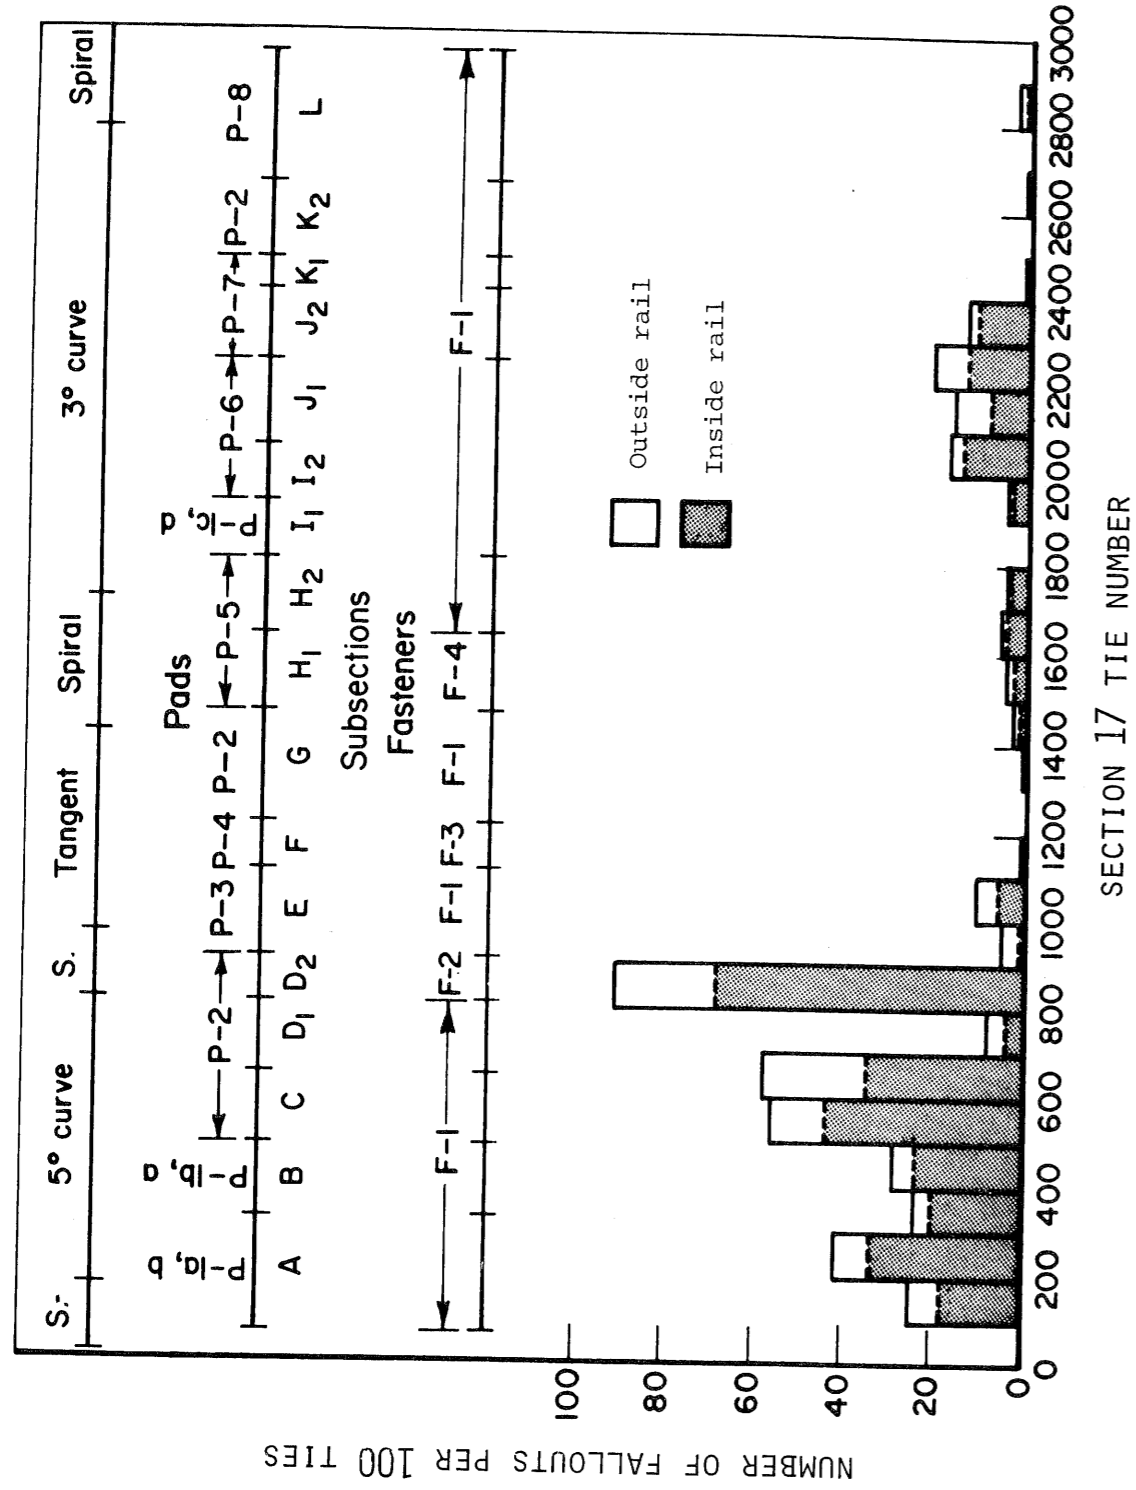
FIGURE 5-6. SUMMARY OF ELASTIC CLIP FASTENER FALLOUTS IN SECTION 17, 0-150 MGT.

Extensive fallouts of types F-1 and F-2 clip fasteners occurred between 0 and 150 MGT in the 5° curve and adjacent spiral. Figure 5-6 summarizes their spatial distribution. The influence of several effects can be seen:

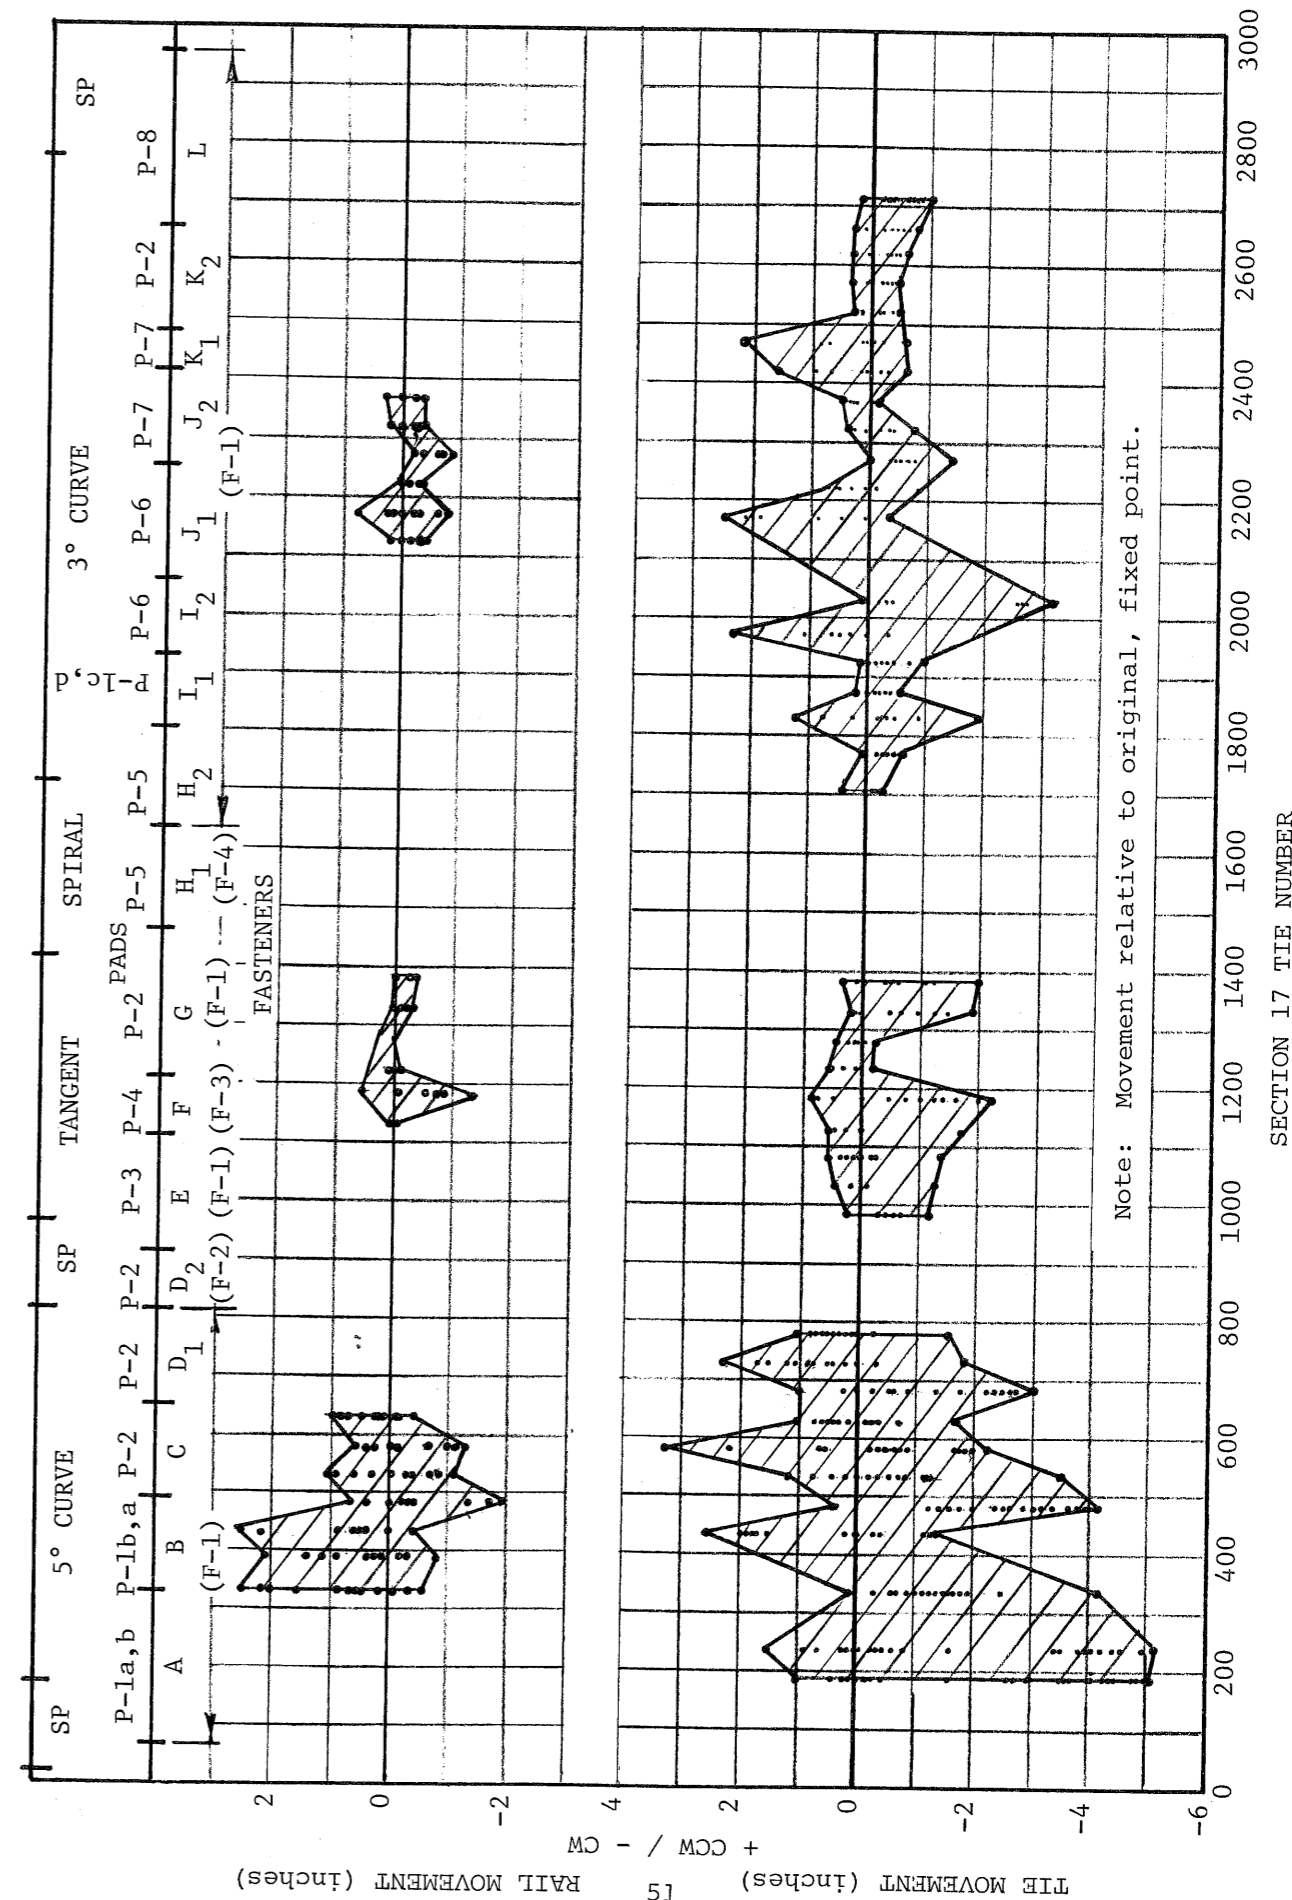
FIGURE 5-8. ENVELOPES OF LONGITUDINAL RAIL AND TIE MOVEMENT IN SECTION 17.

A summary of the longitudinal tie and rail movement data is shown in figure 5-8. With one exception, all subsections covered by the data have type F-1 elastic clip fasteners. Subsection F has type F-3 fasteners. Figure 5-8 shows that:

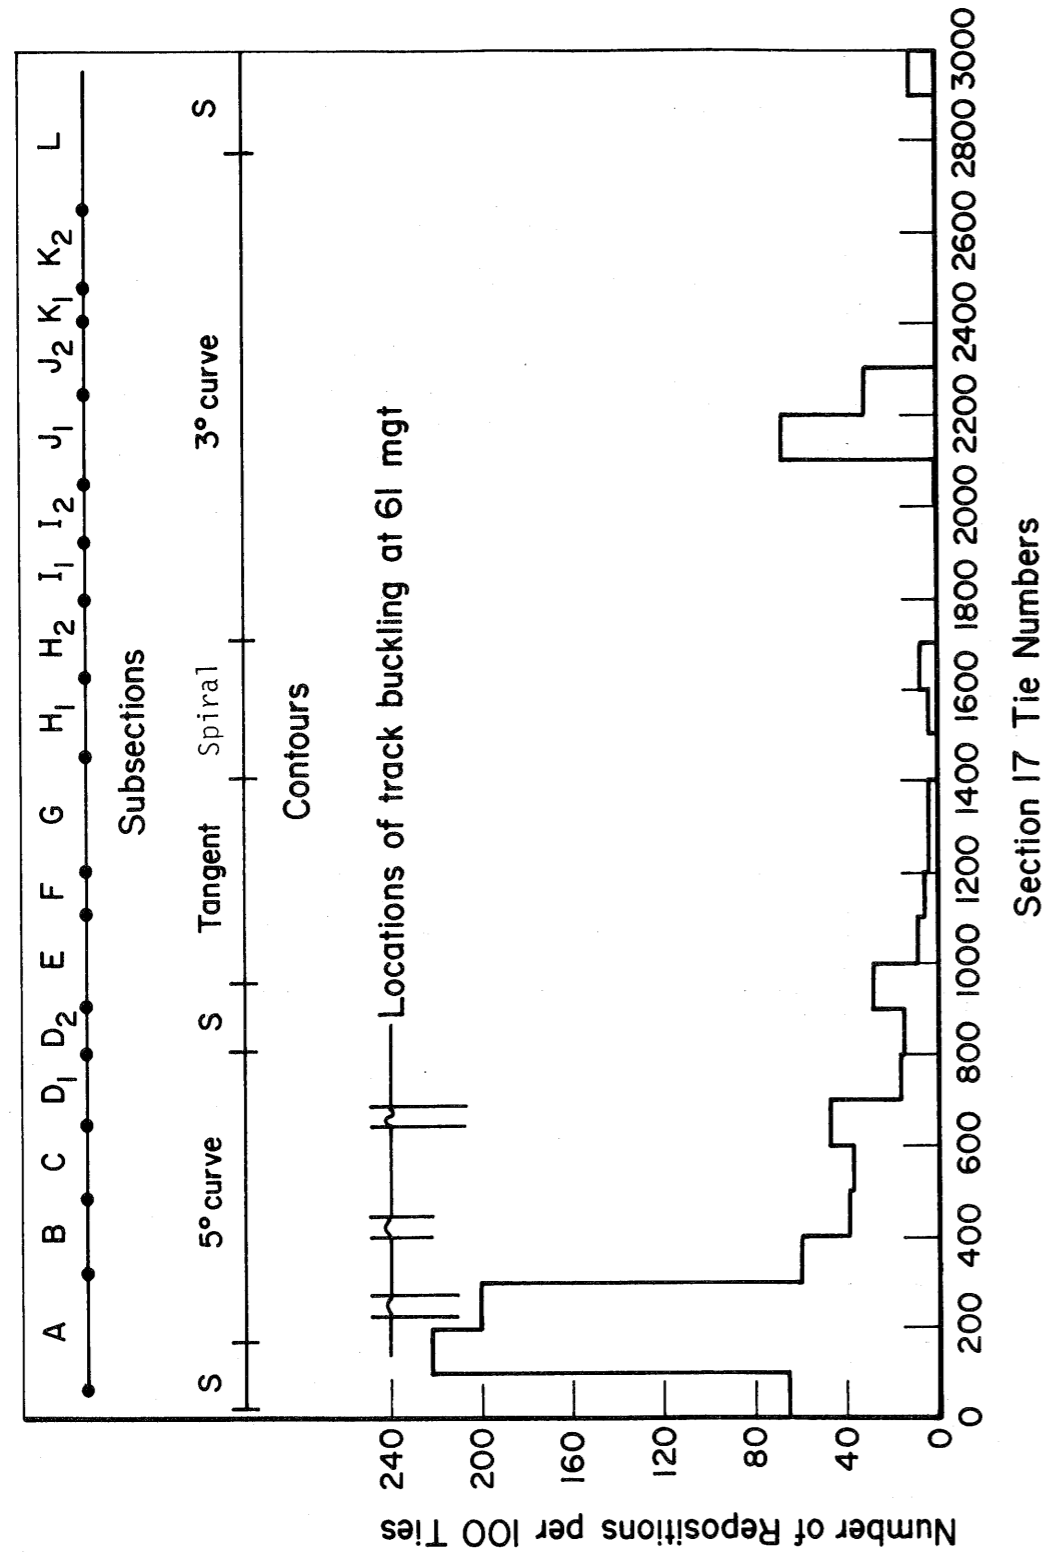
FIGURE 5-9. SUMMARY OF TIE REPOSITIONING IN SECTION 17, 0-150 MGT.

The problem of tie movement at the start of the curve is verified by figure 5-9, which summarizes tie repositioning activity over Section 17. Tie repositioning was required when longitudinal spacing varied from the standard 24" by more than 6", or if the skew (relative longitudinal position of the two ends of the tie) exceeded 6".

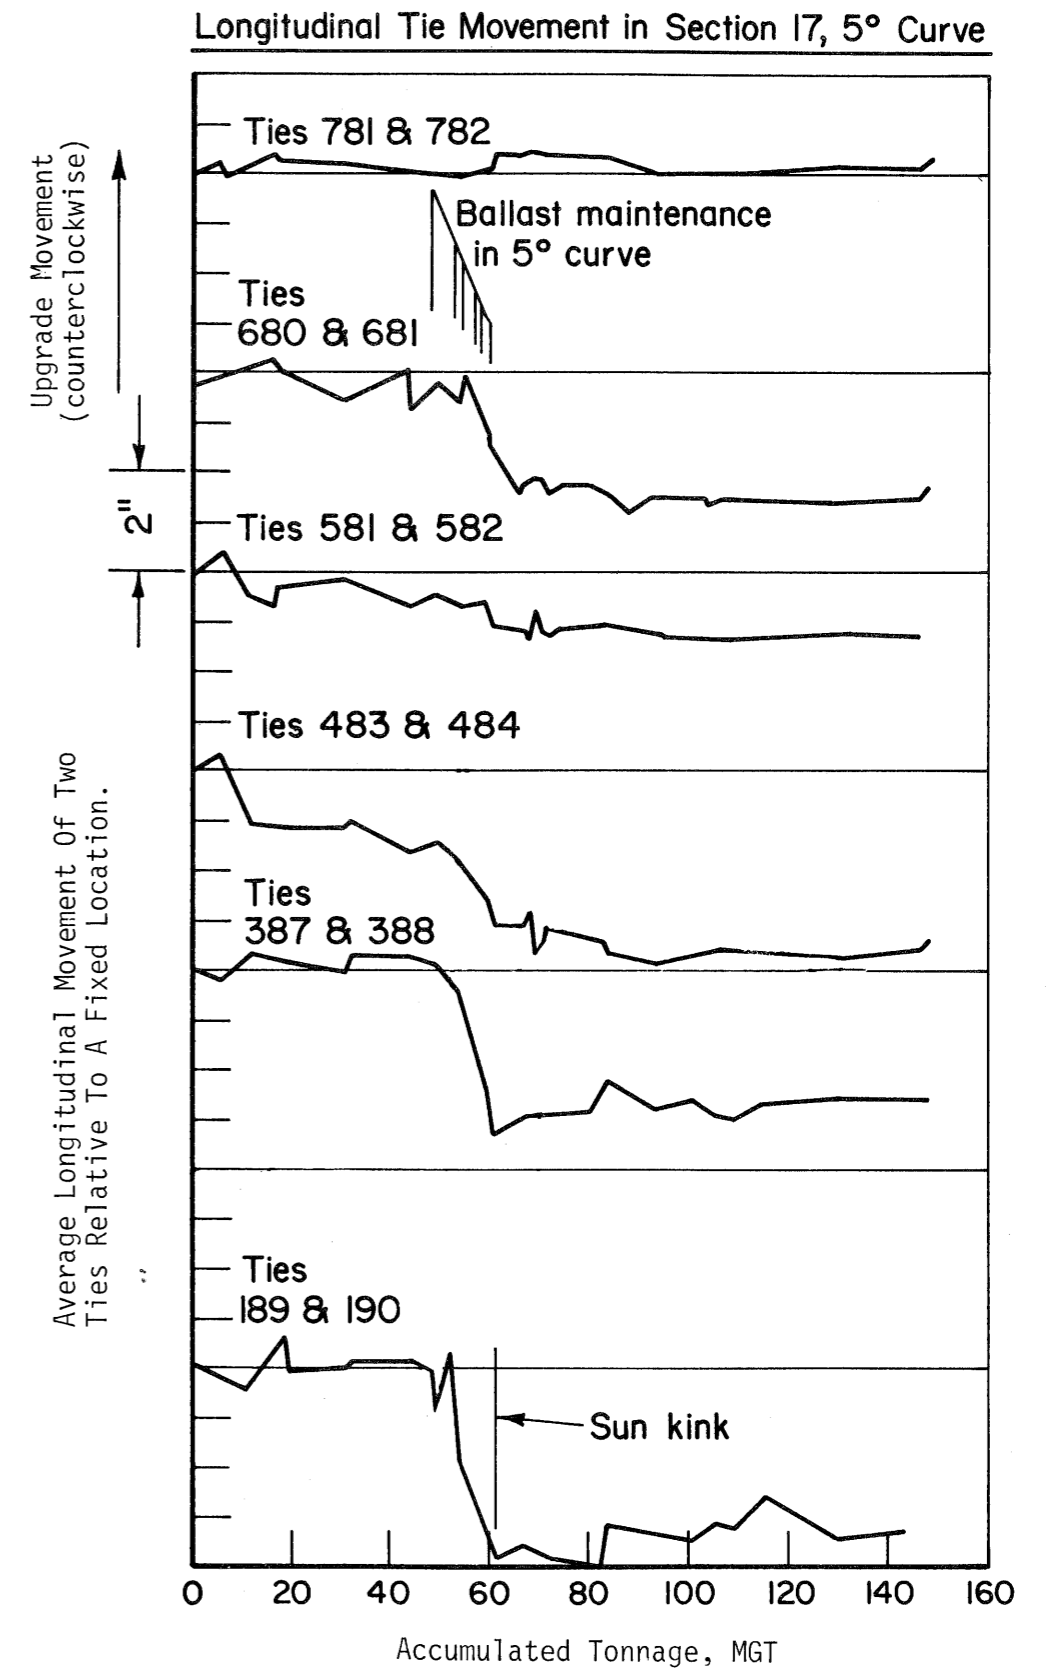
FIGURE 5-10. AVERAGE LONGITUDINAL TIE MOVEMENT VS. MGT FOR SPECIFIC SITES IN THE 5° CURVE, 2% GRADE OF SECTION 17.

maintenance had a major impact on the lateral stiffness of the track.⁵⁻⁴ The frequency of maintenance beginning at 48 MGT coincided with a rapid increase in tie movement seen earlier in figure 5-10. This tie movement culminated in the lateral instability incident at 61 MGT.
