CONCRETE AND WOOD TIE PERFORMANCE THROUGH 425 MGT

TRANSPORTATION TEST CENTER
PUEBLO, COLORADO 81001

1. Report No. FRA/TTC-81/06		2. Government Accession No.		3. Recipient's Catalog No.	
4. Title and Subtitle Concrete and Wood Tie Performance, 425 MGT				5. Report Date October, 1981

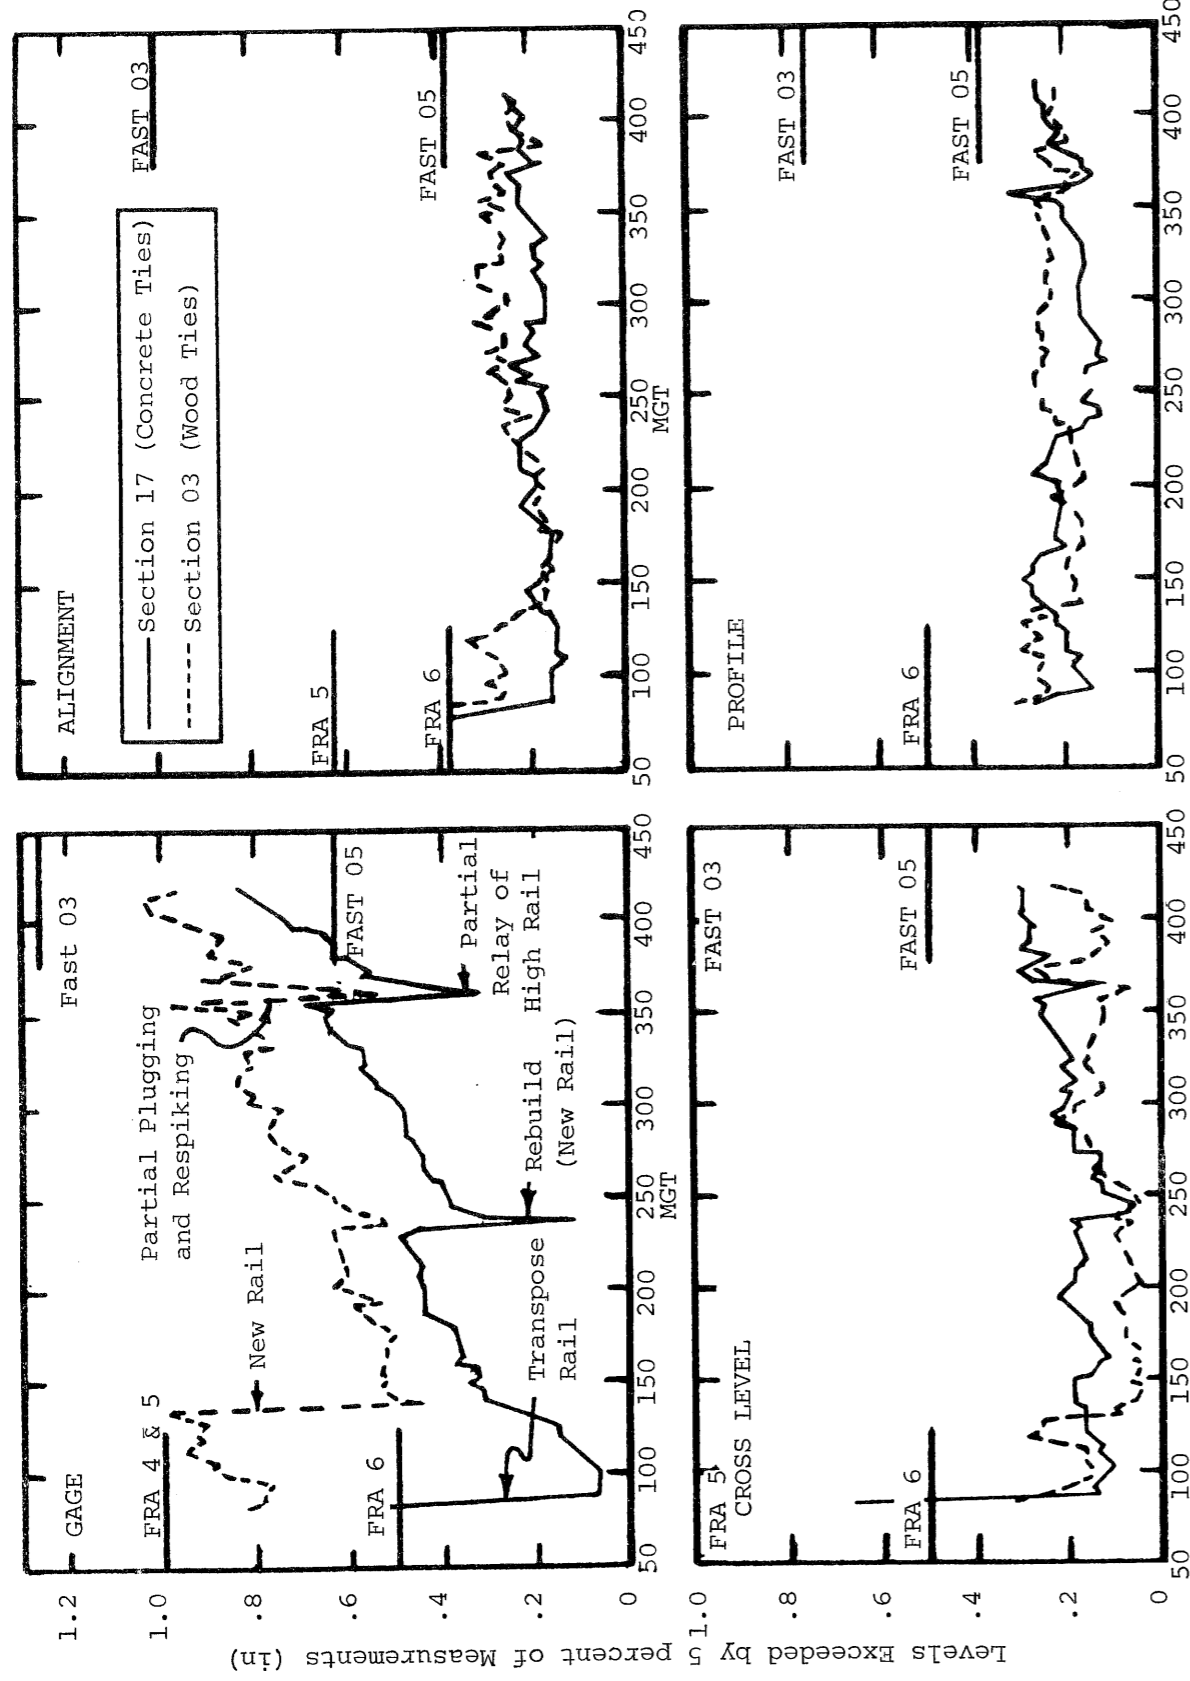
FIGURE 4-1. TRACK GEOMETRY MEASUREMENTS VS MGT ON 5° CURVES OF CONCRETE AND WOOD TIE TRACK.

Figures 4-1 and 4-2 show that with respect to alignment, crosslevel and profile, the track is maintained within the limits for FRA Class 6 track, although the 45 mi/h maximum track speed would require maintenance only to Class 4 levels. Only the gage variation on curved track displays any progression toward limits requiring maintenance. On wood tie track, this gage widening results from spike yielding in the ties and from rail wear. Gage widening on concrete ties results almost entirely from rail wear, but some compression of the insulator lip between the rail base and the fastener shoulder is also possible.

In the upper left-hand plot of Figure 4-1, it can be seen that:

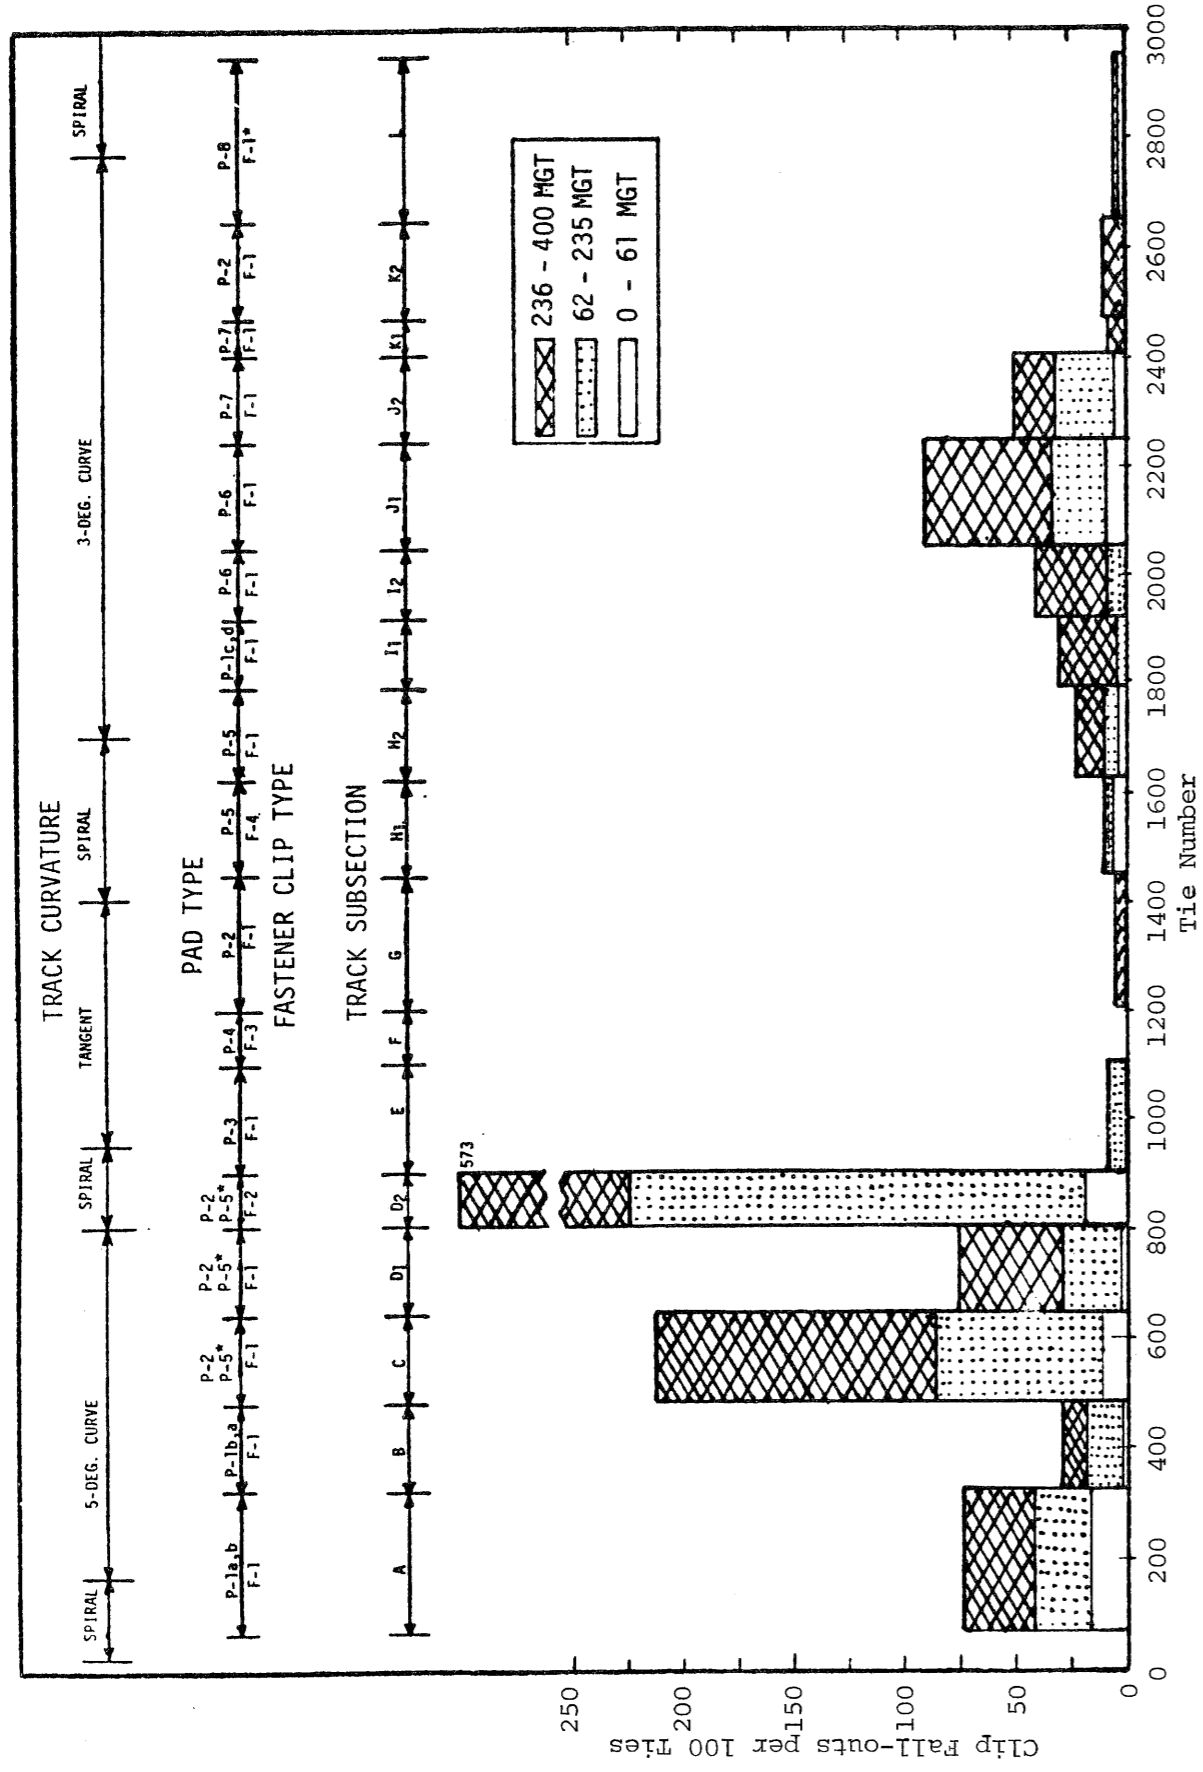
FIGURE 5-2. FASTENER CLIP FALL-OUTS IN CONCRETE TIE SECTION 17, 0-400 MGT.

The history of clip fall-outs through 425 MGT is summarized in figure 5-2. It can be seen that by far most fall-outs occurred in subsection D₂ where no external insulator was used. This installation with its internal insulator was not approved by the manufacturer. Other subsections where high fall-out rates occurred were:

One issue, which arose when the fall-out problem became evident, concerned the possible effect of pad hardness on the fall-out rate. In subsections C, D₁ and D₂ the soft Type P-2 pad was replaced with a medium hard Type P-5 pad at 235 MGT. It can be seen in Figure 5-2 that fall-outs continued at a slightly higher rate after the pad replacement. The highest fall-out rate in the 3° curve occurred with a hard type P-6 pad.

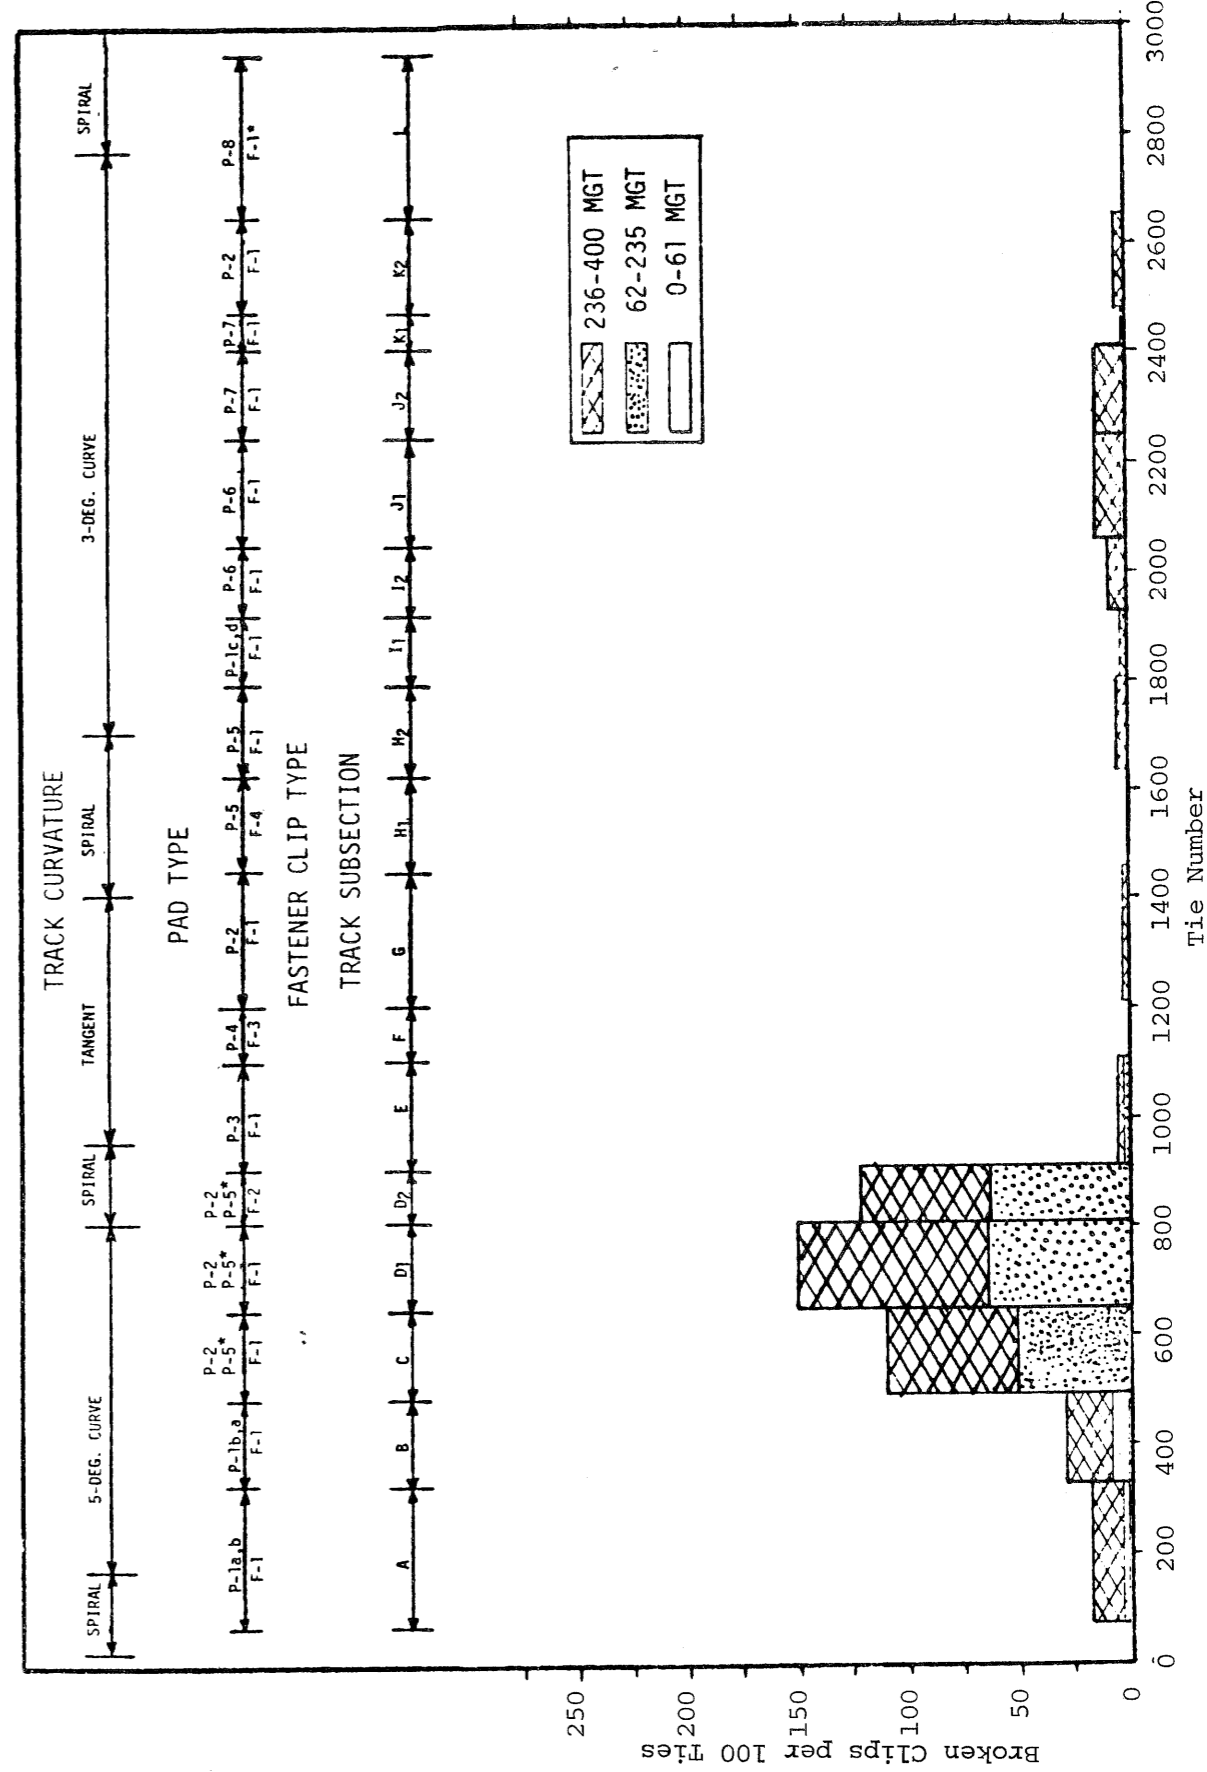
FIGURE 5-3. REPLACEMENTS OF BROKEN FASTENER CLIPS IN CONCRETE TIE SECTION 17.

A summary of clip fractures in Section 17 over the first 425 MGT is shown in Figure 5-3. The highest rates occurred in subsections C, D₁ and D₂. These fractures were approximately equally distributed over the period before 235 MGT (soft Type P-2 pads) and after 235 MGT (medium hard Type P-5 pads). Apparently, the hardness of the pads had little, if any, effect on the rates of either fall-outs or fractures.

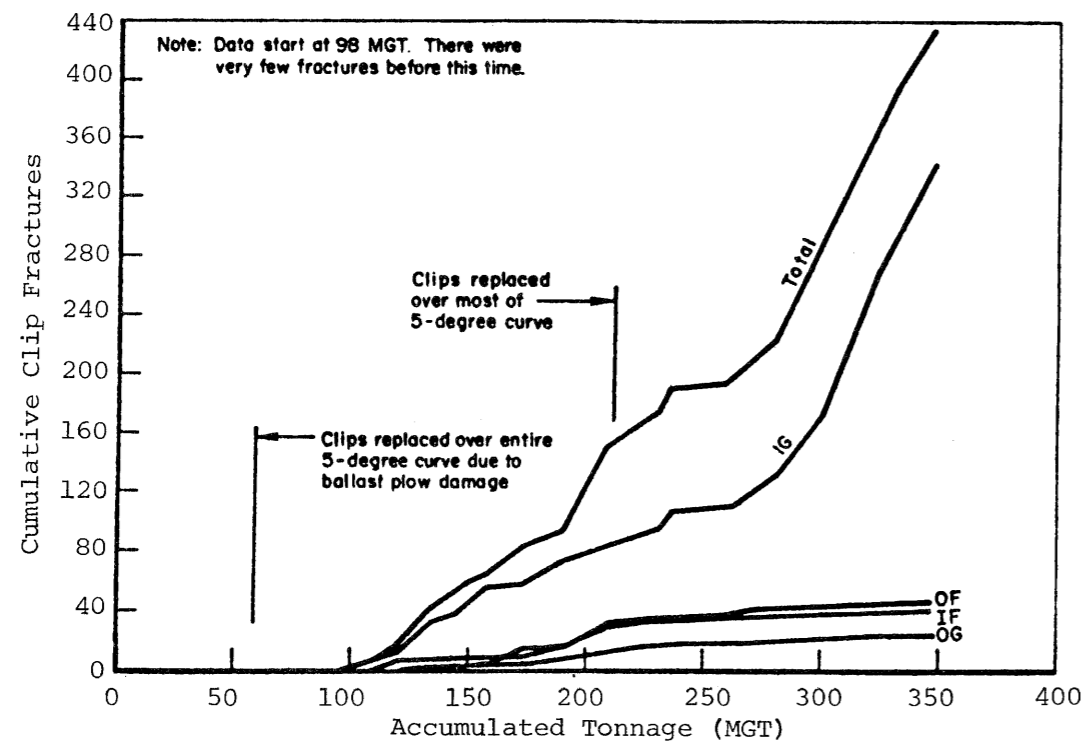
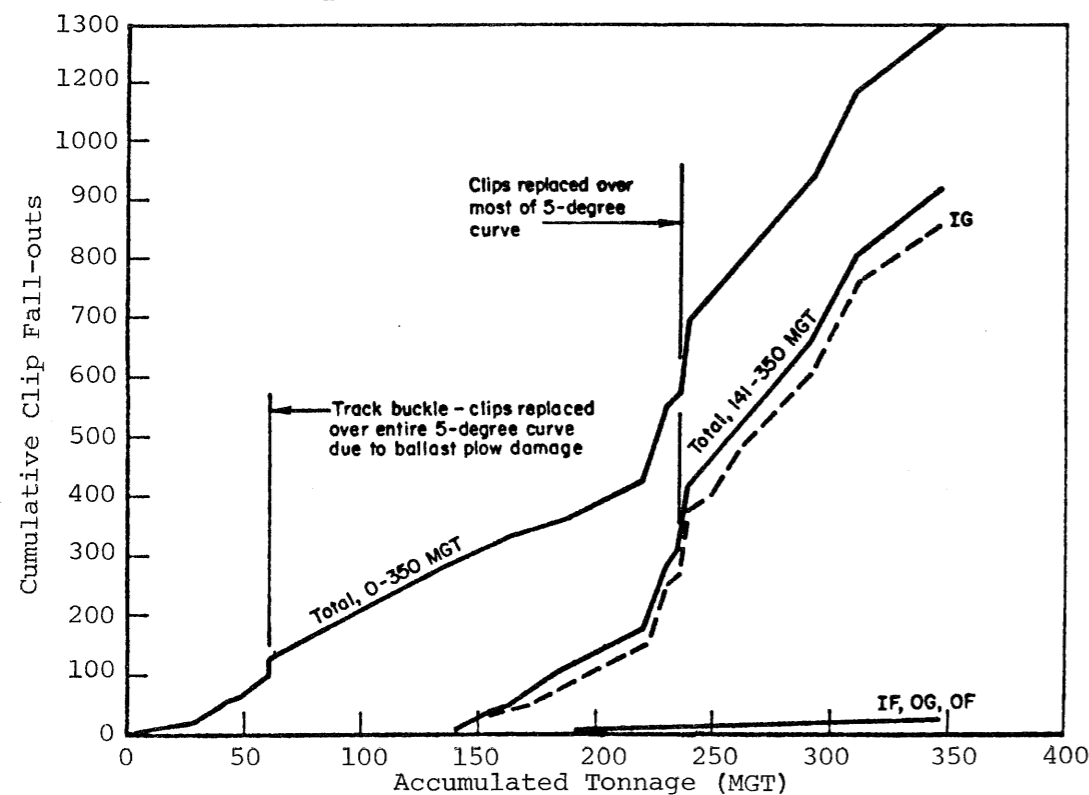
FIGURE 5-4. CLIP FALL-OUTS AND FRACTURES BY LOCATION ON TIE.

Rates of fall-out and fracture are plotted vs MGT, over the period of 0 to 350 MGT, in Figure 5-4. For a restricted period (141-350 MGT) the rates are presented by location on the tie. It can be seen from the figure that:

- Most clip fall-outs and fractures occurred at the inside gage (IG) location on the tie. Over all of this period of time (until a train derailment at 358 MGT) the counterclockwise travel of the train up the grade in the 5° curve resulted in a reduction of speed to about 31-32 mi/h, vs a balance speed of 34 mi/h with 4" superelevation. In addition, the draft force of the train on this grade is thought to have created a significant component of lateral load on the inside rail, directed radially inward.
- The clip fracture problem began at about 100 MGT, or about 40 MGT after the replacement of the original clips with clips from a batch made in England. (The replacement was necessitated by damage from a ballast regulator rather than by the sun kink at 61 MGT.)

Cumulative fastener fractures vs MGT for period 0-350 MGT (Subsection D₂ fractures not included).

Cumulative fastener fall-outs vs MGT for period 0-350 MGT (Subsection D₂ fall-outs not included).

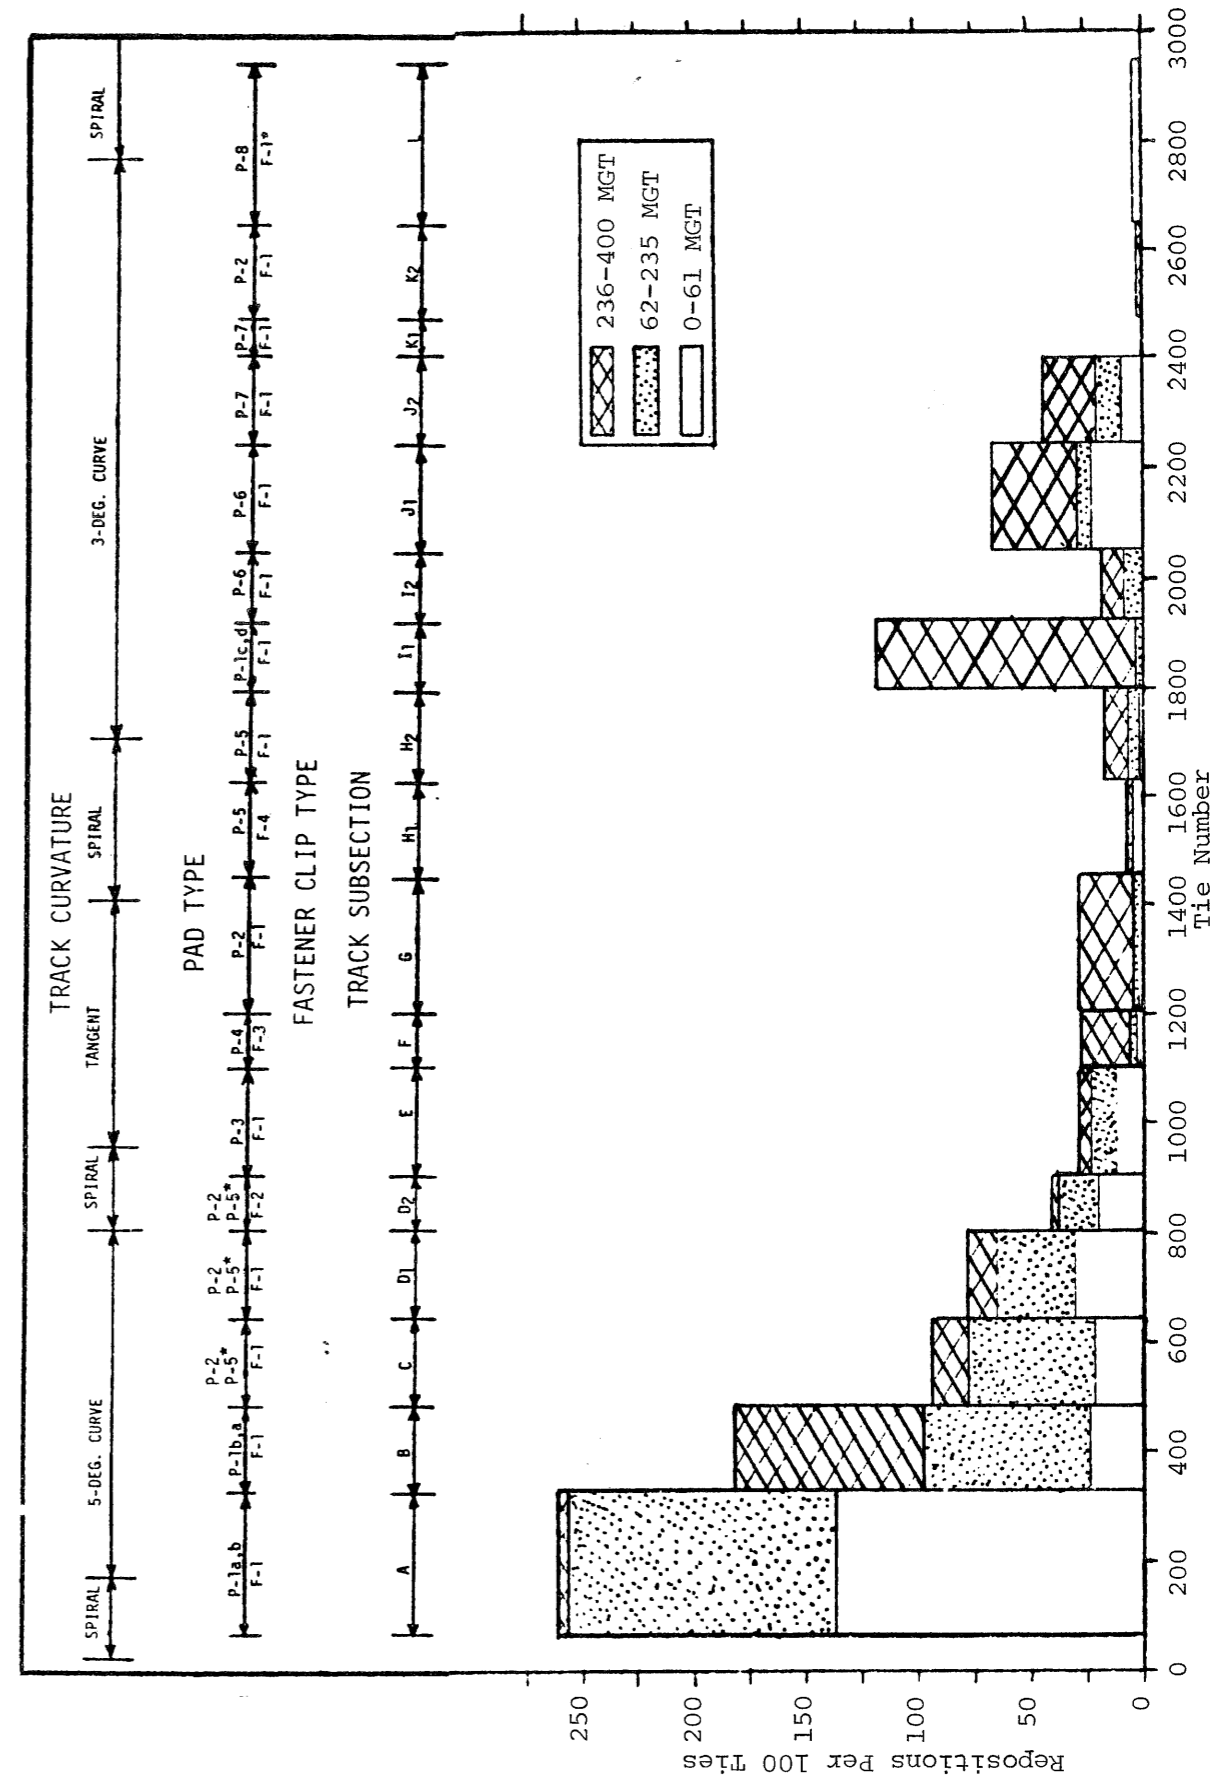
FIGURE 5-5. TIE REPOSITIONS IN CONCRETE TIE SECTION 17.

A primary function of the fastener system is to provide sufficient longitudinal restraint between the rail and the tie to inhibit tie skewing and bunching. A lower longitudinal restraint is indicated in Figure 5-5 by the frequency with which tie repositioning was required in the 5° curve with 2% grade and in the 3° curve. The restraint was lowest in subsections A and B, which were located near the bottom of the 2% grade in the 5° curve. The frequency of repositioning to correct tie skewing led to the installation of rail anchors in subsections A and B shortly before the rebuild at 235 MGT and in the 3° curve at 235 MGT. Anchors were installed on every tie in subsection A and on every other tie (normal wood tie practice) in subsections B and in the 3° curve. It can be seen in Figure 5-5 that subsection B continued to require repositioning after the 235 MGT rebuild.

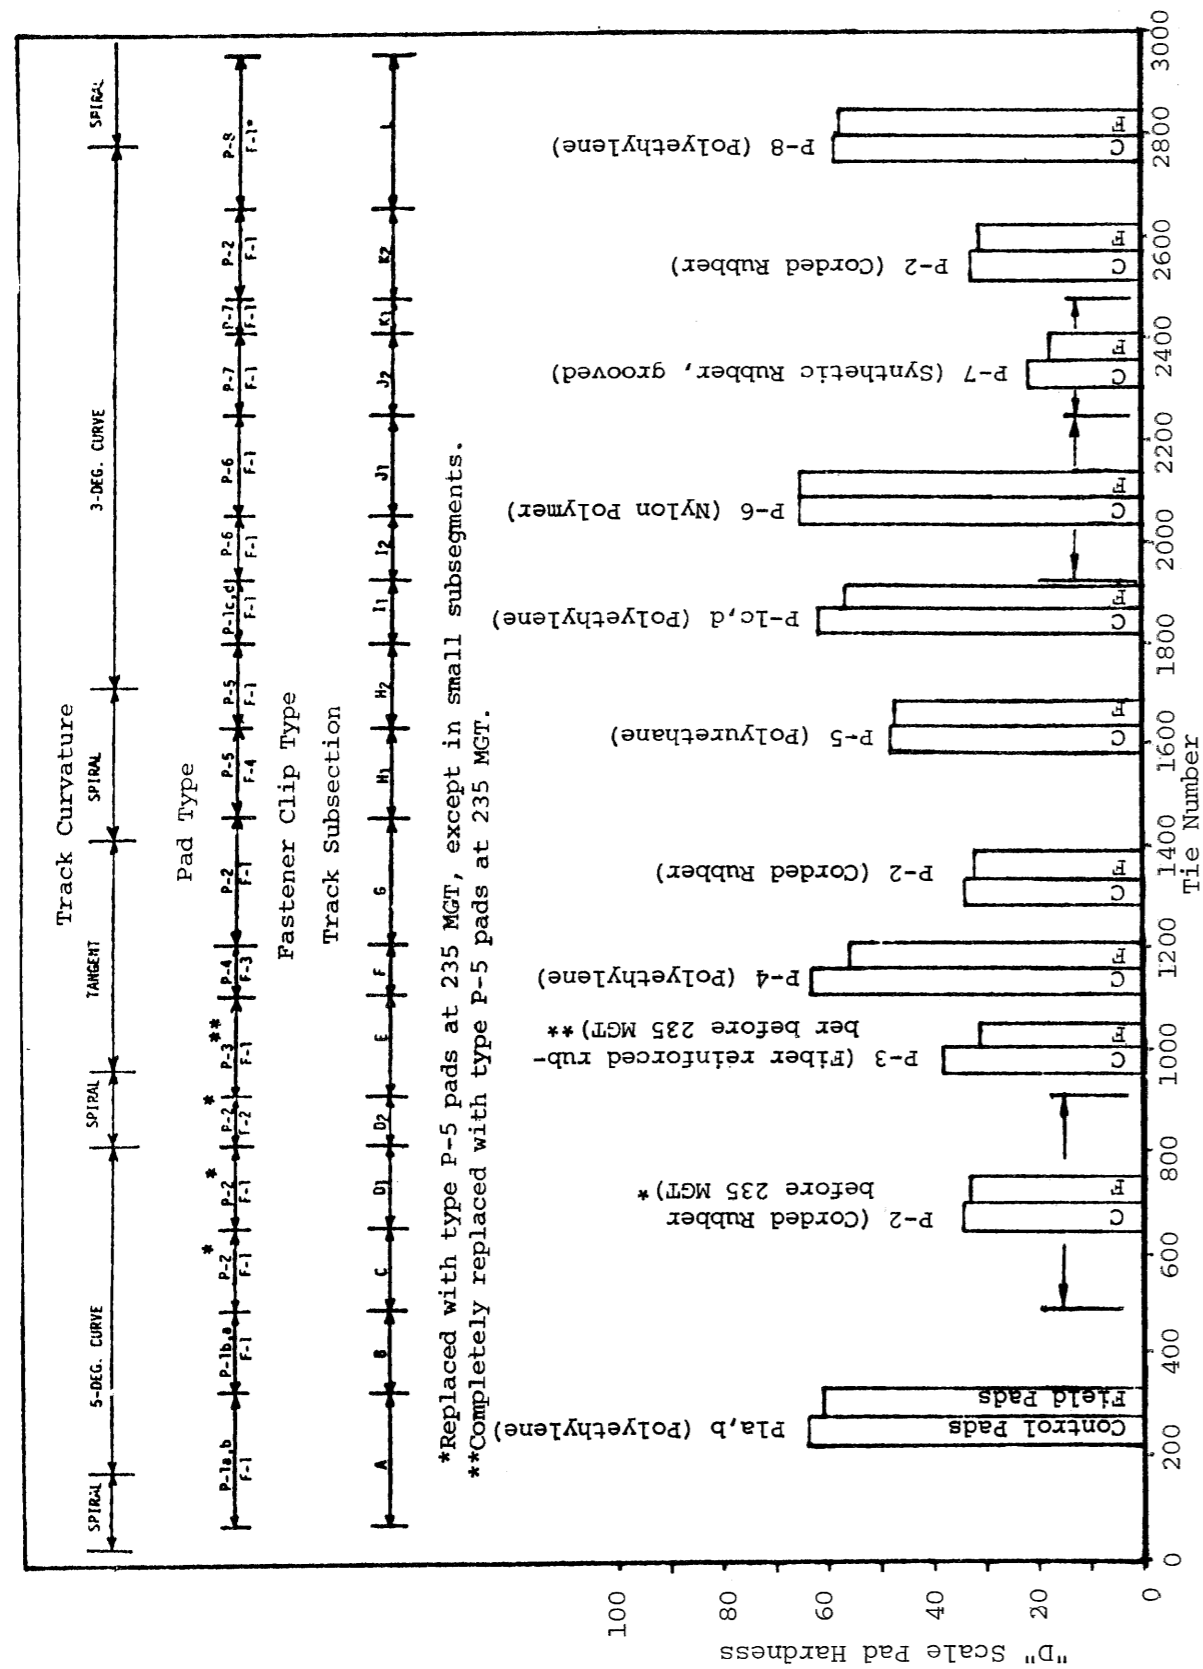
FIGURE 5-6. HARDNESS OF PADS IN CONCRETE TIE SECTION 17.

A total of 8 types of pads were installed in the various subsections of concrete tie Section 17 for the first 425 MGT. Pad materials and average hardness measurements are shown in Figure 5-6. "D" scale durometer measurements (a scale normally used for hard rubber) were taken on field pads and on control pads stored off-track. It can be seen that the field pads generally lost hardness relative to the control pads. The pads can be classed generally by their initial hardness as:

- "Hard" - Types P-1, P-4, P-6, P-8
- "Medium Hard" - Type P-5
- "Soft" - Types P-2, P-3, P-7.

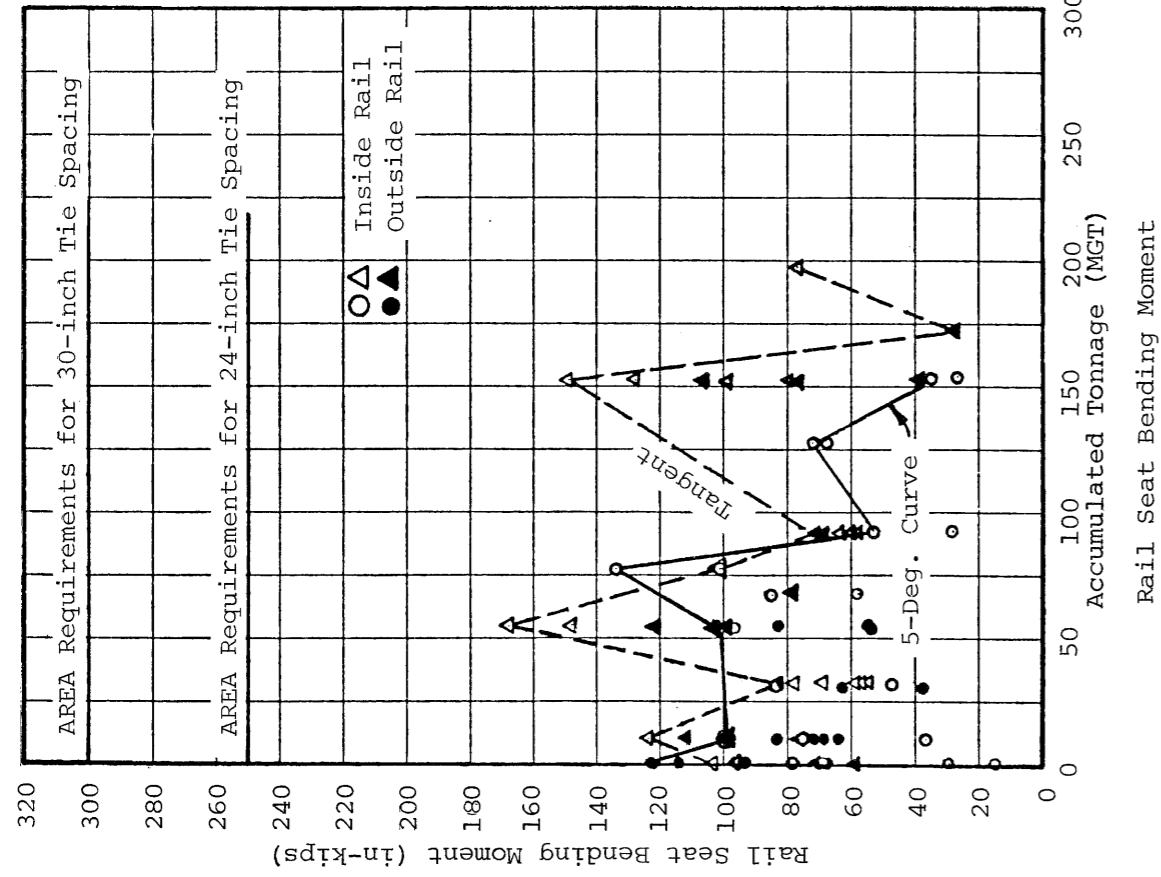
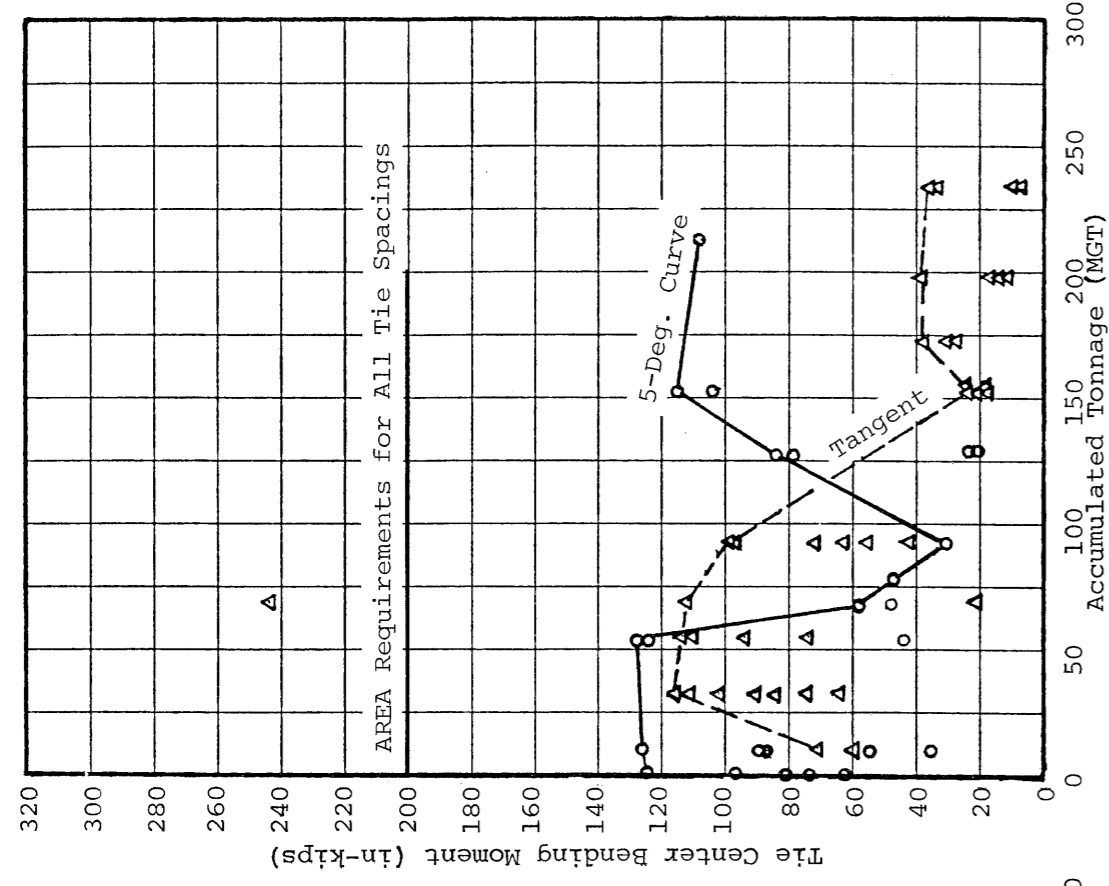
FIGURE 5-15. CONCRETE TIE BENDING MOMENT VS MGT - MAXIMUM VALUES FROM SINGLE TRAIN PASSES.

Strain gage measurements of tie bending moment at the rail seats and tie centers were made in Section 17 over the first 235 MGT. Several ties were instrumented at each of two measurement sites, one in the 5° curve and the other on tangent track. A summary of peak bending moments from each monitored train pass is shown in Figure 5-15. Also shown are the applicable AREA requirements for bending strength which is to be sustained before structural cracking occurs in laboratory qualification tests. A structural crack is defined as one which propagates to the level of a prestress tendon.

The data in Figure 5-15 show that, with the exception of one questionable tie center measurement, no measured bending moments approached the levels to which the ties were designed. In spite of the heavy concentration of 100-ton cars, this result can be anticipated from the fact that wheel flats are not allowed to develop in the FAST test train.

requirement of 300 in-kips at the rail seats, Figure 5-15, while the revenue service ties were designed to the 24" requirements (250 in-kips). The revenue service ties have developed rail seat cracks while the FAST ties have not.

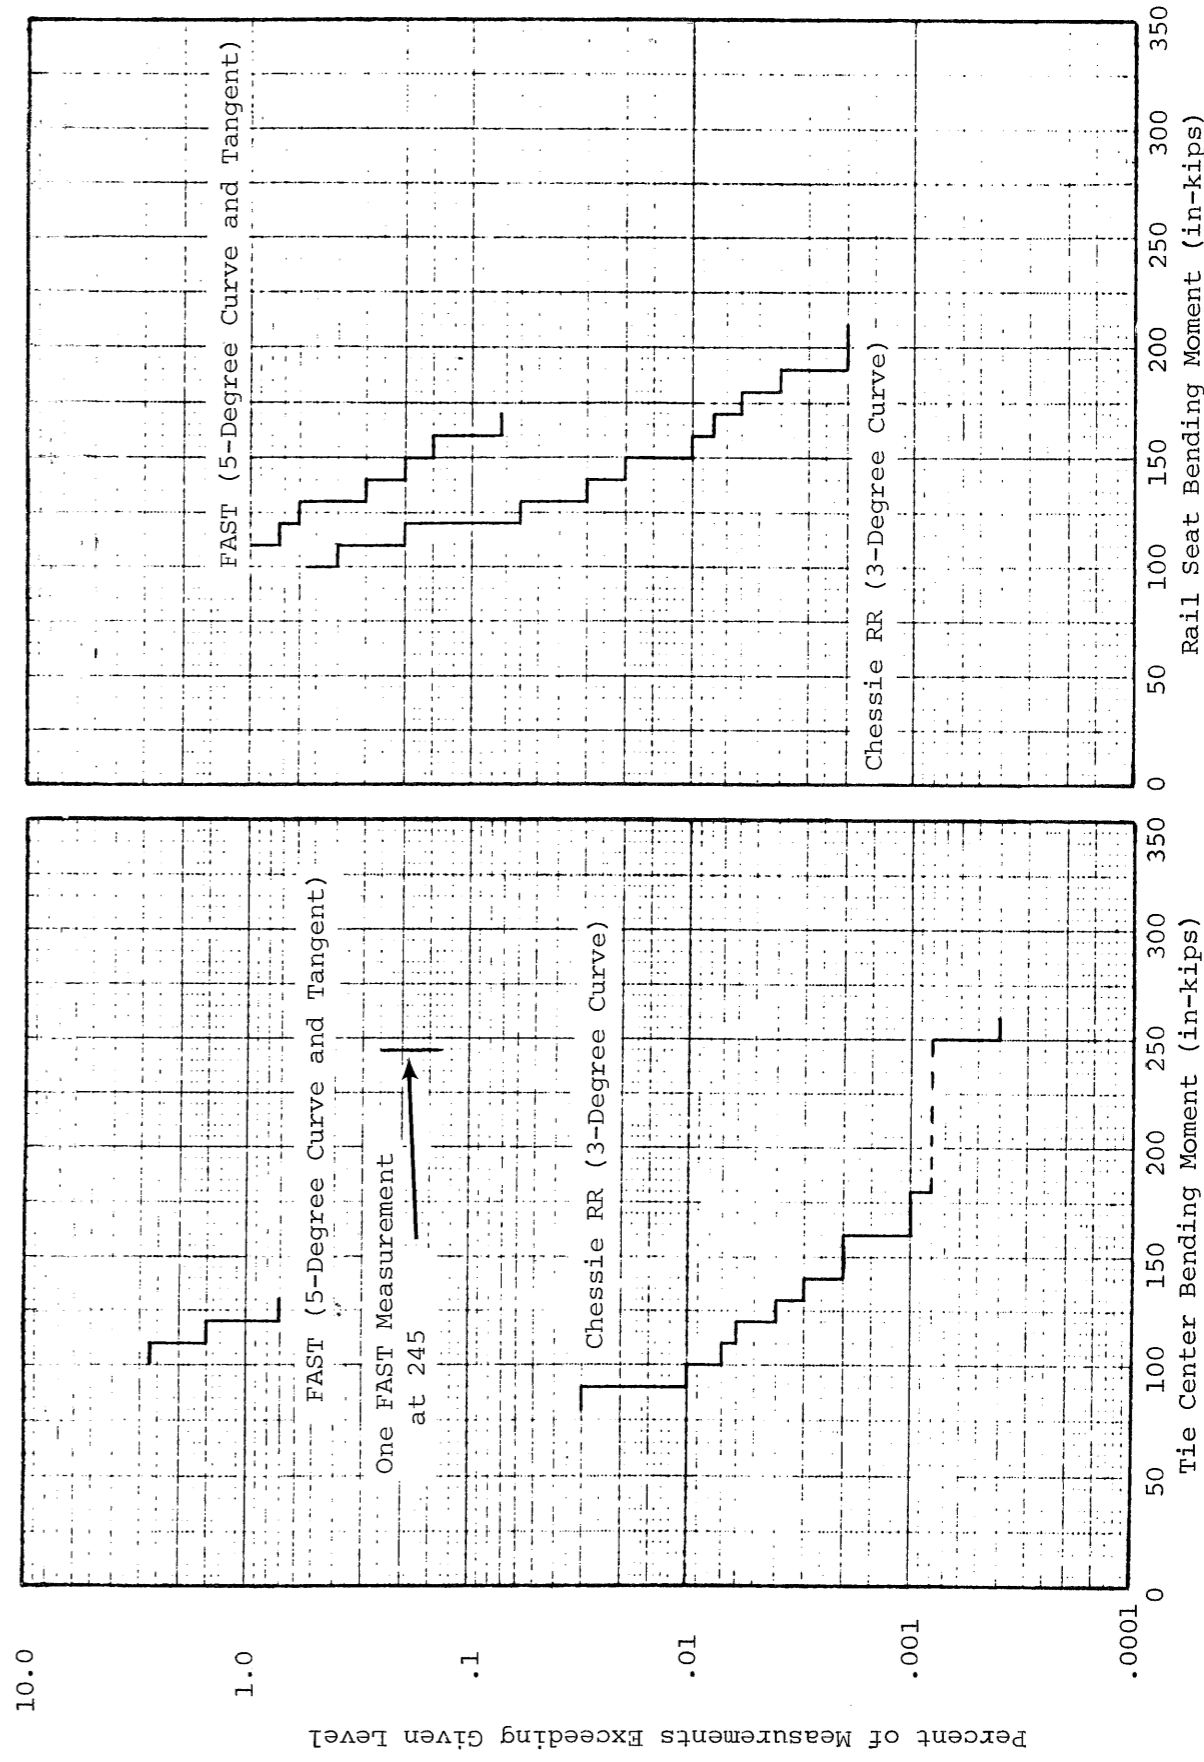
FIGURE 5-16. EXTREME VALUES OF TIE BENDING MOMENT AT FAST AND IN REVENUE SERVICE.

The difference between the FAST bending moment spectrum and one typical of revenue service is shown in Figure 5-16*. This figure shows only the low-probability range of the cumulative distribution of bending moments for all measurements taken at FAST and for approximately 200,000 measurements at the revenue service site, a 3° curve with a high percentage of unit coal train traffic. Meaningful levels of bending moment (greater than 100 in-kips) are produced at the revenue service site by less than 0.01% of tie center measurements and less than 0.1% of rail seat measurements. While the FAST train produced these levels at a much higher frequency, its maximum values are significantly lower than those from the revenue service site.

It should be noted that only the revenue service site produced bending moments (at tie center) comparable to the AREA requirements for laboratory qualification tests. The FAST ties were designed to the 30" tie spacing

* Data in Figure 5-16 were processed with frequency bandwidth of 0-300 Hz. Recent processing of data from the Northeast Corridor track reveals high frequency spikes in the range from 300-2,000 Hz. The spikes are due to wheel flats which are present in all revenue service traffic but only rarely in the FAST train. Therefore, the differences in FAST and revenue service data shown in Figure 5-16 should be greater when the data are processed at the higher bandwidth.
