FRA/TTC-80/06

EVALUATION OF STEEL TIE PERFORMANCE AT THE FACILITY FOR ACCELERATED SERVICE TESTING

SEPTEMBER 1980

FINAL REPORT

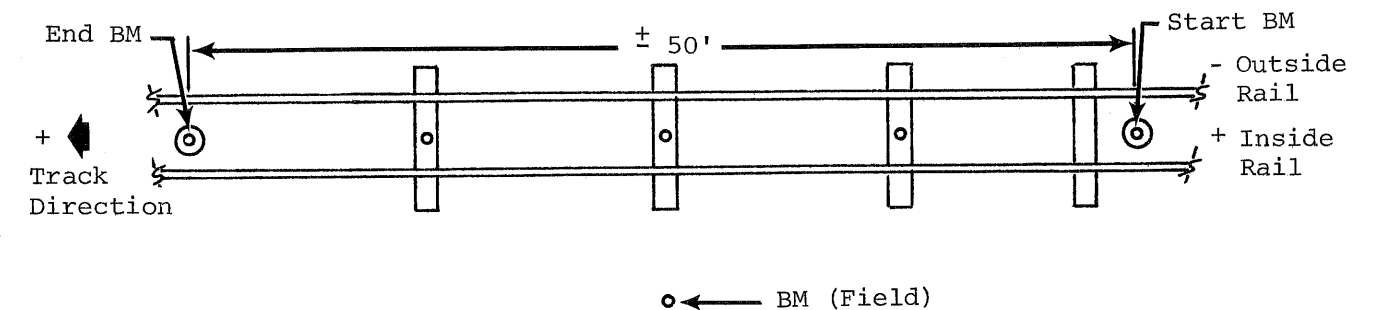
FIGURE 2-1. TYPICAL STEEL TIE PERFORMANCE MEASUREMENT ZONE AND BENCHMARKS.

Performance measurements were centered around 12 benchmarks specially installed for this experiment between the two rails and spaced over Section 06 and a portion of Section 07 (figure 2-1). Measurements of lateral and longitudinal shift were taken relative to the benchmarks. Gage widening and crosslevel were measured on groups of ties centered on the benchmarks. Additional survey-to-benchmark (STB) measurements were taken at regular STB sites in the two sections. One measurement of horizontal track stiffness was taken at 20 MGT. The significant results of these measurements are summarized below.

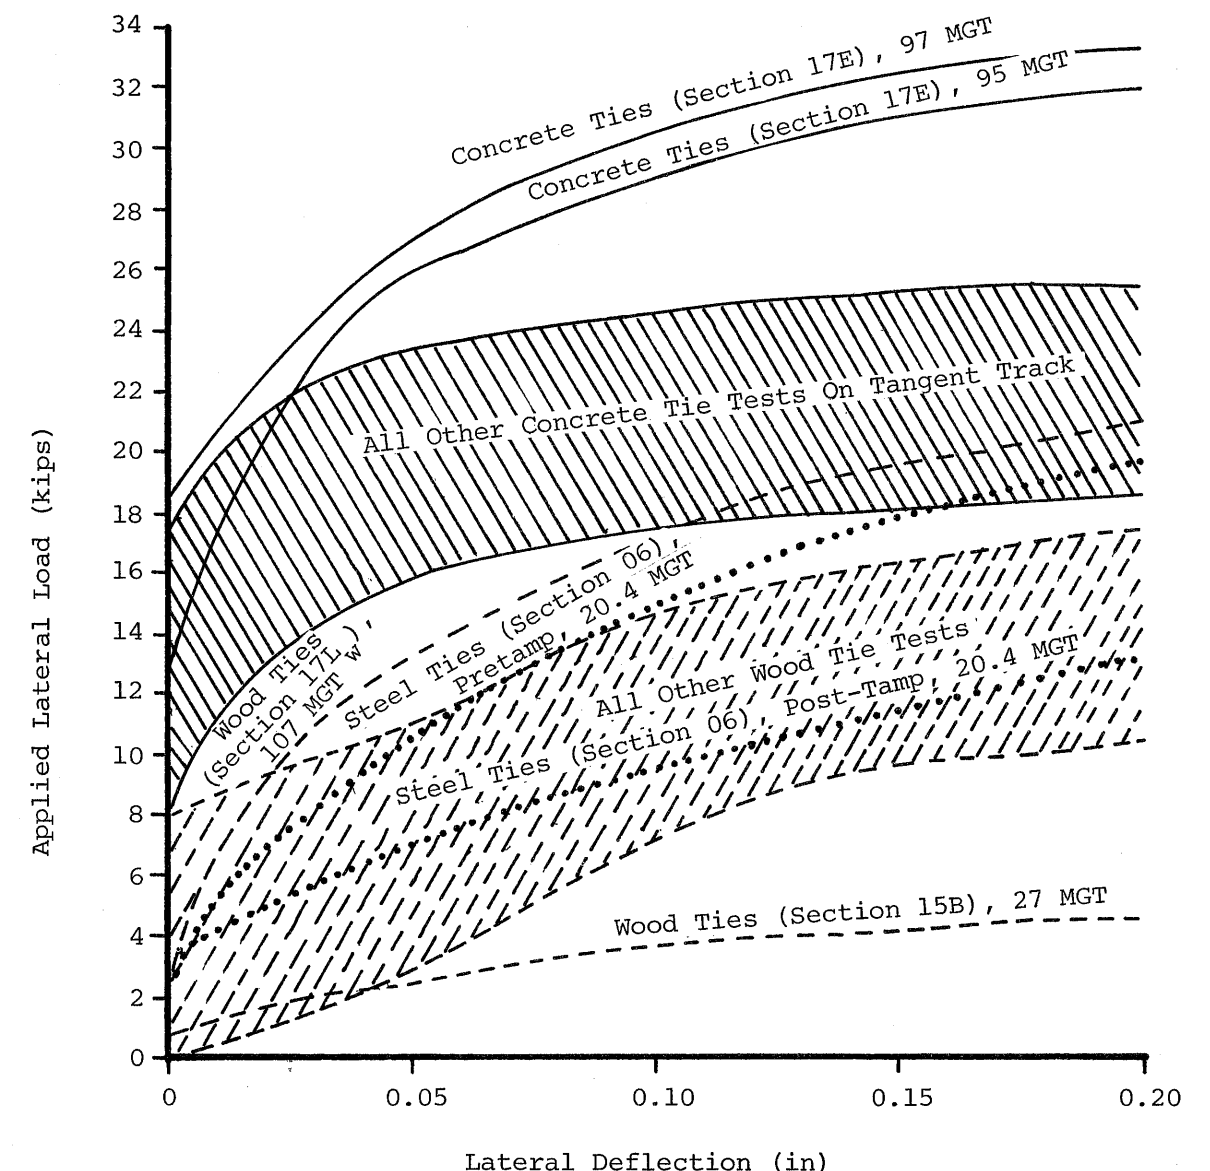
FIGURE 2-4. FORCE-DEFLECTION CURVES FROM HORIZONTAL TRACK STIFFNESS TESTS ON WOOD, CONCRETE, AND STEEL TIES.

Tests of horizontal track stiffness at FAST consist of applying a lateral load through a yoke to one rail at two points 60" apart. Lateral displacements were measured at 11 locations along the track, 10 ties apart. Two such measurements were taken on the steel tie section at 20.4 MGT, just before and after the tamping operation. In figure 2-4, the force-deflection results were compared with a summary of results from measurements on wood and concrete ties. In comparison to results from wood ties, the steel tie lateral strength before tamping was about the same as the average strength of the wood tie track at very small deflections, and approximated the upper range of wood tie strength at larger deflections (up to 0.2"). Tamping reduced the steel tie

lateral strength to slightly less than the average of the wood tie strength. These tests indicate that the steel ties should perform about as well as wood ties with regard to resistance to lateral movement.

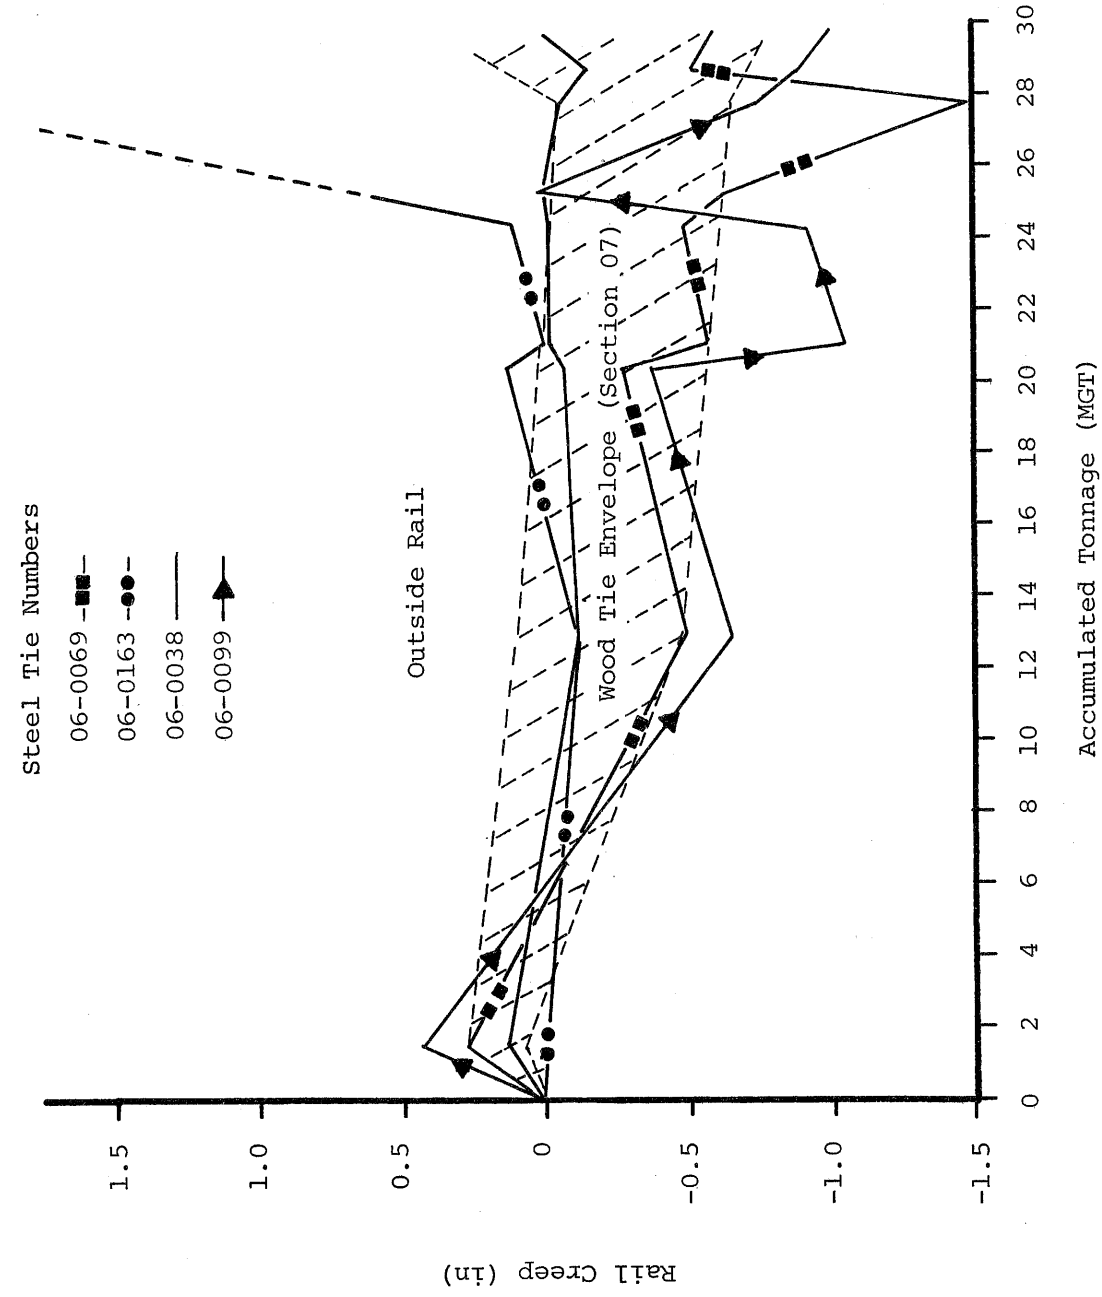
FIGURE 2-6. RAIL CREEP VS. MGT FOR OUTSIDE RAIL OF SECTIONS 06 (STEEL TIES) AND 07 (WOOD TIES).

Rail creep data are plotted vs. MGT for the inside and outside rails in figures 2-5 and 2-6, respectively. The loss of fastener strength in the higher-curvature end of the steel tie section is definitely indicated by figure 2-5.

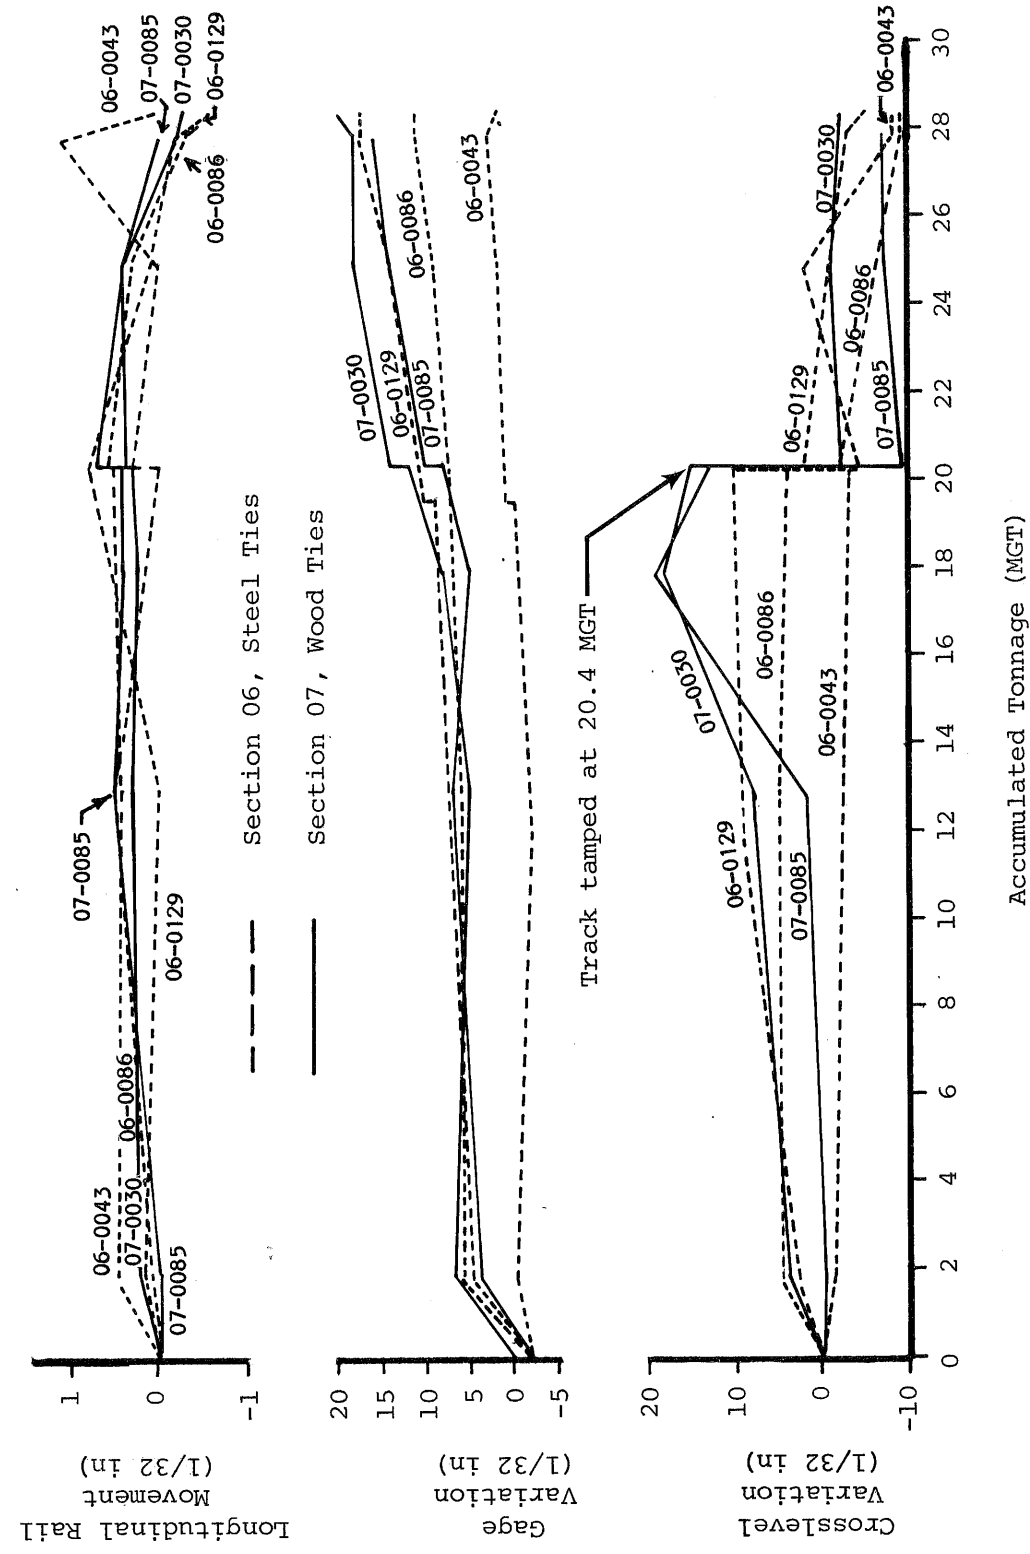
FIGURE 2-7. SUMMARY OF SURVEY-TO-BENCHMARK MEASUREMENTS VS. MGT.

In addition to the steel tie performance experiment, regular measurements were taken at STB locations in the two test sections. Longitudinal rail movement, gage reduction, and crosslevel variation are plotted vs. MGT in figure 2-7. Each of these measurements shows approximately equivalent performance for the wood tie and steel tie track. However, the highest curvature for the steel tie track, among the data locations represented in figure 2-7, is 3.5°. All wood tie track has 5° curvature.

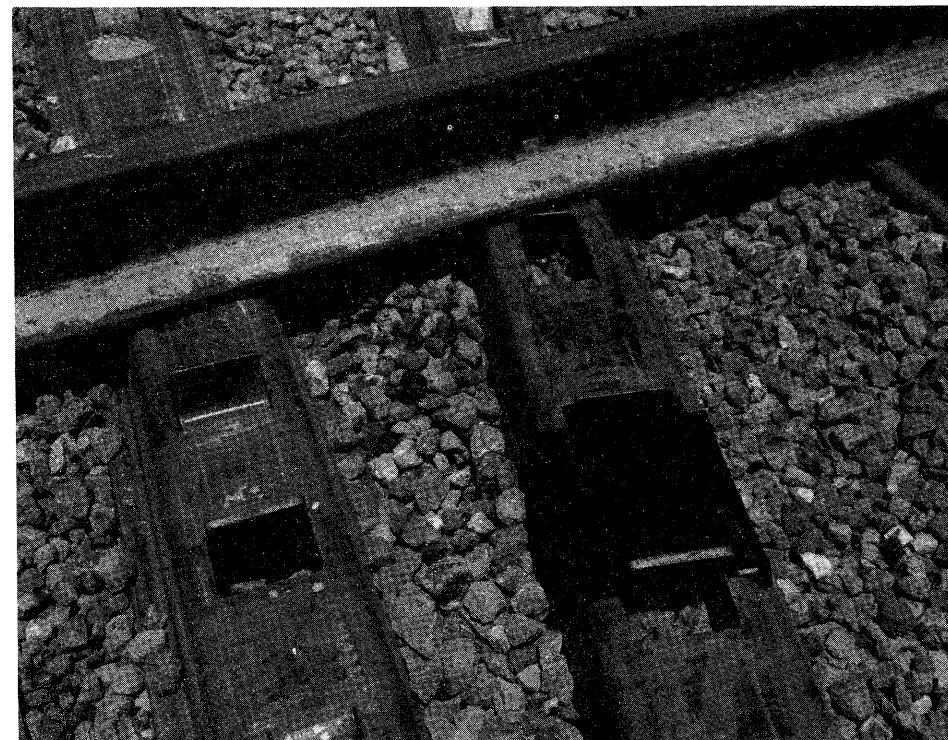
FIGURE A-2. TIE RAIL SEAT WITH PAD IN PLACE.

Figures A-2 through A-5 illustrate the tie installation, which took place in June 1976. High-density polyethylene pads were placed over the rail seat and the partially bent fastener tabs (figure A-2). After placement of the rail, the fastener tabs were bent by hand tools (figure A-3) while the gage was controlled with jacks and gage bars. Figure A-4 shows the ties in place before track raising. Figure A-5 shows the completed section just before the beginning of operations in September 1976. Figure A-6 shows the section on November 22, with gage rods and broken tabs evident. Figure A-7 shows an example of a tab with a lateral crack.

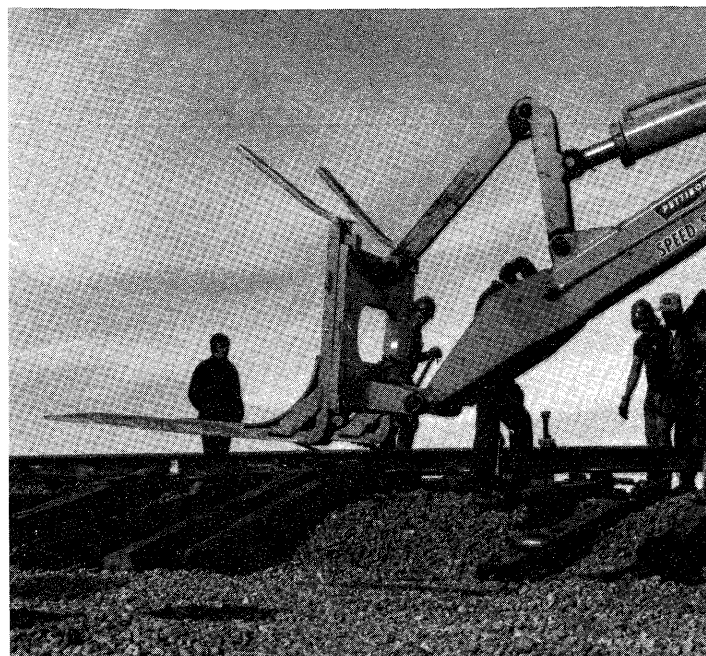
FIGURE A-9. TIE REMOVAL, DECEMBER 1976.

Figure A-8 illustrates the cutting of the fastener tabs required for removal in late December 1976. After the rail was jacked, the ties were removed in conventional fashion, as shown in figure A-9.
