Research Results

RR08-21
December 2008

Evaluation of Tie Plate Cracking on Composite Ties

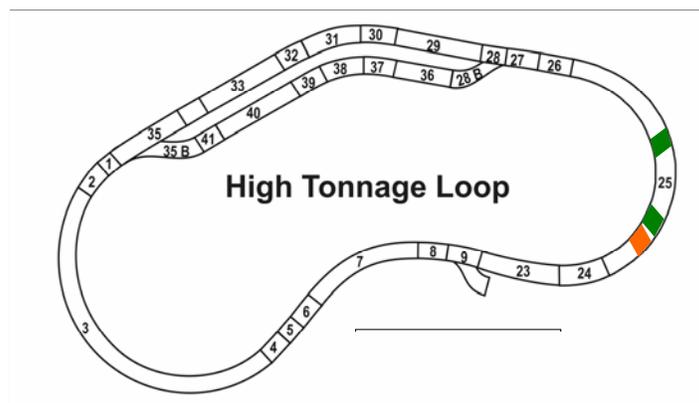
Figure 1. Test Tie Locations on HTL.

Recently, a segment of plastic/composite ties installed on the HTL at FAST (Figure 1) and exposed to more than 900 MGT exhibited a higher rate of tie plate cracking in comparison to tie plates mounted on wood ties in a similar location. All fractures were on the high rail along the field side spike holes. Visual inspection of the fractured tie plates suggested fatigue was the major issue contributing to failures. Laboratory and field tests were conducted to determine if tie plate stress for plastic ties was significantly higher than stresses in wood ties under similar operating conditions.
