IMPROVING THE EFFICIENCY AND EFFECTIVENESS OF RAILCAR SAFETY  
APPLIANCE INSPECTIONS USING MACHINE VISION TECHNOLOGY

THESIS

Submitted in partial fulfillment of the requirements  
for the degree of Master of Science in Civil Engineering  
in the Graduate College of the  
University of Illinois at Urbana-Champaign, 2006

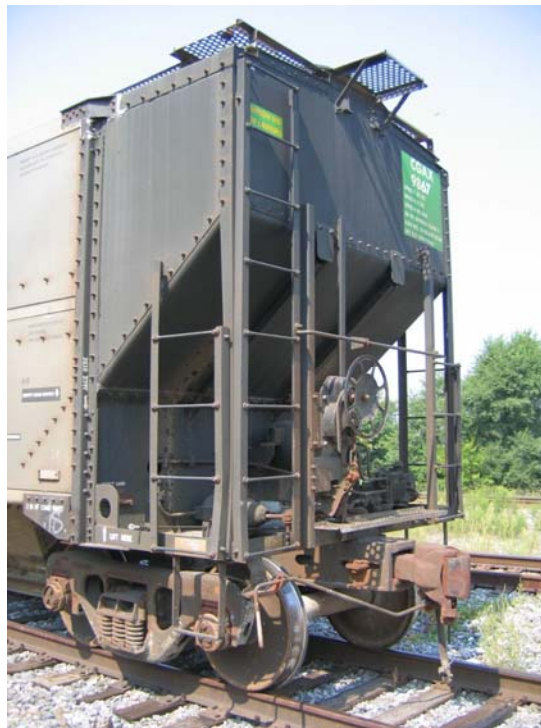
**Figure 1.1 Picture of the end of a covered hopper car showing the safety appliances: sill step, side and end ladder, brake step, side and end handholds, and the brake wheel**

Safe and efficient movement of trains and execution of railroad employee duties are critically important to the railroad industry. Consequently, any method of providing additional productivity, efficiency, and safety benefits is of great interest to railroads. Currently, before a train departs a rail yard it is inspected for a variety of defects, including safety appliance defects. Safety appliances on railcars are the interface between humans and rolling stock with regard to movement of railcars. They consist primarily of handholds, sill steps, brake steps, ladders, running boards, uncoupling levers, and the brake wheel (Figure 1.1).

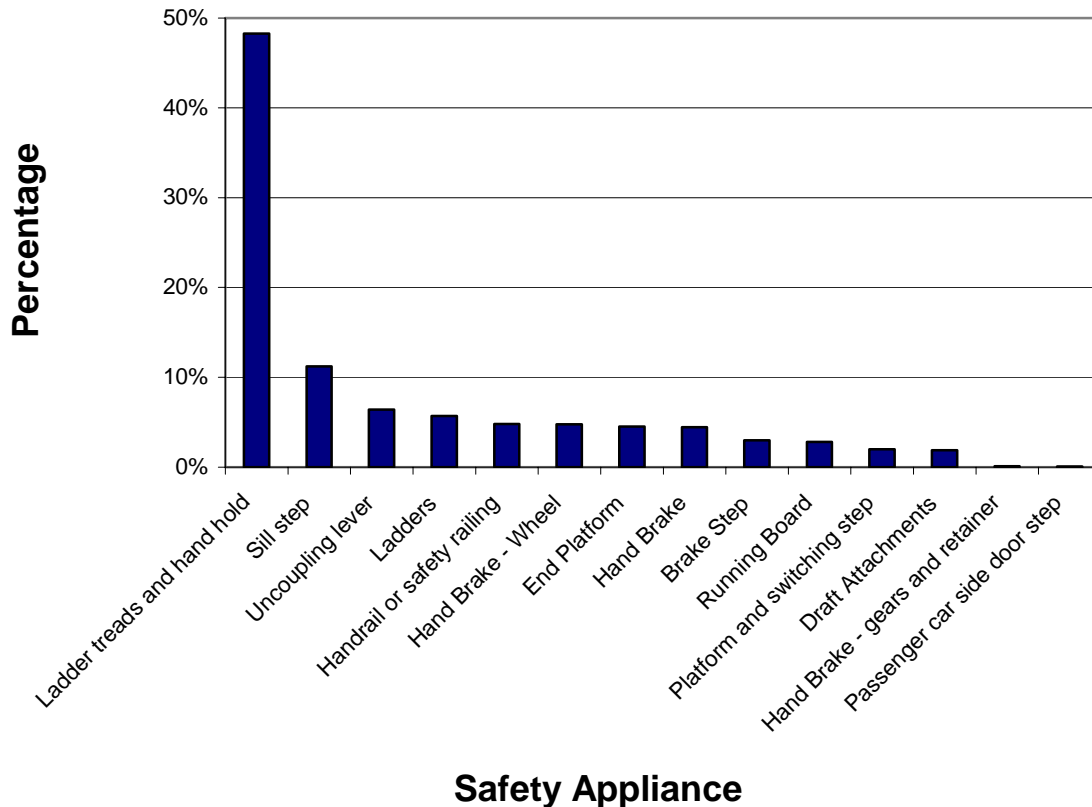
**Figure 2.1 FRA safety appliance defects found by FRA inspectors between 1995 and 2004 grouped by major rule of CFR Part 231**

The FRA maintains a database of all inspections conducted by both federal and state inspectors. The data are grouped by specific part of the CFR and also by type of inspector; state or local. The data for Part 231 are divided into major rules. Generally, each major rule pertains to a specific safety appliance. In the case of ladder treads and handholds, as many as four separate safety appliances are covered by one major rule. Other appliances, such as the hand brake, are separated into three major rules. Analysis of these data for the period 1995-2004 showed that 59% of defects occurred on ladder treads, handholds, and sill steps (FRA 2005, Figure 2.1).

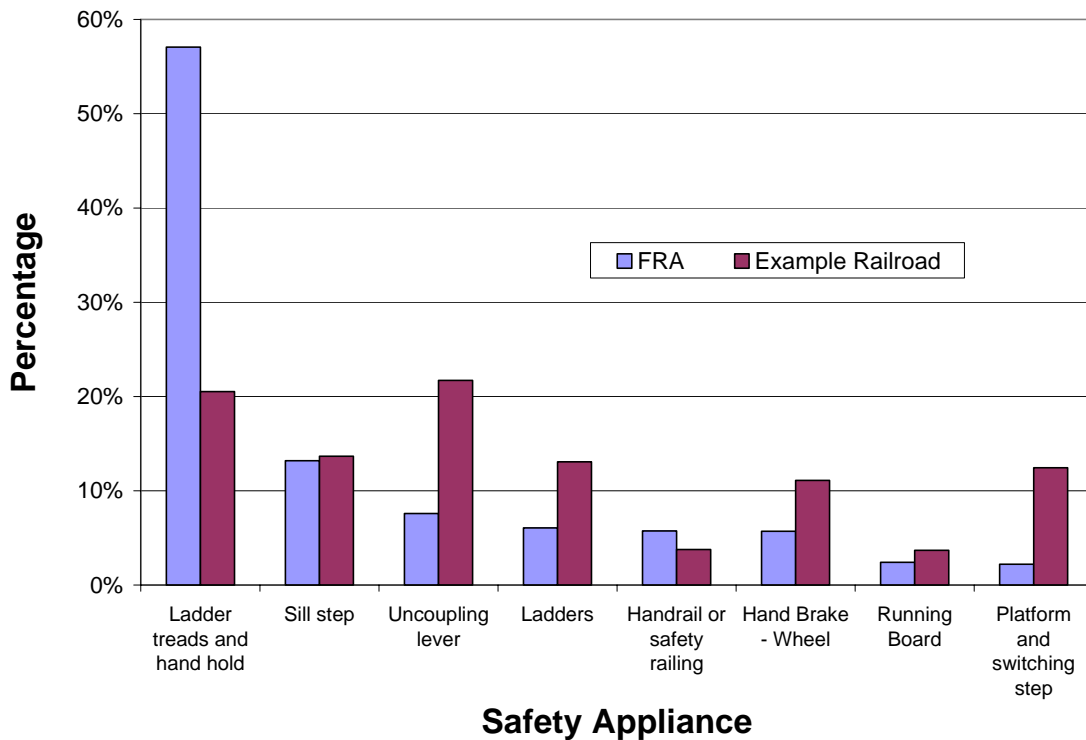
**Figure 2.3 Comparisons of FRA and Class 1 railroad safety appliance defects by car type**

In addition, the differences between the FRA defect rates and the railroad bad order rates are the result of differing amounts of inspection scrutiny. FRA inspectors spend considerably more time inspecting a railcar than do railroad carmen. They may climb on and over a car, checking all the handholds and running boards, whereas railroad carmen are not expected to, nor do they have time to, conduct such an intensive inspection on a routine car inspection. The differences in percentage of safety appliance defects between FRA and railroad car inspections are broken down by appliance in Figure 2.3.

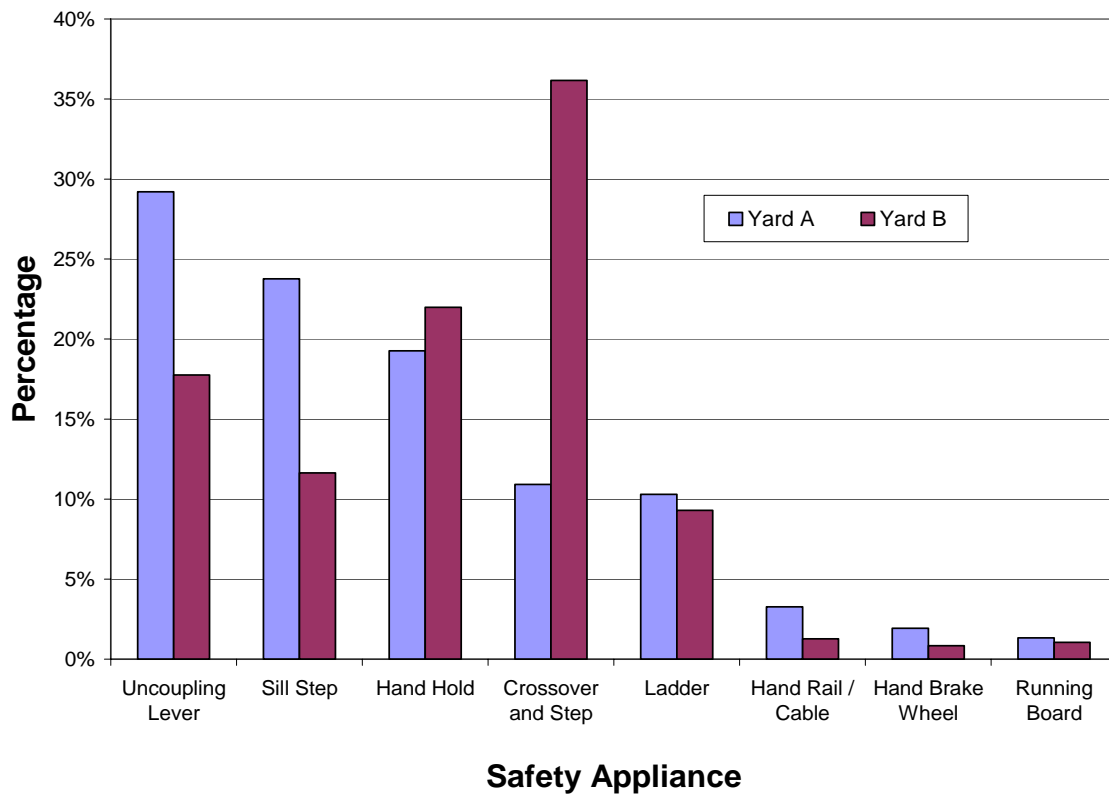
**Figure 2.4 Comparison of safety appliance defects at two Class 1 railroad yards**

Interestingly, there are considerable differences between the distributions of safety appliances defects in the two yards (Figure 2.4). In Yard A there are more sill steps and operating lever defects whereas in Yard B over 35% of the defects are found on crossover steps alone. According to management at one Class I railroad, the percentage of safety appliance defects is affected by the amount of interchange traffic (Hoyt 2004, Smith 2004). Another cause of the inter-yard variability in safety appliance defects is the differing distribution of car types due to different yard and traffic make-up (Smith 2004, Ameen 2006).

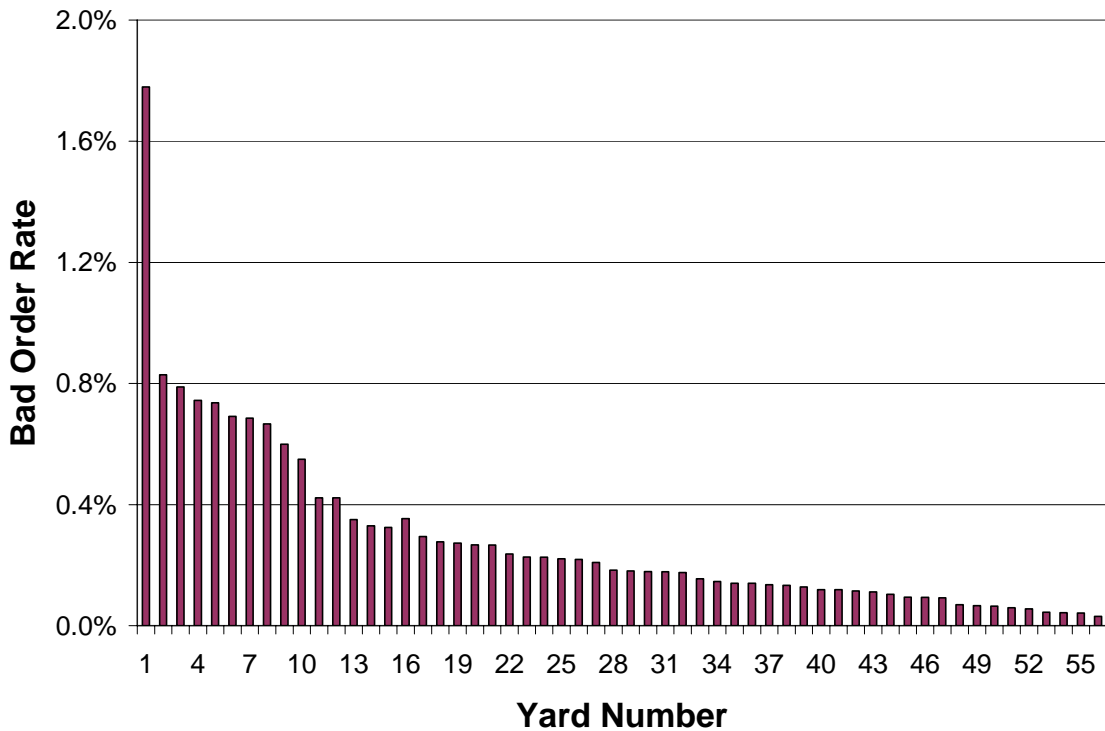
**Figure 2.5 Distribution of safety appliance bad order rates at 60 locations on one Class I railroad**

for October and November of 2005 for each location in which cars were reported to the railroad's mechanical inspection database as being inspected. Locations in which fewer than 1,000 cars were inspected during the two-month period were omitted from the analysis because the average number of cars inspected at all the locations was 29,000 and locations with fewer than 1,000 railcars inspected in a two-month period are likely representative of a location that does not specialize in regular inspection of railcars. The data from the two-month period consists of 2.38 million car inspections and the resulting 5,216 mechanical bad orders from a total of 60 locations on the railroad. The safety appliance bad order rates ranged from 0.018% to 1.779% at each yard with an average rate of 0.269% and a median rate of 0.178% (Figure 2.5).

Using the estimate that only 25% of safety appliance defects result in the bad ordering of the car, the number of cars with defective safety appliances is 1.076%. All but one of the 60 locations has a bad order rate of less than 1.0% (Figure 2.5).

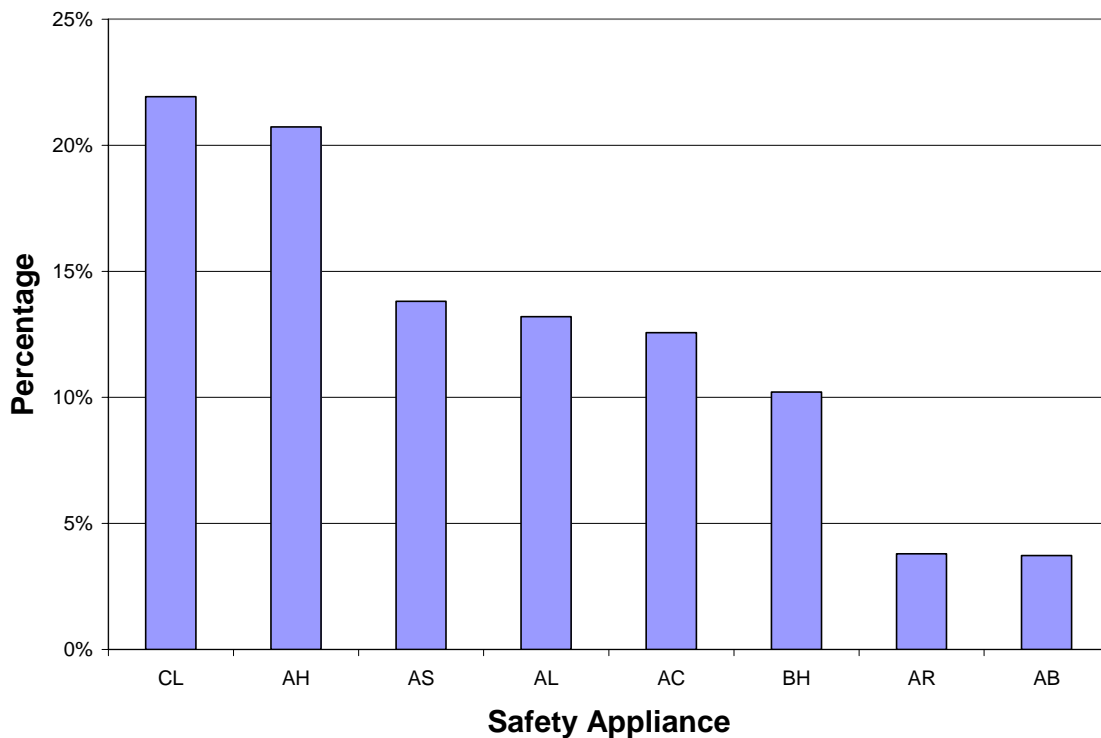
**Figure 2.6 Specific appliances bad ordered on one Class I railroad during October and November of 2005**

The relative frequency of safety appliance bad orders is also of interest (Figure 2.6, Table 2.1). The greatest percentage of safety appliance bad orders (21.7%) occurred on the uncoupling lever and the fewest (1.0%) occurred on the hand brake wheel.

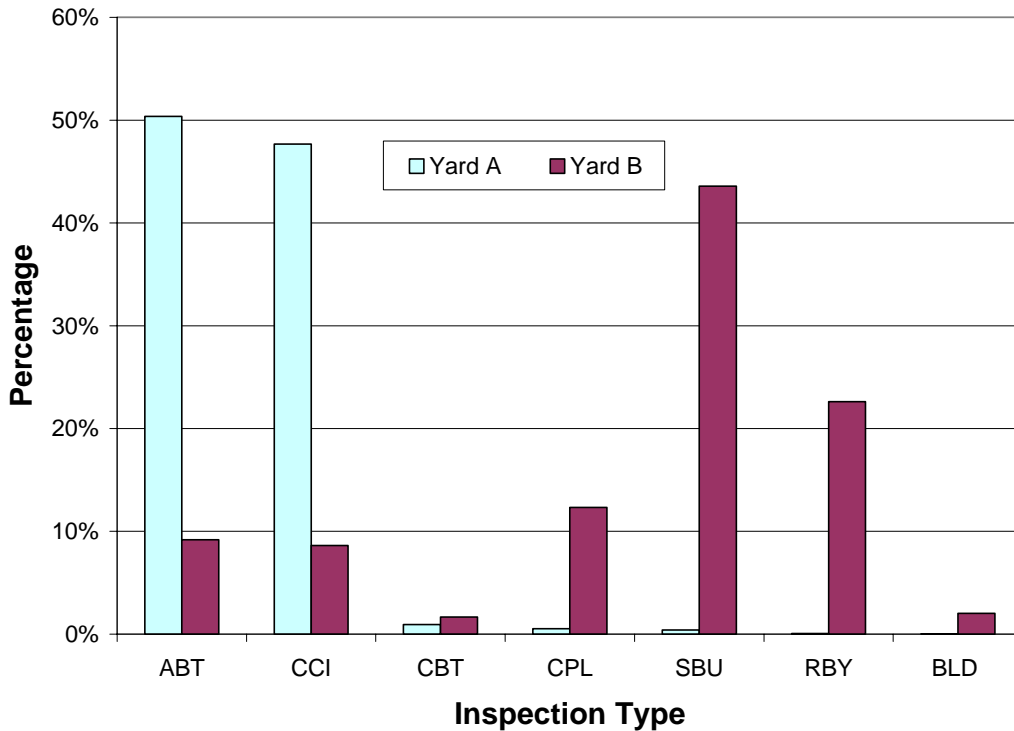
**Figure 3.1 Comparison of the percentage of cars inspected by each inspection type at two Class I railroad yards**

Which inspection type and how many inspections occur depends on the specific parameters of a given yard. Figure 3.1 shows the differences between the numbers of each type of inspection between two yards at the railroad.

98% of the inspections at Yard A are either inbound inspections or air brake inspections. Yard A sees a substantially lower percentage of safety appliance bad orders. This is counterintuitive given the fact that this yard conducts a much higher percentage of

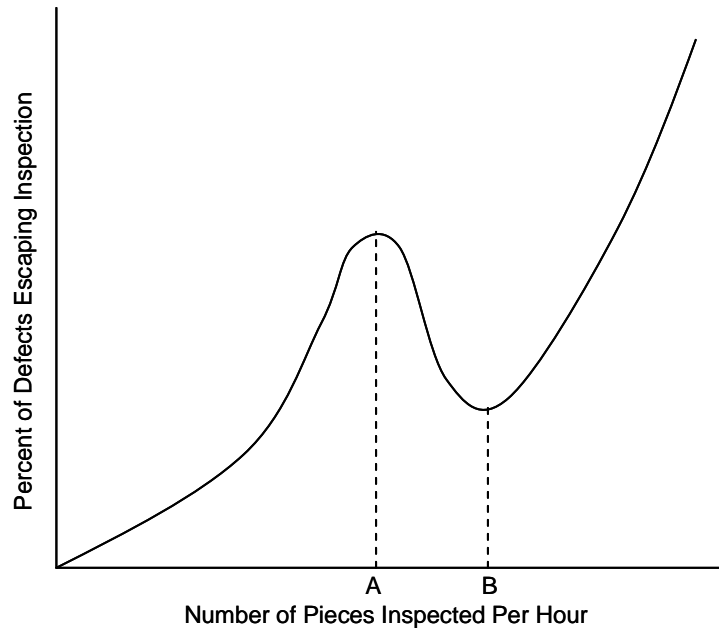
**Figure 5.1 Functional relationship between percent of defects escaping detection and inspection rate of a human inspecting using 100% inspection (Kennedy and Andrews 1977)**

The functional relationship between the number of defects escaping inspection and inspection rate is not as simple as intuition might suggest. Audited studies of inspection effectiveness indicate a more complex relationship (Kennedy and Andrews 1977). A typical inspector completing 100% inspections at differing inspection speeds shows the effect of inspection rate on percent conformance (Figure 5.1).

When inspection rate is low, the number of missed defects is also low (Figure 5.1). As inspection rate increases, so does the percentage of defects that are missed until a local maximum is reached at point A. As the inspection rate continues to increase after point A, the percentage of defects escaping detection actually decreases due to reduction in monotony until it reaches a minimum at point B. Beyond point B, the percentage of defects missed increases once again as fatigue and the limits of human cognitive ability begin to have a greater effect and the percent conformance decreases.

Applying this model to railcar inspection should be done with some caution however. The functional relationship described in Figure 5.1 applies to inspections of like pieces inspected under consistent conditions. This is not necessarily the case with railroad safety appliance inspections. It is also important to consider the varying levels of difficulty of inspecting different safety appliances using current methods. For instance, a

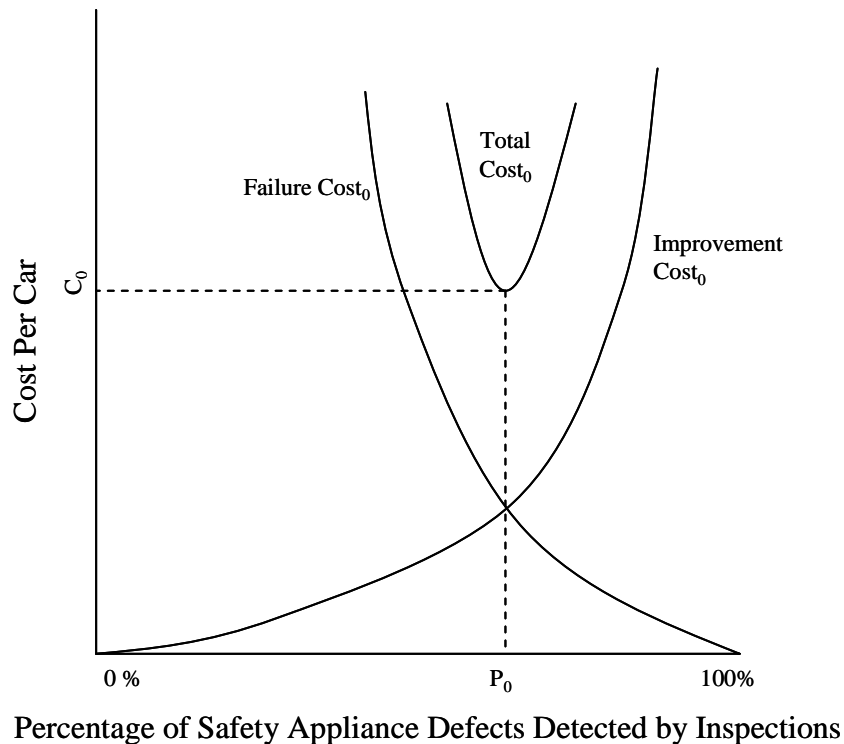
**Figure 5.2 Qualitative model of optimum inspection costs as inspections are currently performed ( $P_0$  and  $C_0$ ) (Kennedy and Andrews 1977)**

Costs associated with improving inspections become incrementally larger as 100% conformance is approached (Figure 5.2). One hundred percent conformance is only hypothetical, as the improvement cost curve (Figure 5.2) never reaches the point of complete conformance (Cielo 1998). As a carman inspects a train, the most obvious defects are those that would be flagged first, with the more difficult ones being detected at a decreasing rate relative to the effort expended. Thus, as more time is spent inspecting a given train, more defects will be located. Each additional incremental amount of time and effort detecting defects should return more defects, but will do so at a decreasing rate. For example, as previously explained, FRA inspectors spend more inspection time per car than railroad carmen, thus their rate of conformance should be higher.

Figure 5.2 shows a plot of all three curves. The x-axis represents the number of safety appliance defects that are correctly flagged by inspectors, or the conformance percentage.  $P_0$  is the point of optimum conformance. The y-axis represents the cost of

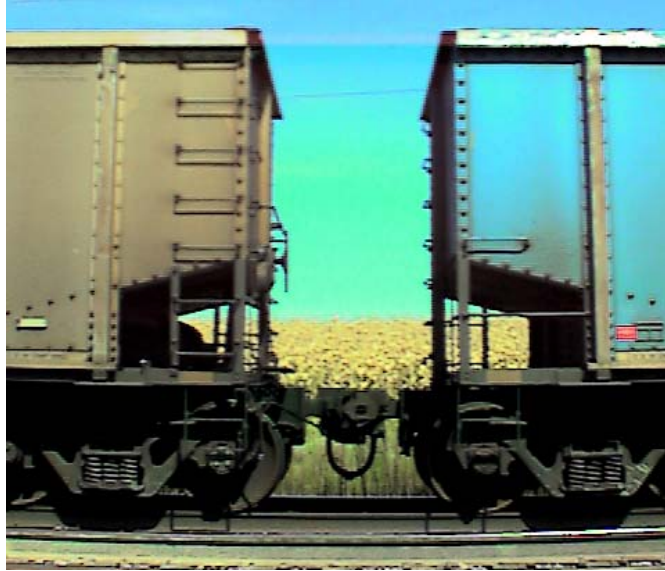
**Figure 7.1 Perpendicular view of the railcar**

Figure 7.1 shows the side view perpendicular to the tracks. This camera view has been successfully used in another project imaging intermodal train loading configurations (Lai et al 2005). In that project the camera was set a distance of approximately 35.5 feet from the track center. The perpendicular angle provides a good view of brake wheel clearance and vertical displacement of side ladder rungs. On the other hand, it is impossible to detect any aspects of the end ladder from this angle and it is also not possible to determine if there is adequate clearance between ladder rungs and the car body. Finally, it is difficult to detect sill step deformation in plane with the side of the car body (e.g. violating the rule of being more than 4" inside the face of the car). Only one camera is required to analyze a train from the perpendicular side view.

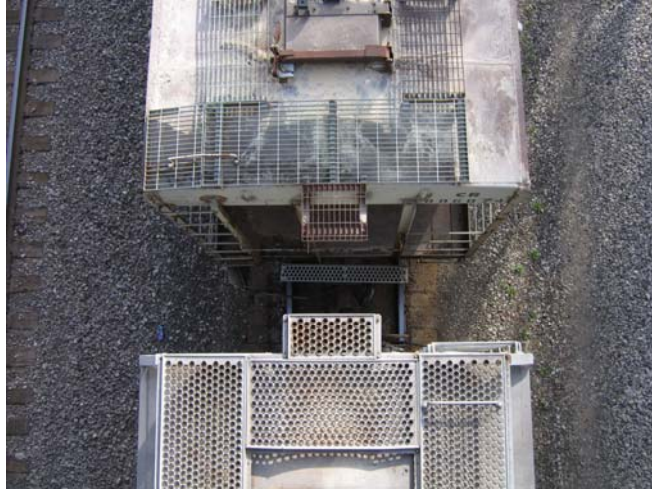
**Figure 7.2 Perpendicular overhead view of a railcar**

A view from above the tracks was also considered. There are several means by which a railcar can be imaged from overhead. The first of these is with the camera looking straight down perpendicular to the tracks (Figure 7.2). This angle provides a suitable view of both the brake wheel clearance and possibly even end ladder clearance given the fact that the train can be imaged at a frame rate that provides the optimal image for this recognition task. However, this view does not provide a vantage point for identifying vertical displacement of side or end ladders rungs and the sill step is not visible. A camera capable of capturing this view would need to be mounted on some type of structure above the track. Like the perpendicular side view, only one camera is required to analyze a train from the perpendicular overhead view.

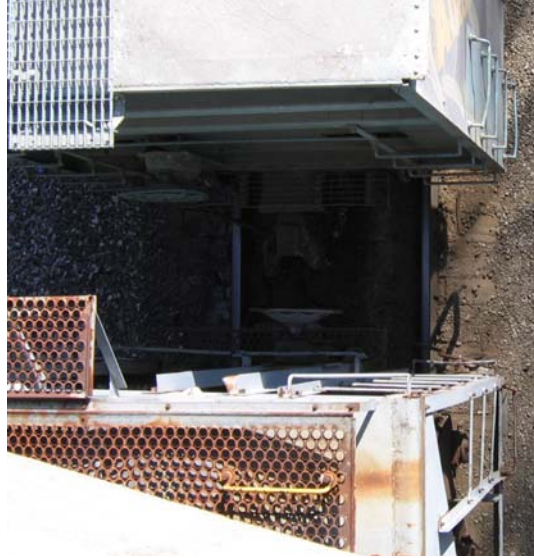
**Figure 7.3 Angled overhead view of a railcar**

Some of the disadvantages of the perpendicular overhead view could be overcome by the use of an angled overhead view (Figure 7.3). With the camera placed at the correct angle on each side of train (two cameras total), each rung of the ladder is visible. A disadvantage of overhead views is that they create a background problem. Safety appliances would be imaged on a moving train that creates moving shadows on the substrate that provides the background. This complication of the safety appliance recognition task caused me to consider other viewing angles.

Another drawback to this location is the need to perform a perspective correction because the car is not being imaged normal to any one surface. This effect is known as foreshortening and there is an algorithmic solution to this problem, known as unforeshortening.

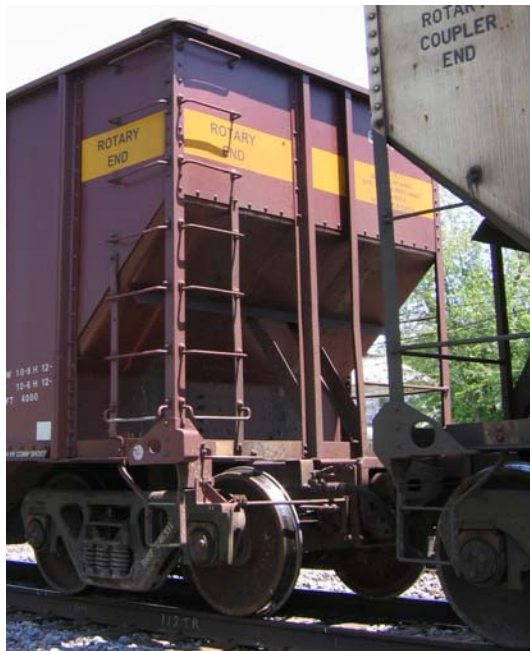
**Figure 7.4 Angled side view of railcar**

An angled view from the side of the tracks was considered (Figure 7.4). At the correct angle in the vertical plane (referring to the camera's location with respect to the top of rail) it is possible to see ladder rung clearance as well as vertical displacement of ladder rungs. This camera location would be near the surface of the ground and is more accessible than one that is located above the tracks. This view would require four cameras to image the four corners of each railcar. Like the angled overhead view this view would also require foreshortening correction.

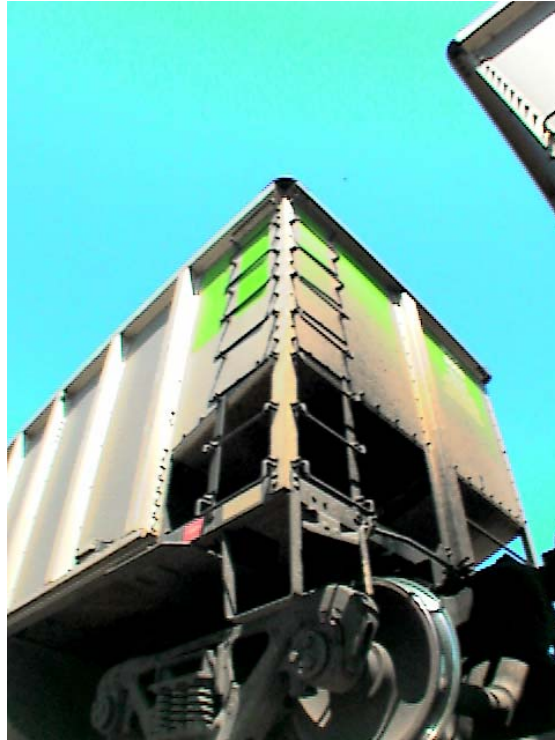
**Figure 7.5 Upward angled side view of railcar representing the optimal angle for viewing ladder, handholds, and the brake wheel**

Based on this, it was decided that the corner post of the car should be in the leading position when the optimal image is taken. Furthermore, the angle between the camera and the tracks should be  $45^\circ$  (Figure 7.5). Finally, the camera should be lower than the top of the rail and aimed upward at an angle to be discussed in the next section.

This view, after unforshortening takes place, allows for clearances as well as vertical displacements in ladder rungs and handholds to be recognized using machine vision algorithms. It is also possible to obtain images of both the sill step and uncoupling lever from this view, although other views may be more effective for these recognition tasks. Using this angle, four cameras would be required, one for each corner of the railcar.

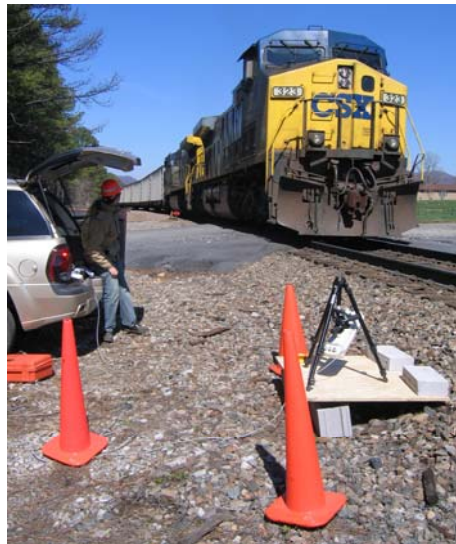
In the initial, portable setup, the camera is mounted upside down below the tripod head, close to the substrate supporting the tripod, and remains outside the clearance plate for rail equipment (ORER 2005, Figure 7.9). The clearance plate represents the maximum cross section that railcars and their loads must fit within for unrestricted interchange.

**Figure 7.9 Temporary portable field setup for machine vision collection of safety appliance images**

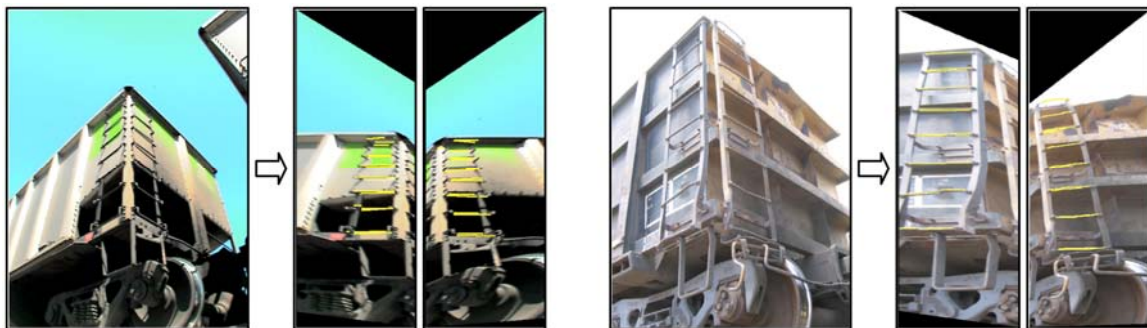
Additional examples of detected ladder rungs and handholds are presented in Figure 7.14. The left images represent a newer gondola whereas the right images represent an older hopper car that is highly deformed. The car on the right posed additional recognition problems due to the horizontal parallel lines that are external ribs on the side of the car. The algorithm was successfully modified to detect these hoppers.

**Figure 7.14 Additional examples of detected ladder rungs and handholds**

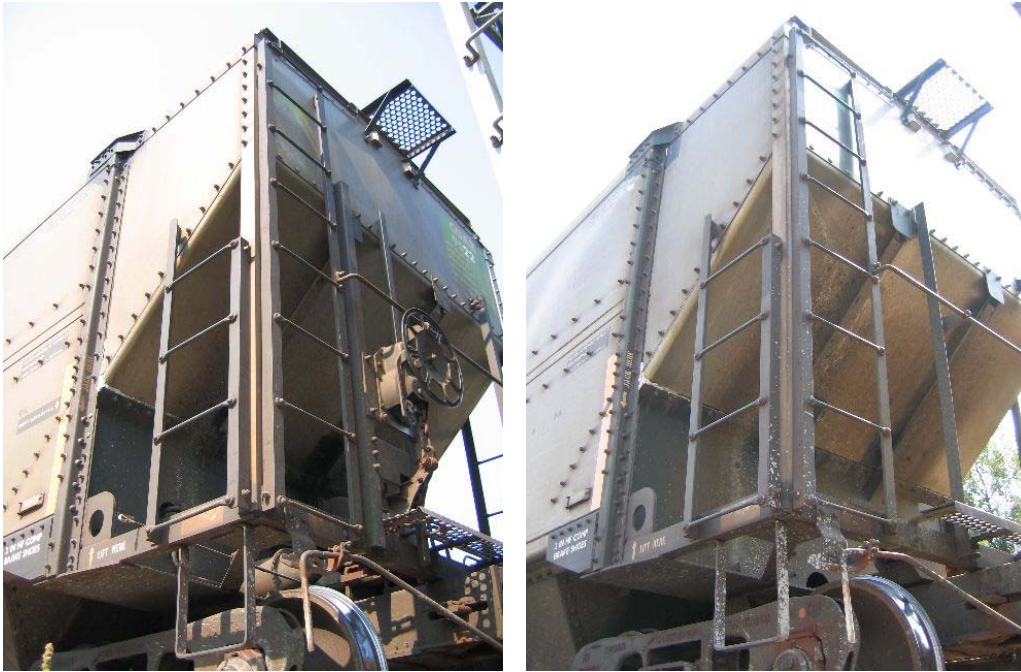
A potentially elegant alternative to developing algorithms to detect deformations was considered. This approach would take advantage of the symmetry of opposite corners of a railcar (Figure 8.1 explains that  $AR = BL$  and  $AL = BR$ ). Images of the opposite corners of a railcar would be recorded and overlaid on top of one another, and any differences in the safety appliances would be assumed to be deformation (Figure 7.19). Unfortunately, this method proved to be less efficient than anticipated. Obtaining the perfect alignment needed for image comparison was time consuming and appears to involve much tighter tolerances regarding image perspective and composition than the

**Figure 7.19 View of both the BL and AR corners of a covered hopper demonstrating the ease as to which the two opposite corners can be compared**

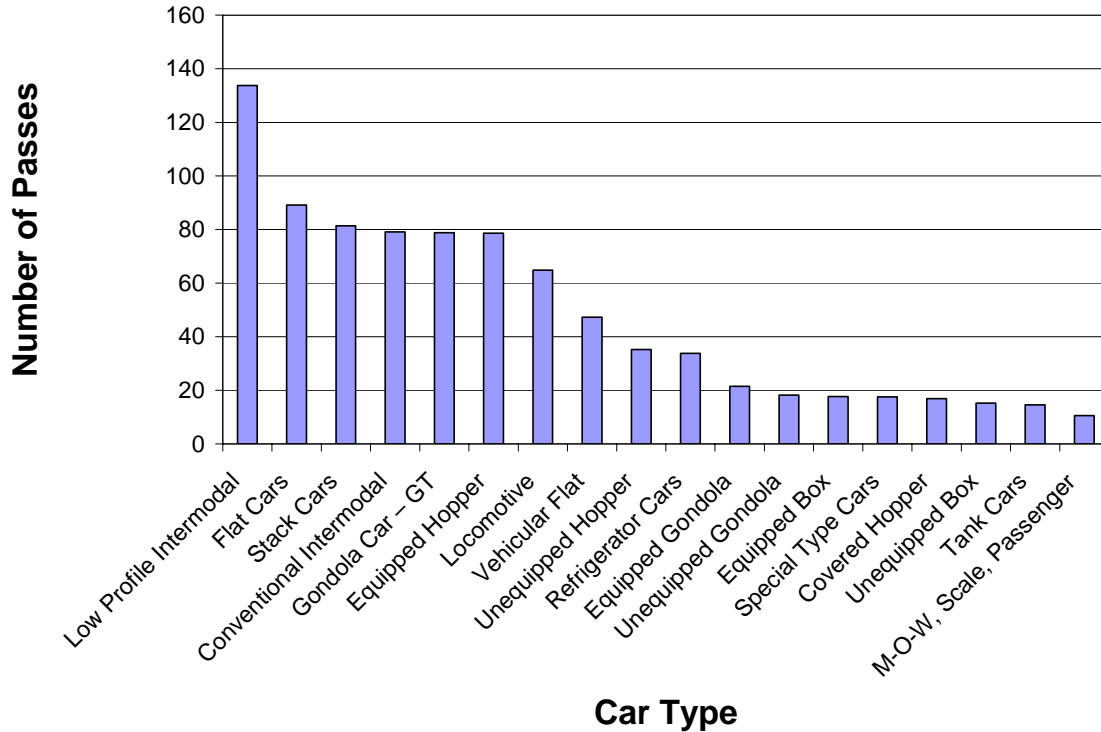
Another method that could be used to prioritize car types is use of Wheel Impact Load Detector (WILD) data. WILD data shows the number of times each car passes a WILD installation during a set period of time (Figure 7.22).

**Figure 7.22 Average number of visits to WILD sites between October 2004 and November 2005**

Equipped gondolas, unequipped gondola, and unequipped hoppers have had safety appliances successfully identified on them using machine vision algorithms. The data in Table 7.2 indicates that low profile cars are passing by the WILD detectors most frequently.

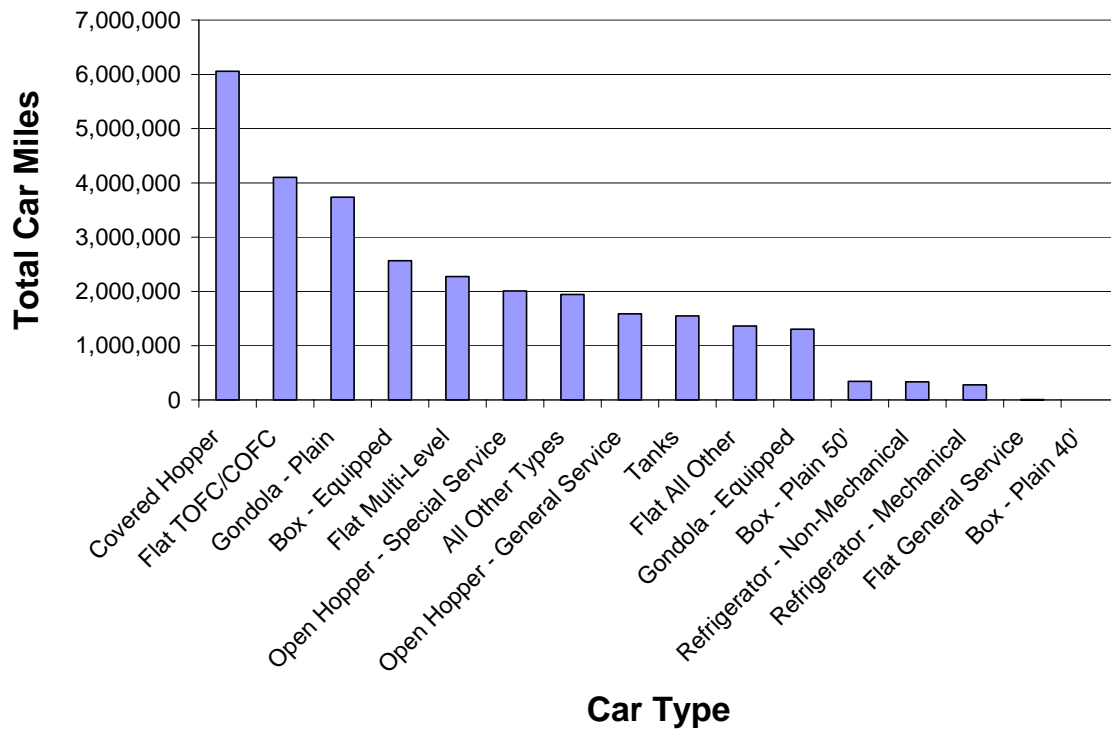
Another means of prioritizing car types is through the use of AAR (2005) data on car miles for each car type found in the AAR’s Analysis of Class I Railroads (Figure 7.23). Although the categorization used by the two sources differs somewhat the data generally agrees with the WILD data with one notable exception. The car mileage data show that covered hoppers traveled more miles than any other car type whereas they were

ranked 15<sup>th</sup> in frequency among car types passing WILD sites. Intermodal flats and equipped gondolas ranked 2<sup>nd</sup> and 3<sup>rd</sup> which is similar to the WILD data. These data are also consistent with the hypothesis that WILD sites are located on routes that see high volumes of coal and intermodal traffic.

**Figure 7.23 Car miles traveled by car type in 2004 (AAR 2005)**

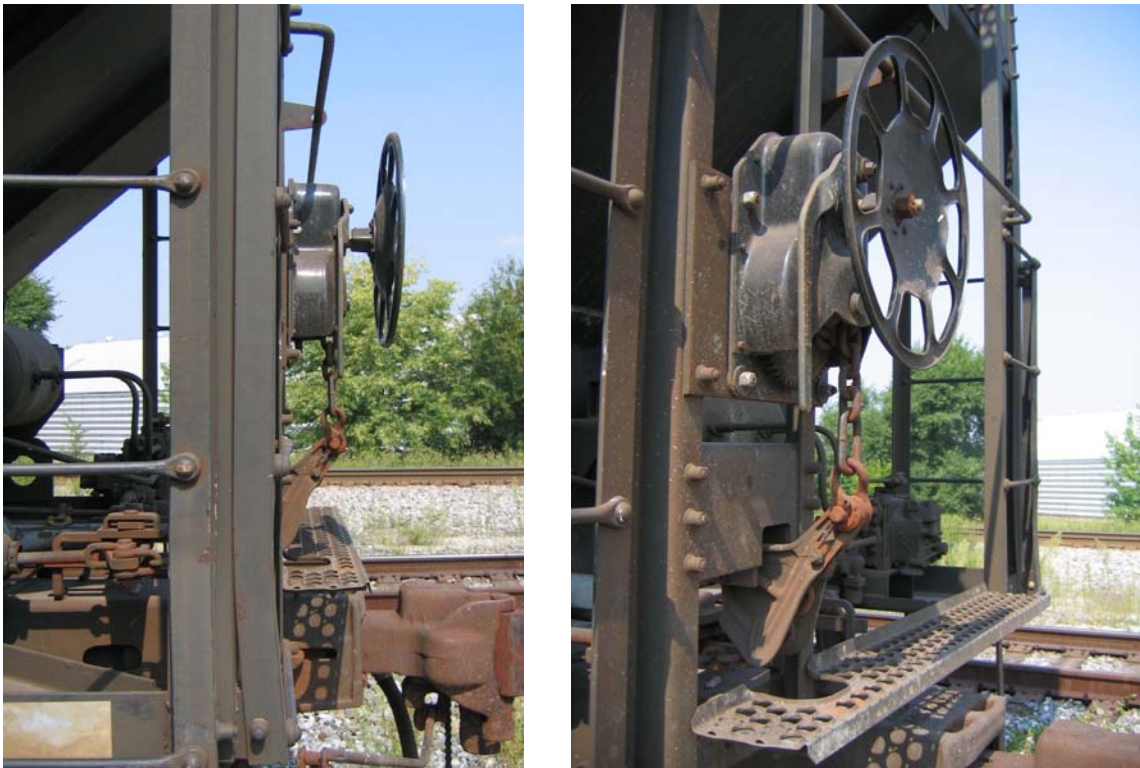
**Figure 9.1 Images of the brake wheel**

The handbrake is used to manually apply the brakes on a railcar and basically serves as a “parking brake”. The brakes are applied by turning the hand brake wheel, which, through a series of chains and rods, apply force to the brake shoe against the tread of the wheel. Examples of hand brakes, brake wheels, and their configuration are shown in Figures 9.1 and 9.2.

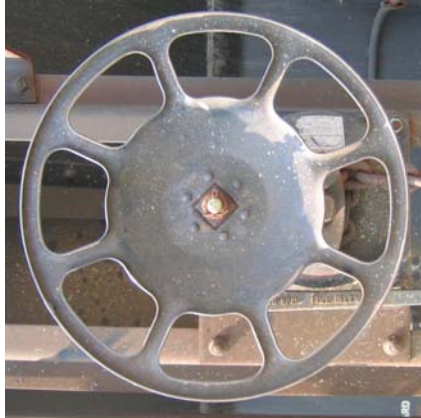
**Figure 9.2 Profile view of a common brake wheel design**

The brake wheel is identified by unfolding the image and moving the template over the image to find the best fit. If the brake wheel does not match the template it is classified as deformed. There are two primary designs of the brake wheel, dished and flat, both of which are captured in the template. The brake wheel shown in Figure 9.2 is

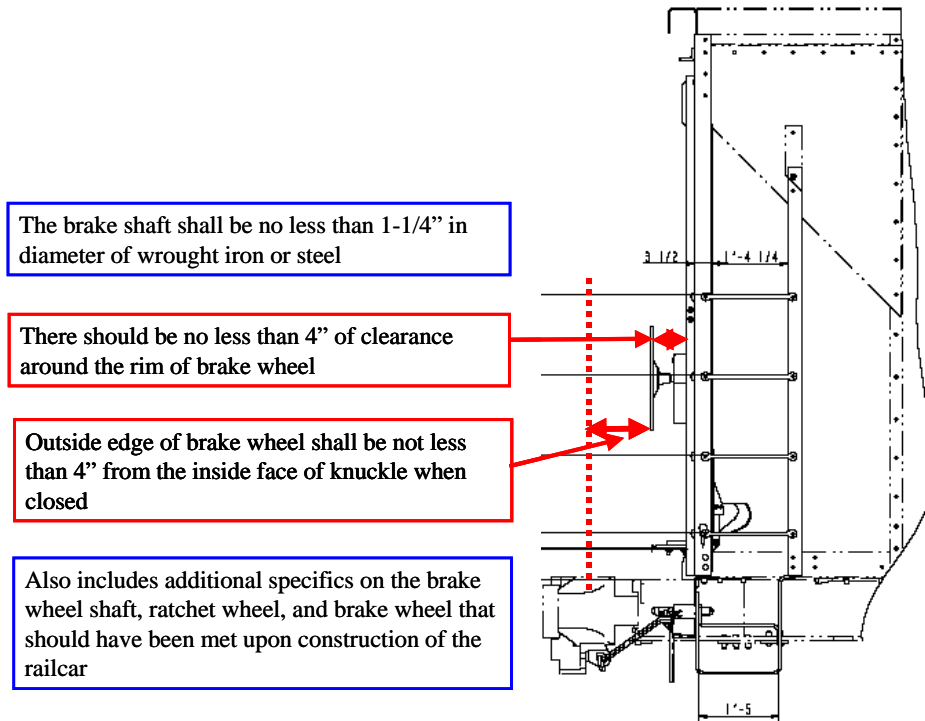
**Figure 9.4 Additional brake wheel parameters**

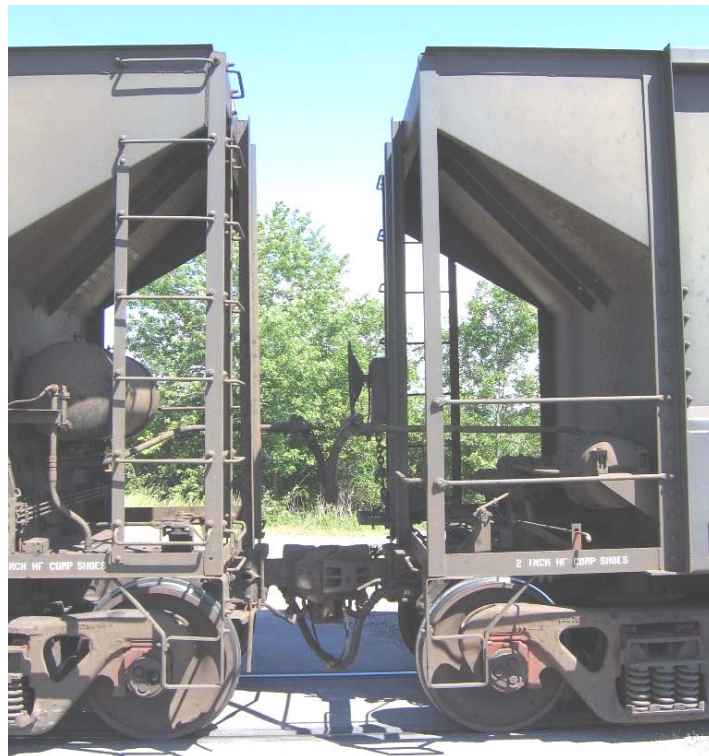
**Figure 9.5 Brake wheel viewed from perpendicular to the track showing brake wheel clearance**

An alternative means of measuring brake wheel clearance should be through the use of an image that is perpendicular to the side of the train (Figure 9.5). The frame rate must be high enough to ensure that an image is captured when the brake wheel is perfectly in line with the camera target, or within a very small tolerance that would allow for accurate measurement of clearance.

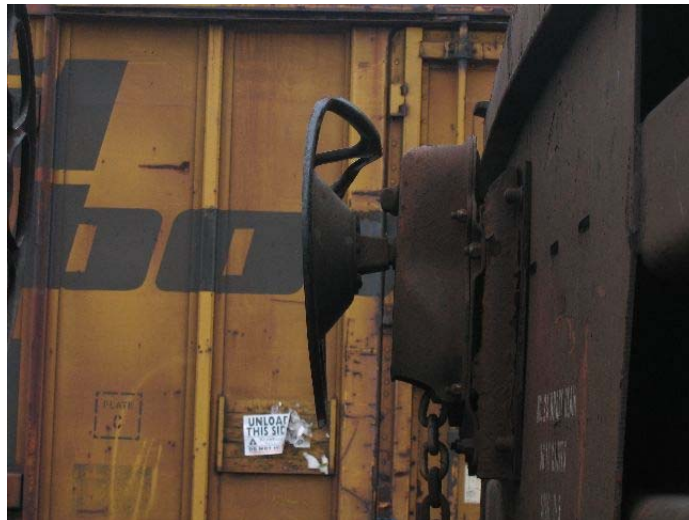
**Figure 9.6 Brake wheel with insufficient clearance per CFR Part 231**

If the brake wheel is deformed, the clearance at any point in a complete rotation of the brake wheel must meet or exceed the FRA requirement. There are several approaches to determining whether or not brake wheel clearance is violated. The first of these would be through exact measurement. This is not feasible because while clearance may not be violated at the time the train passes, the brake wheel could be rotated into a position in which clearance is not met. The approach used in this research is to use template matching to flag any deformation and then allow learning to handle the categorization between FRA defects and deformation that does not constitute an FRA violation. Figure 9.6 shows a brake wheel that does not satisfy the 4” clearance requirement prescribed by CFR Part 231.

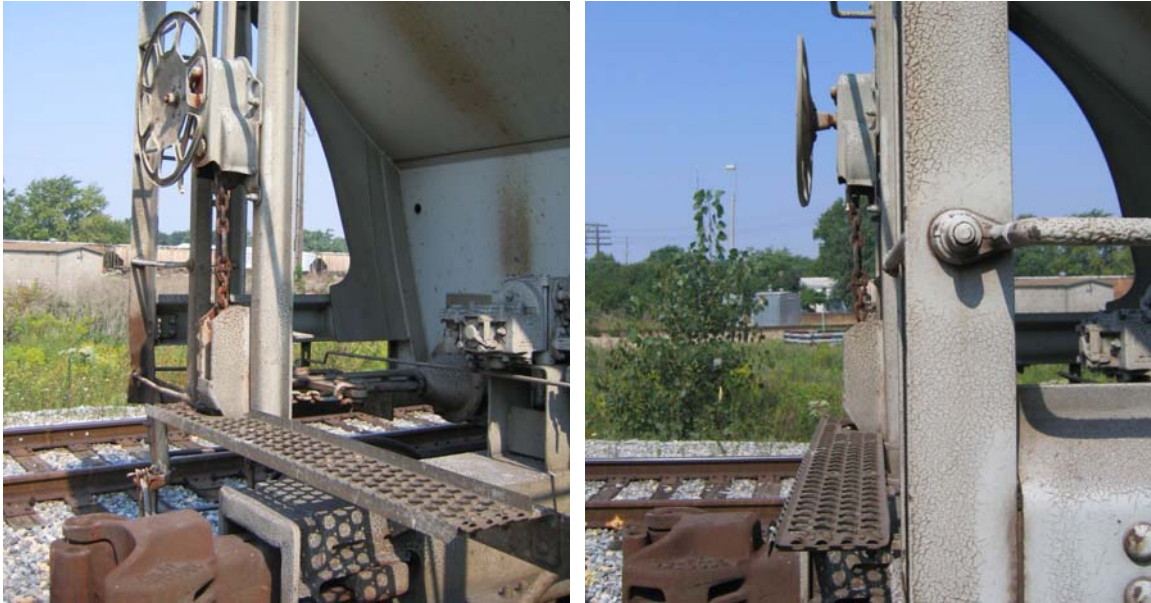
**Figure 9.7 Example images of the brake step and brake wheel**

The brake step provides a platform for a railroad employee to safely operate the handbrake. It is located immediately below the brake wheel on a railcar and extends beyond the brake wheel on either side (Figure 9.7). The platform is generally constructed of some type of grating to provide a more slip resistant surface under all conditions.

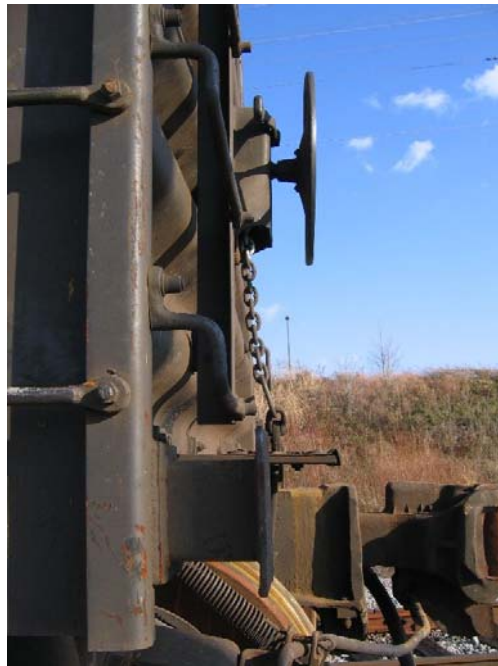
**Figure 9.10 Image of the brake step taken perpendicular to the tracks and in-line with the brake step**

There are multiple possible views when it comes to imaging the brake step. First, if a camera were mounted perpendicular to the railcar in line with the brake step (Figure 9.10), it is possible that deformation in the vertical plane could be identified.

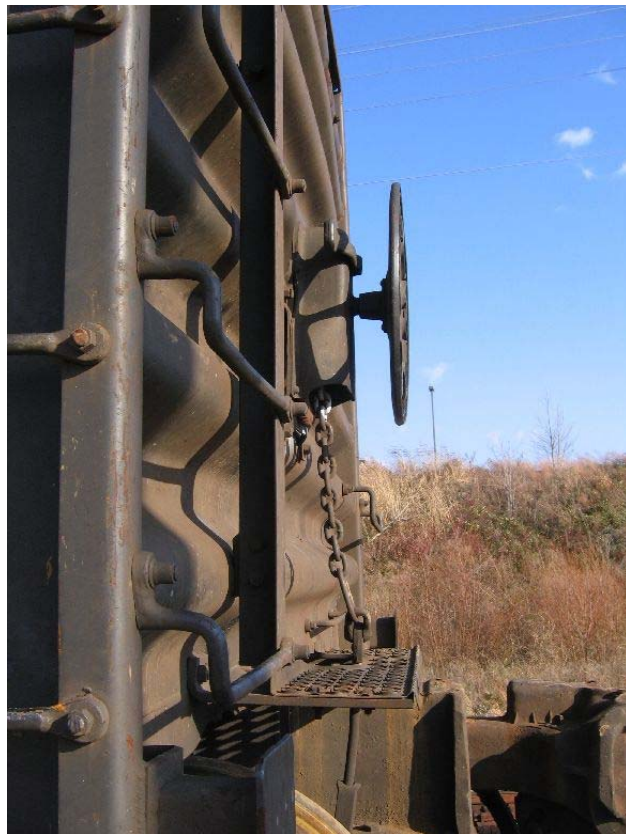
**Figure 9.11 Image of the brake step taken perpendicular to the tracks and above the brake step showing the step's length**

Instead of a perpendicular view, one that is perpendicular to the tracks and above the brake step should also be considered, allowing the overall length and width of the brake step to be captured in the image (Figure 9.11). From this angle the brake step has depth and the necessary width and length parameters can be viewed allowing deformations to be identified.

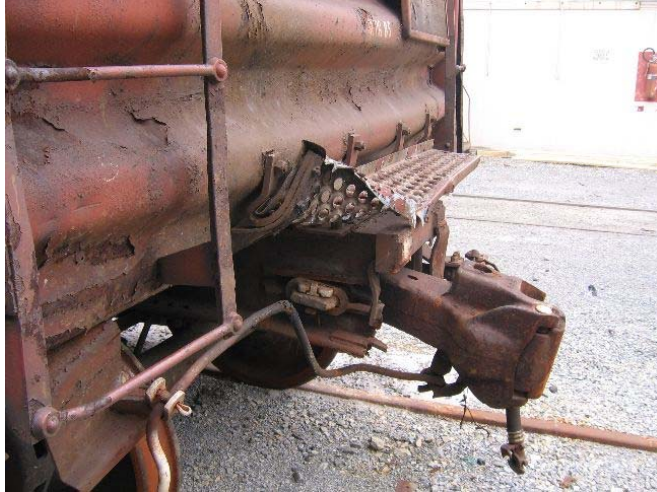
**Figure 9.12 End platform on a boxcar showing significant deformation**

This section does not describe end platforms, which are oftentimes referred to as crossover steps. End platforms are not required on open-top hoppers and gondolas, but when the car is equipped with an end platform it is required to be in compliance with CFR Part 231. End platforms are covered in §231.27, box and other house cars without roof hatches or placed in service after October 1, 1966. They are required to be no less than 8” in width and not less than 60” in length. They should be secured with no less than 3 metal braces at a height of no more than 8” above the top of center sill. An example of an end platform with significant deformation can be seen in Figure 9.12.

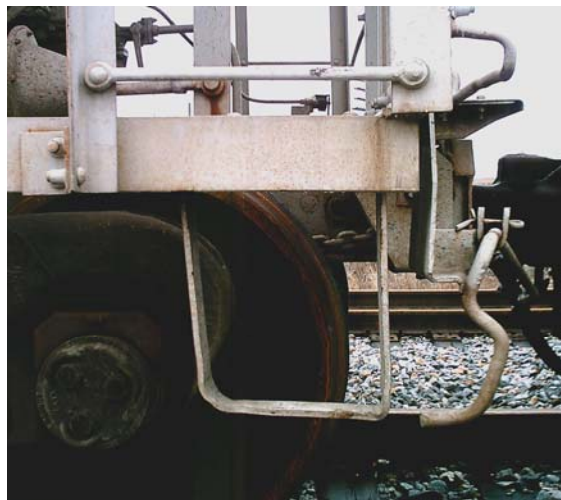
**Figure 9.13 Sill step without additional rung**

The sill steps provide a location from which a transportation employee can mount a car on any of the four sides. Sill steps are the location where the employee's feet often rest while they hold on to the car's handholds during movement of the railcar. Examples of sill step designs are shown in Figures 9.13 and 9.14

Sill steps are one of the most challenging safety appliances to identify defects using machine vision. This challenge results from the shape, location, and background behind the sill steps. There are three primary designs of sill steps (Figures 9.13, 9.14, 9.16) with many subcategories due to differing means of attachment. Occasionally, these designs are changed to allow the sill step to be offset underneath the car (Figure 9.16).

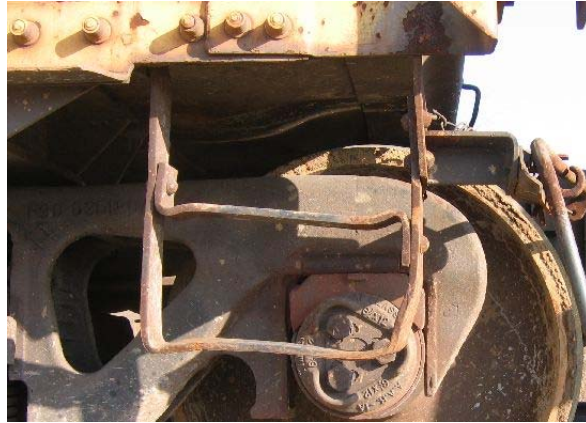
**Figure 9.14 Sill step with additional rung**

The maximum clear depth of the sill step is 8". The distance between the center of the sill step and the end of car should be no more than 18". The outside edge of the sill step tread shall be no more than 4" inside the face of the car, preferably flush with the edge of the car. The tread shall be no more than 24" above the top of the rail, preferably no more than 22". Sill steps with a depth (vertical height) greater than 21" must have an additional tread (Figures 9.14, 9.15).

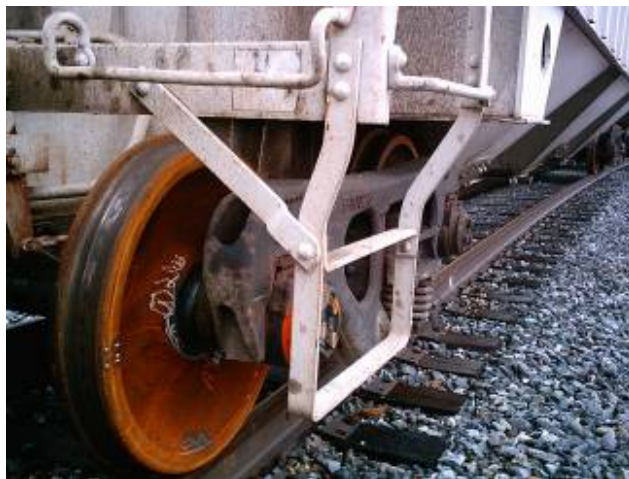
**Figure 9.16 Sill step offset underneath the railcar**

This poses a problem for a vision system in that it is difficult to determine if a sill step is offset by design or if it is deformed. One solution to this problem is only flagging the sill step for deformation if the distance between the outside edge of the step and the edge of the car is greater than four inches. The other solution will be supplying the learning algorithm with exhaustive examples of sill steps that are offset by design as well as deformed ones that look similar to offset sill steps. The effectiveness of the algorithm at distinguishing between the two should then be evaluated.
