IMPROVING THE EFFICIENCY AND EFFECTIVENESS OF RAILCAR SAFETY  
APPLIANCE INSPECTIONS USING MACHINE VISION TECHNOLOGY

THESIS

Submitted in partial fulfillment of the requirements  
for the degree of Master of Science in Civil Engineering  
in the Graduate College of the  
University of Illinois at Urbana-Champaign, 2006

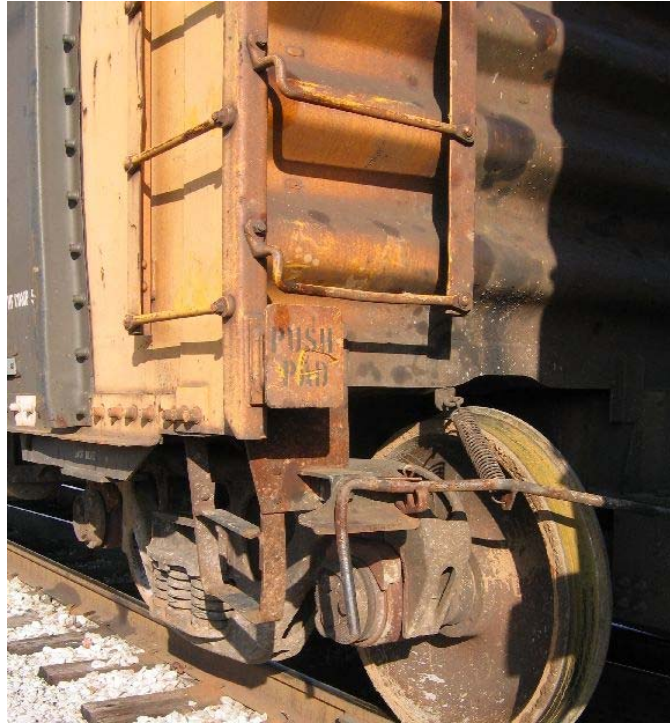
**Figure 9.17 Sill step viewed from shallow angle to show sill step deformation**

One view that could be effective in detecting sill step deformation is shown in Figure 9.17. This view is taken from an angle that is more acute with regard to the track (i.e. less than  $45^\circ$ ) than the images taken from the initial camera view. This would provide better definition of deformations in the plane of the side of the car body. This angle does not allow the distance between the center of the sill step and the end of the car to be viewed, but would allow for the measurement of distances between rungs as well as the distance to the top of rail – both of which are dynamic parameters that will need to be assessed.

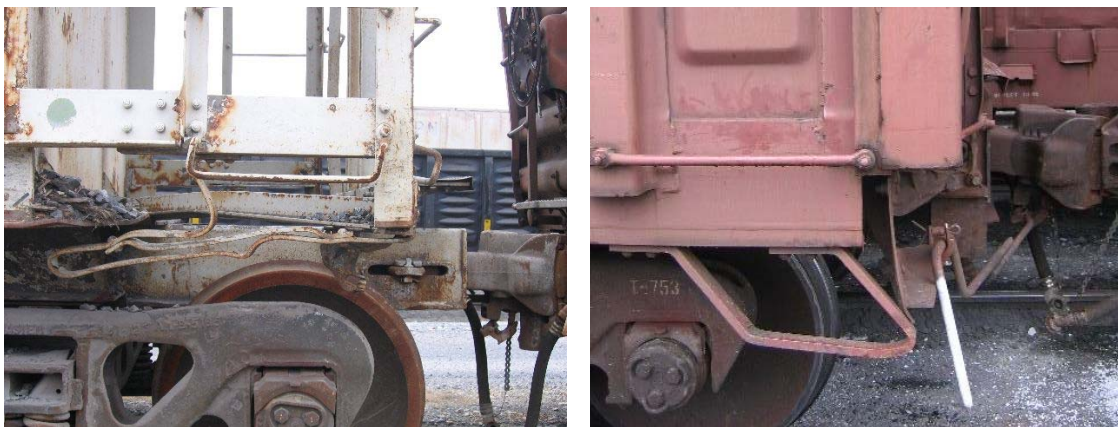
**Figure 9.18 Sill step deformation showing an FRA defect (left) and significant deformation (right)**

Sill step deformation may come in many forms as shown in Figure 9.18. The image on the left shows an FRA defect whereas the image on the right shows deformation that is not an FRA defect.

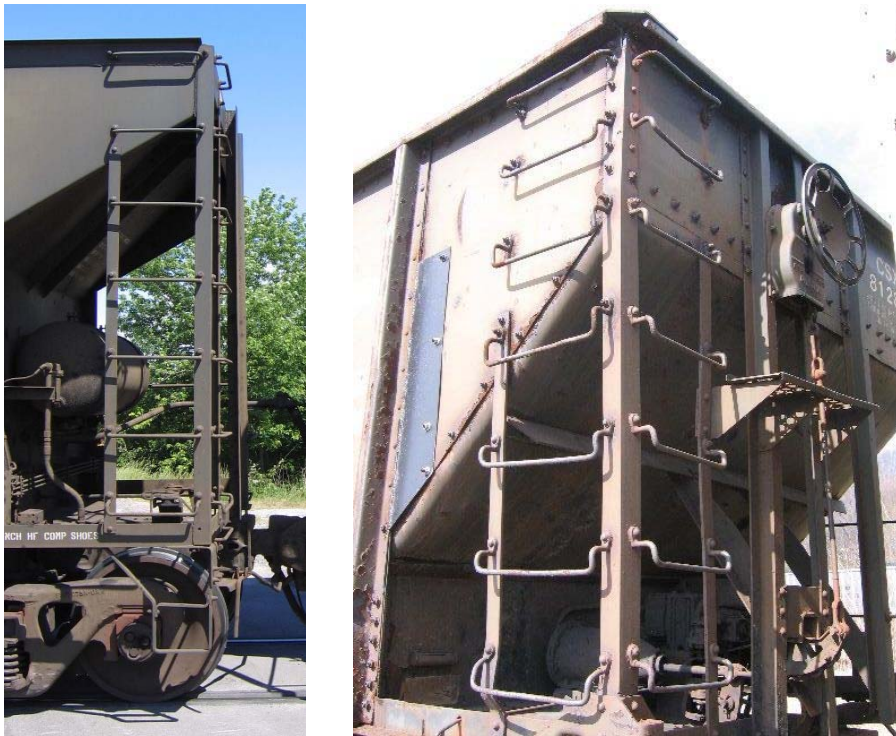
**Figure 9.19 Images of the side ladder (left) as well as an image of both the side and end ladders (right) on open-top hopper cars**

Ladders are used by employees to mount a railcar, ride a railcar, and obtain access to the roof or brake wheel of the railcar if necessary (Figure 9.19). Employees use both hands and feet when using the ladder treads. Certain lower treads of the side and end ladders are considered side and end handholds per the FRA regulations and will be identified below.

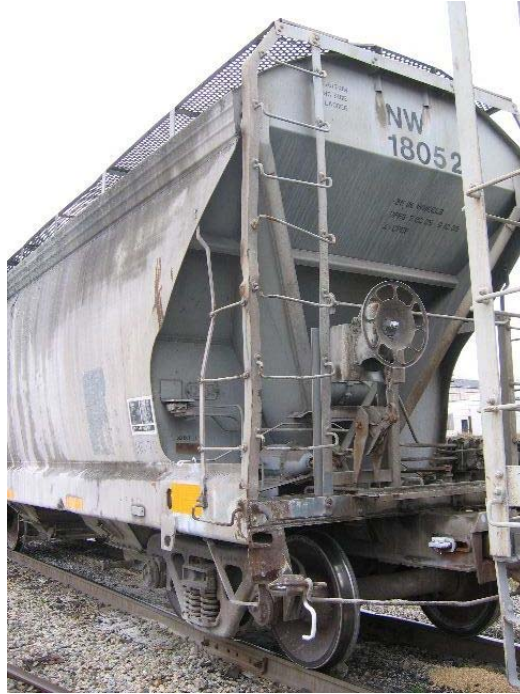
**Figure 9.22 Deformations of side and end ladders on a covered hopper car**

gondolas will likely be undertaken on additional car types. Figure 9.22 shows deformation of both the side and end ladder on a covered hopper car and Figure 9.23 shows deformation of the top ladder rungs on a hopper car.

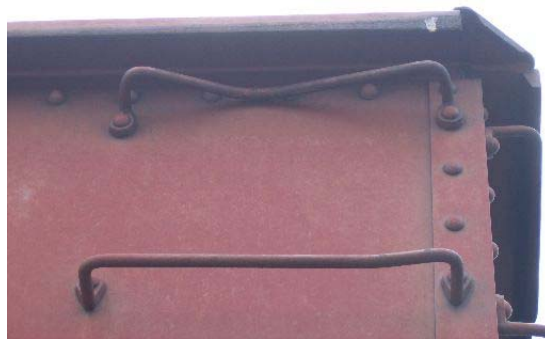
**Figure 9.23 Deformations of the top side ladder rung on an open-top hopper car**

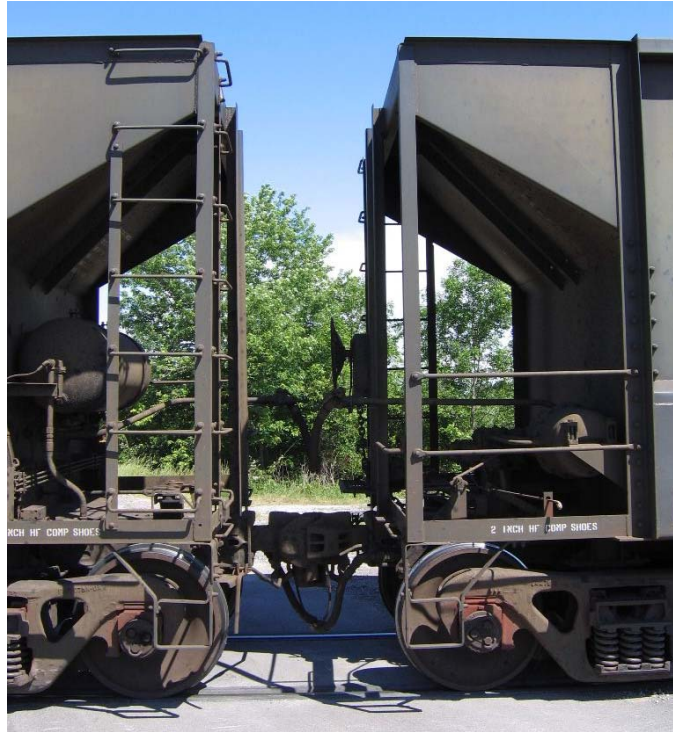
**Figure 9.24 Side handholds on both the AL and BR corners of open-top hopper cars**

Side handholds are used for employees to hold onto the side of a railcar. The lower rungs of the side ladder on the AR and BL ends serve as the side handholds. On the AL and BR ends the side handholds are separate distinct items (Figures 9.24 and 9.25).

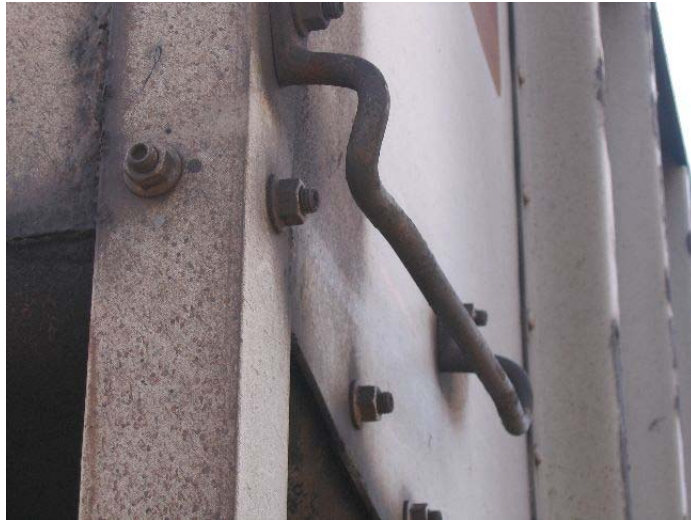
**Figure 9.26 Side handhold on an open-top hopper car showing less than the required 2" clearance**

Side handholds are identified much the same way that ladder rungs are identified except that it may be more difficult to recognize handholds because there are fewer available for recognition. In Figure 9.26 the bolt attached to the end post of the car causes the 2" clearance parameter to be violated. Figure 9.27 shows another means by which the 2" clearance might be violated; by a piece of coal in this case. The author has

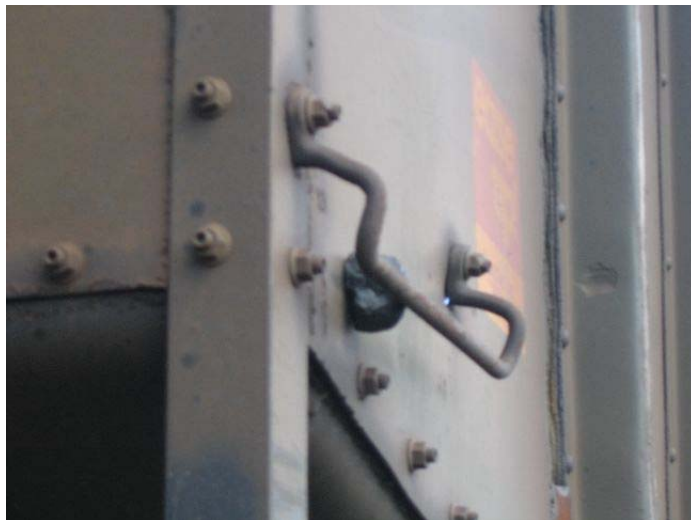
**Figure 9.27 Side handholds clearance potentially affected by a piece of coal on an open-top hopper car**

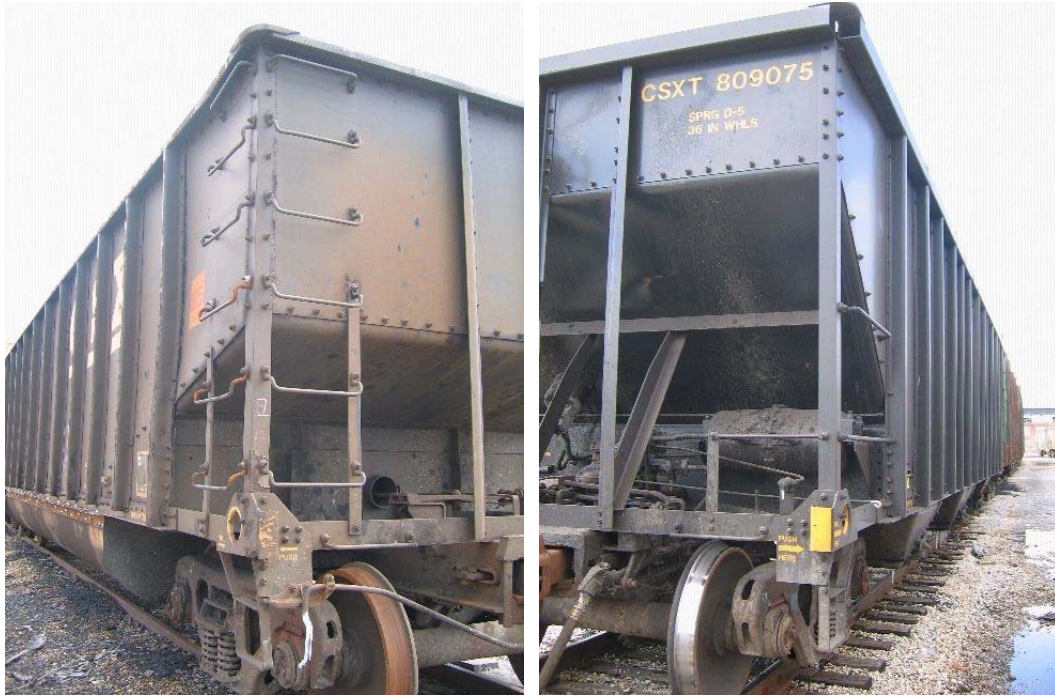
**Figure 9.28 View of both the AR and BR corners of the railcar showing the horizontal end handholds on open-top coal cars**
