RTDF2009-18043

**MACHINE VISION CONDITION MONITORING OF
RAILCAR STRUCTURAL UNDERFRAME COMPONENTS**

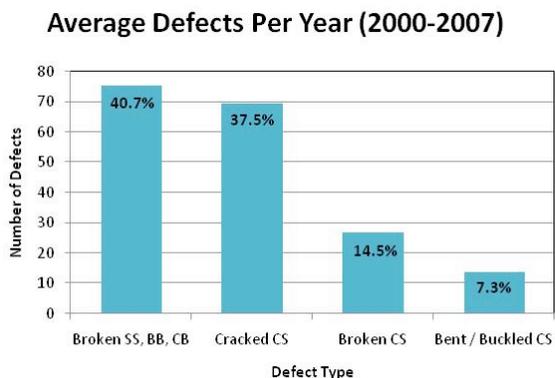
FIGURE 1: AVERAGE NUMBER OF STRUCTURAL DEFECTS RECORDED BY FRA MOTIVE POWER AND EQUIPMENT INSPECTORS PER YEAR

Inspection data from the FRA Office of Safety from 2000 to 2007 show that on average 59% of structural component defects are comprised of cracked, broken, bent, or buckled center sills (CS), while the remaining 41% represent defective sidesills (SS), body bolsters (BB), or crossbearers (CB) (Figure 1). Based on these data and guidance from the AAR, the primary focus of AISC is inspecting the center sill and the secondary focus is the inspection of other structural components. All of these components, although infrequently defective, are critical to the structural integrity of the railcar.

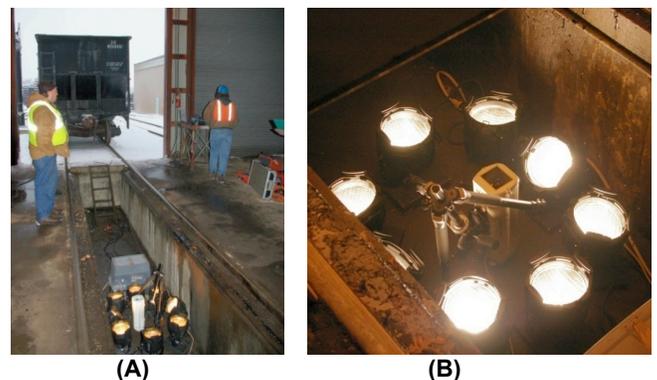
FIGURE 2: EXPERIMENTAL TEST SETUP AT MONTICELLO, IL (A); LIGHTING AND CAMERA ARRANGEMENT IN THE LOCOMOTIVE PIT (B)

Initial tests were conducted at the Monticello Railway Museum in Monticello, IL on an Illinois Central, 1950 era AAR-standard-design hopper car. The car was rolled over a locomotive repair pit, which contained equipment for recording the car's underframe (Figure 2).

The camera and lighting arrangement was placed at the bottom of the three-foot pit, and data were acquired via a laptop computer adjacent to the tracks. Videos were taken at varying train speeds and lighting conditions, and a panoramic image was developed from the video data (Figure 3).

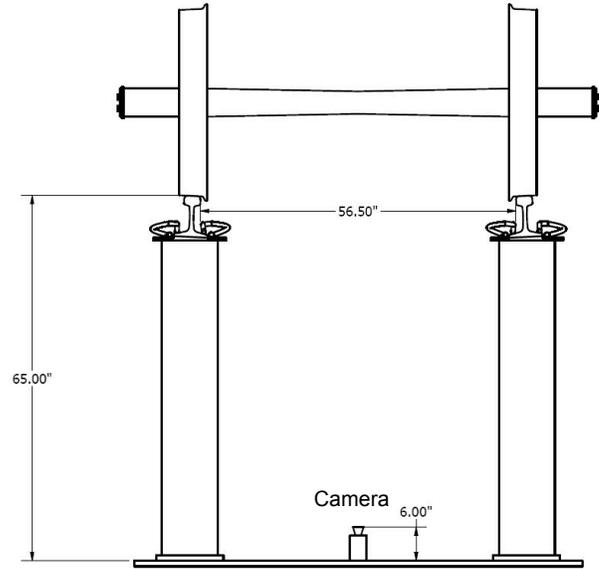
FIGURE 4: EQUIPMENT SETUP SHOWING THE 90° STRAIGHT-UP CAMERA VIEW

After analyzing the preliminary image acquisition results and subsequent data collected using portable image acquisition carts, an experimental setup was developed (Figure 4) and data collection procedures were defined. This equipment arrangement was used during testing at the Norfolk Southern (NS) Locomotive Repair Facility in Decatur, IL (Figure 5). Tests were run on several different NS railcars by rolling them above the camera at 3-5 mph. As before, the videos were converted into panoramic images (Figure 6). Results from the testing at NS Decatur show much more even illumination for the hopper car image (Figure 6a) as compared to the previous hopper panorama (Figure 3). Only the center strip of each individual video frame is extracted to develop the panorama, so lighting improvements were made by focusing illumination on the center of the image. The panorama of the gondola underbody (Figure 6b) provides a clear view of the center sill,

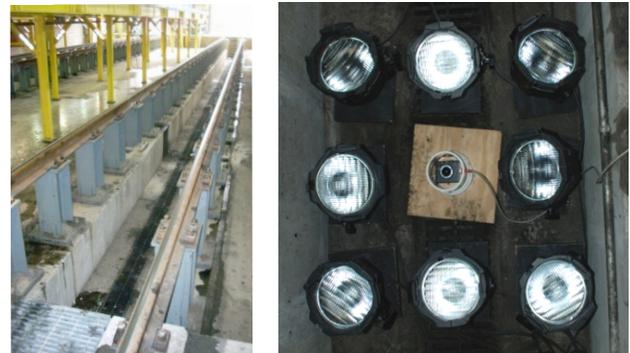
FIGURE 5: LOCOMOTIVE REPAIR PIT USED FOR DATA COLLECTION (A); CAMERA AND LIGHTING SETUP (B)

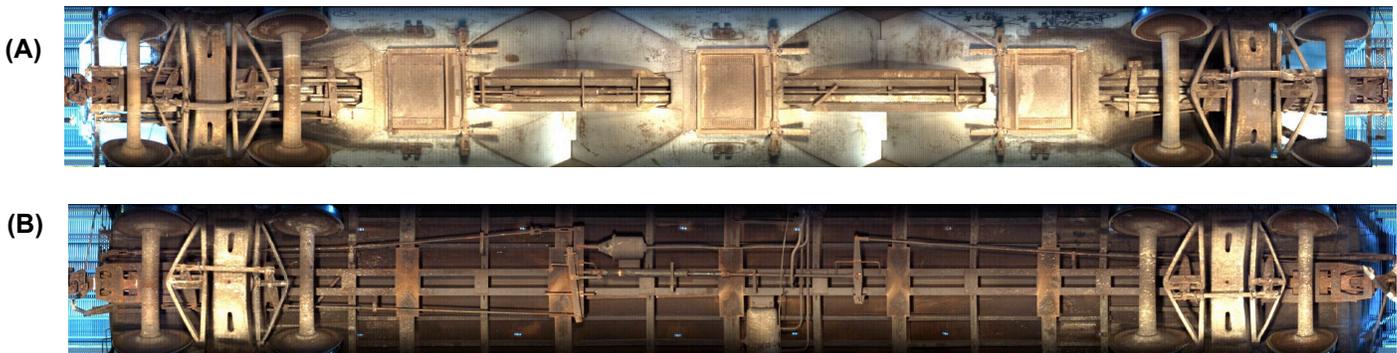
FIGURE 6: PANORAMIC IMAGES OF A HOPPER CAR (A) AND A GONDOLA CAR (B) TAKEN FROM THE NS LOCOMOTIVE REPAIR FACILITY IN DECATUR, IL

crossbearers, and crosssties (thinner lateral members between the crossbearers).

Other components of the gondola that are clearly visible include the brake reservoir, brake cylinder, and the entire foundation of the braking system. In order to determine the resolution of the panoramic images, engineering drawings were acquired from Norfolk Southern for each of the cars that were tested. By measuring the length of components in the panoramic image in pixels and dividing by the actual lengths of the components, the pixel-to-foot ratio (i.e. the image resolution) was determined to be 92.3 pixels per foot.

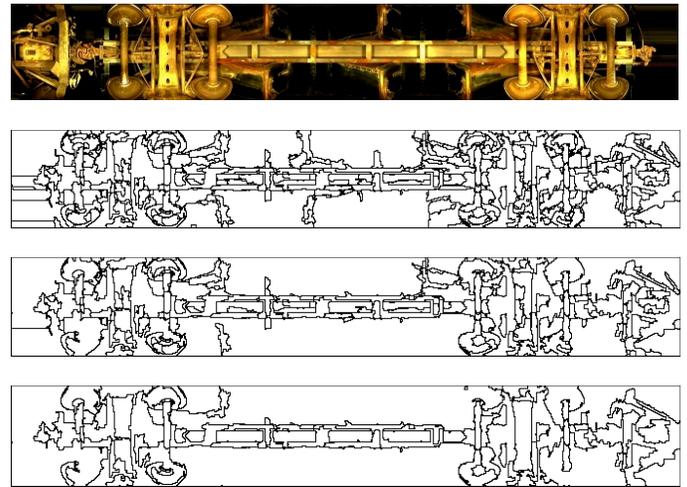
FIGURE 7: MULTISCALE SEGMENTATION HIERARCHY OF THE HOPPER CAR IMAGE SHOWING THE CAR UNDERBODY WITH THE SEGMENTATION SCALE INCREASING FROM TOP TO BOTTOM

The segmentation algorithm partitions the image into homogeneous regions of previously unknown shape, size, gray-level contrast, and topological context. A region is perceived to be homogeneous if variations in pixel intensity within the region are smaller than intensity variations of its surroundings, regardless of its absolute degree of variability. Consequently, image segmentation may be performed at a range of homogeneity values. At any scale, recursive segmentation may be performed to extract finer scale segments characterized by an increasing degree of homogeneity. This process continues until one obtains strictly constant intensity regions, yielding a multiscale segmentation of the image. The black pixels form the boundary lines of the segmented regions (Figure 7).

As the scale increases, smaller regions strictly merge to form a larger region, meaning that the segmentation algorithm is hierarchical. The same multiscale segmentation algorithm can also be used for simultaneous inspection of other structural components in addition to the center sill. For example, analyzing the image segmentation at a finer scale than that used for center sill inspection, crossbearers can also be inspected for breaks, cracks, bending and buckling (Figure 8).

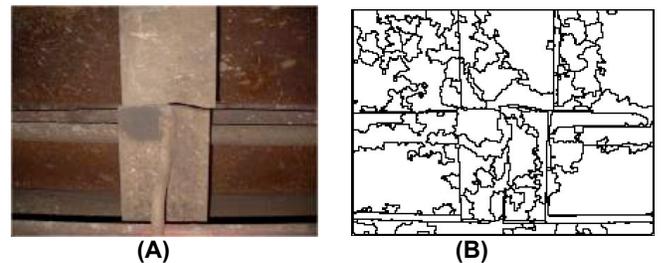
FIGURE 8: DIGITAL IMAGE OF A BROKEN CROSSBEARER (A) WITH A FINE-SCALE SEGMENTATION OF THE IMAGE (B)

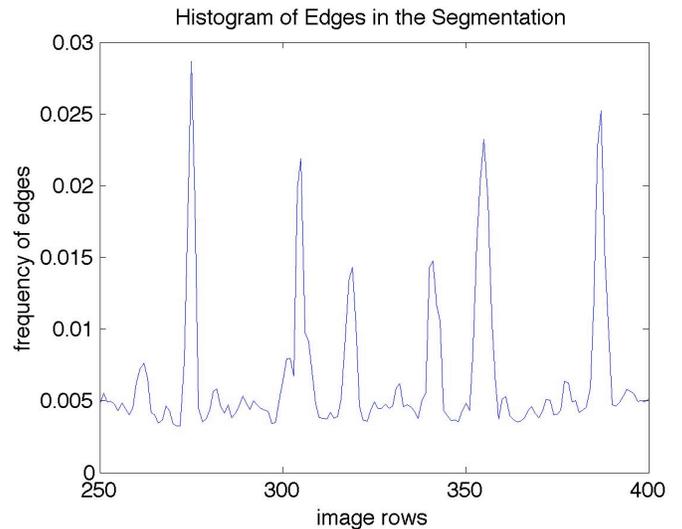
FIGURE 11: HISTOGRAM OF THE PIXEL SUMMATIONS BELONGING TO REGION BOUNDARIES

Along each horizontal row in the edge image (Figure 10a) we compute the number of pixels present (i.e., pixels belonging to longitudinal edge lines in the image). Prominent peaks in the histogram of the pixel summation (Figure 11) denote long, straight sections in the image. Since the center sill creates the longest edges in the panoramic image, the two largest peaks (rows 276 and 388) correspond to the outer contours of the center sill, while the four interior peaks in the histogram correspond to the inner contours of the center sill. The outer contours of the center sill are then denoted with parallel lines (Figure 10b). These detected edges can then be used to guide the search for the remaining parts of the center sill as described in the previous method. Once the contours of the center sill are identified, they are compared with the ideal template. Any deviation from the parallel lines is interpreted as deformation. Note that this method can be applied in the lateral direction as well to identify and inspect crossbearers and crosssties. In this way, pixel summation provides flexibility with reduced computational requirements. However, it does not provide the same level of accuracy or robustness as the multiscale segmentation approach when considering the constraints of the AISC system.

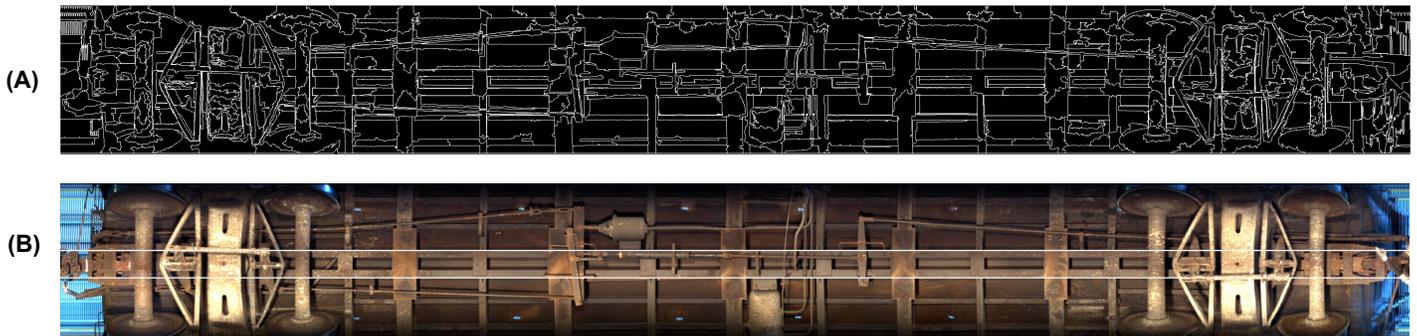
FIGURE 10: EDGE IMAGE OF GONDOLA CAR UNDERBODY PANORAMA (A), AND ORIGINAL PANORAMA WITH CENTER SILL DETECTED (B)

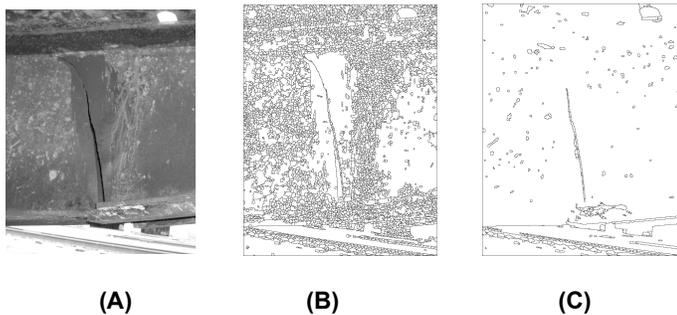
FIGURE 12: ORIGINAL DIGITAL IMAGE OF A CRACK (A), AND FINE TO COARSE SEGMENTATION IMAGES (B & C), FROM MULTISCALE SEGMENTATION, SHOWING CRACK ISOLATION

The algorithm will first identify the region that delineates the boundary of the center sill (Figure 9). To identify breaks and cracks (Figure 12), a multi-scale search strategy will be used that recursively searches smaller subregions embedded in the region occupied by the center sill. At each segmentation scale, the regions found will be compared to the models developed for breaks and cracks, identifying suspect regions like the one seen in Figure 12c corresponding to a center sill crack.
