# **Investigation of the Effects of Tie Pad Stiffness on the Impact Loading of Concrete Ties in the Northeast Corridor**

DOT/FRA/ORD-83/05

April 1983  
Final Report

6. Performing Organization Code Battelle	
7. Author(s) F. E. Dean, H. D. Harrison, R. H. Prause and J. M. Tuten				8. Performing Organization Report No.

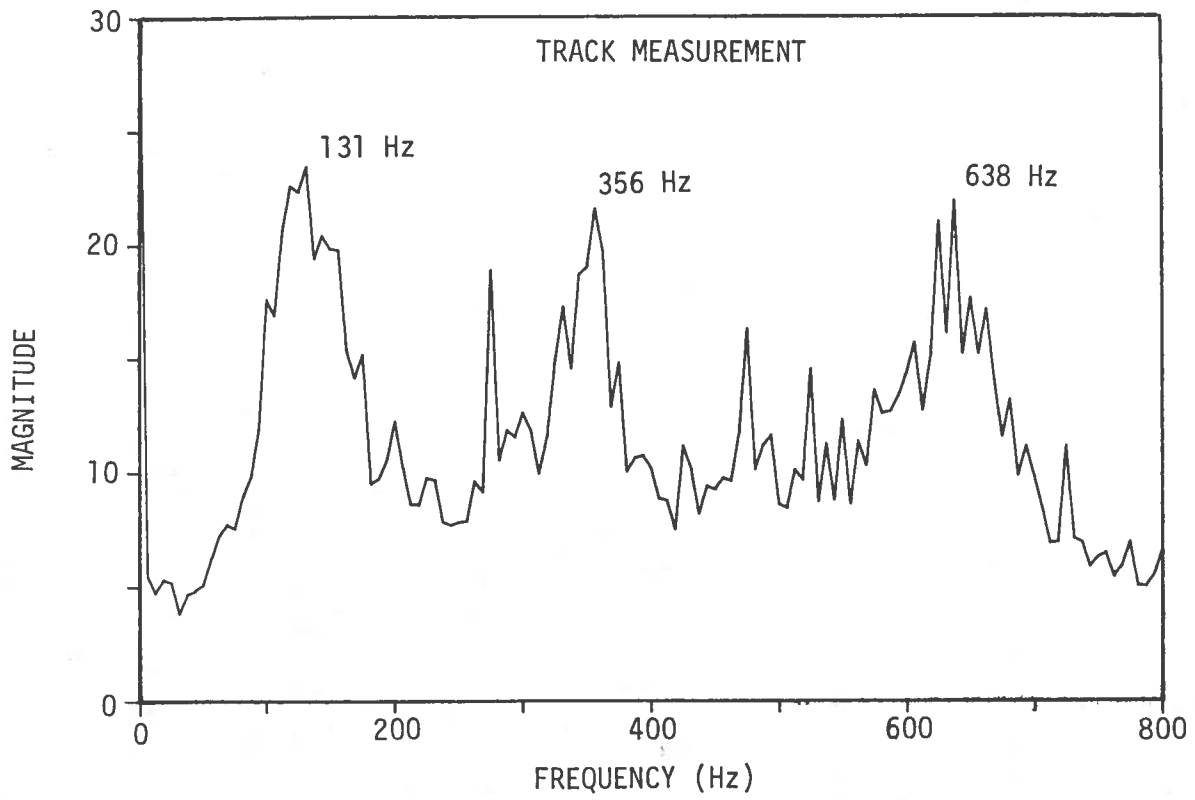
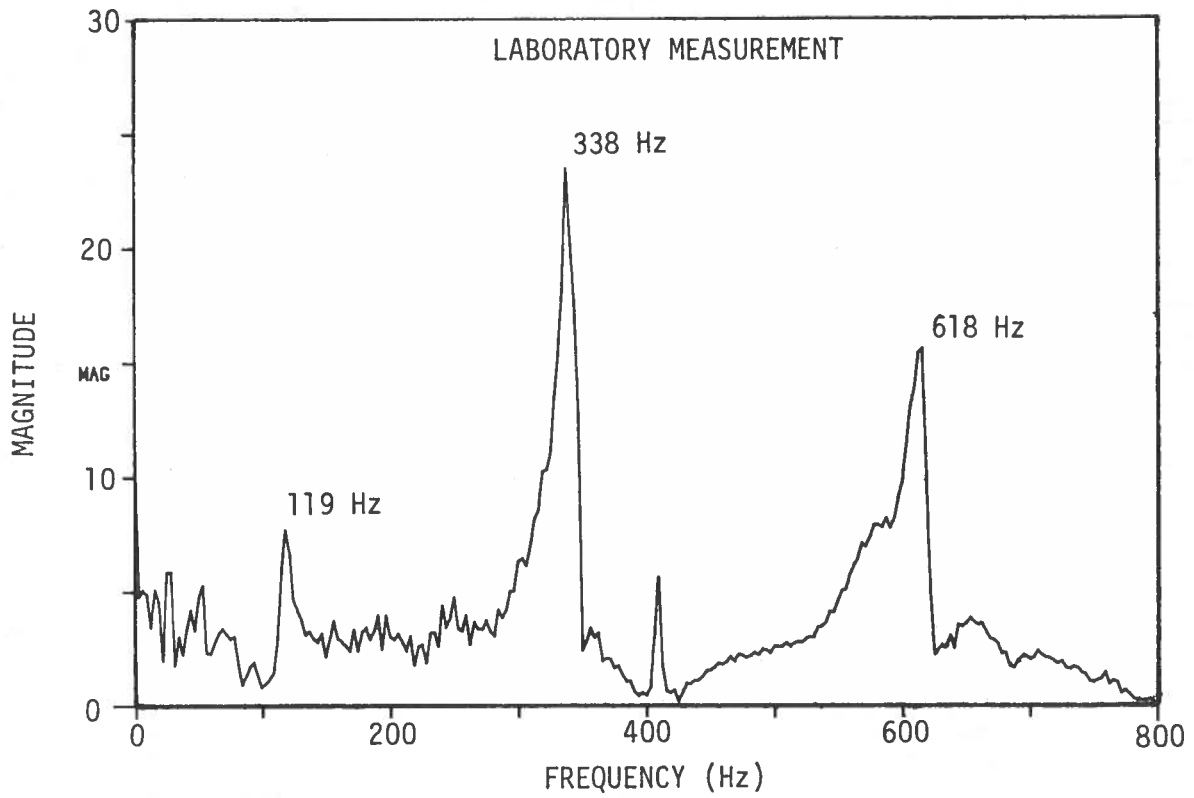
FIGURE 4-3. FREQUENCY SPECTRA OF RAIL SEAT BENDING STRAIN FROM TRACK AND LABORATORY MEASUREMENTS

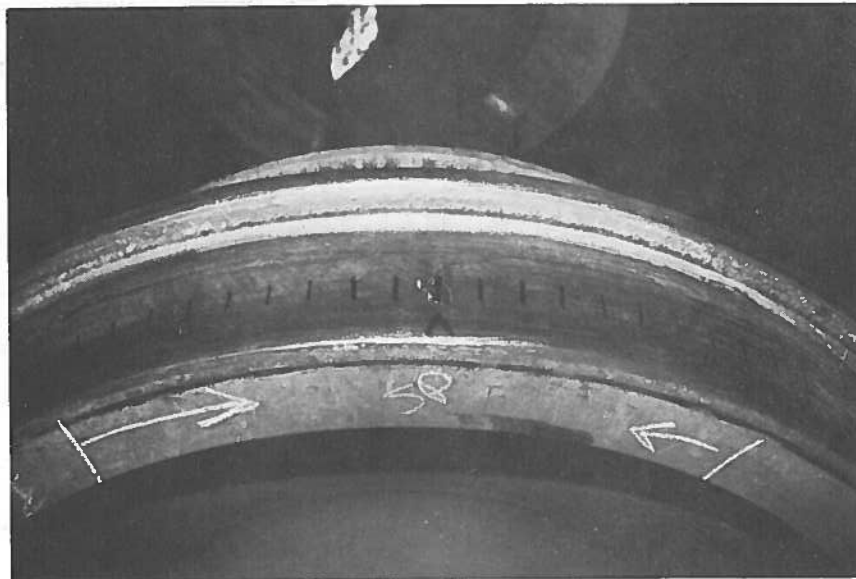
A number of additional wheel impact conditions were traced and the wheels were photographed. Typical spalled conditions are illustrated in Figure 5-15(a). However, the worst impacts were produced by the long-wavelength (12-18 inches) irregularities of the type illustrated in Figure 5-15(b). This particular wheel produced a measured vertical load of 85.8 kips. The wheel irregularity consisted of a flattening or chording of the wheel circumference over a length of about 12 inches. The area contained very little spalling of the type which is usually associated with "flat" wheels. The wheel was placed on a wheel truing machine which permitted the measurement of the radial distance from a fixed reference, across the wheel tread, at several selected stations across the chorded area. The results of these measurements are plotted in Figure 5-16. Each of the tread profiles shown can be compared with the dotted line which represents a new 1:40 tread taper. The measured profiles show radial deviations from the original profile up to 0.16 inches. Of more importance, however, is the fact that the deviations vary by about 0.09 inches from the edge to the center of the chorded area (from left or right edge to the middle of Figure 5-16). This wheel condition illustrates the type of condition which must be eliminated from NEC passenger traffic if the ties are not to sustain further damage. These long-wavelength irregularities are more difficult to identify than are wheel spalls. This emphasizes the necessity for a regular program of wheel inspection and truing.

(a) Typical Spalled Wheel Tread

(b) Worst-Case Flattened Wheel Condition

FIGURE 5-15. WHEEL CONDITIONS IDENTIFIED BY TRACK LOADING MEASUREMENTS

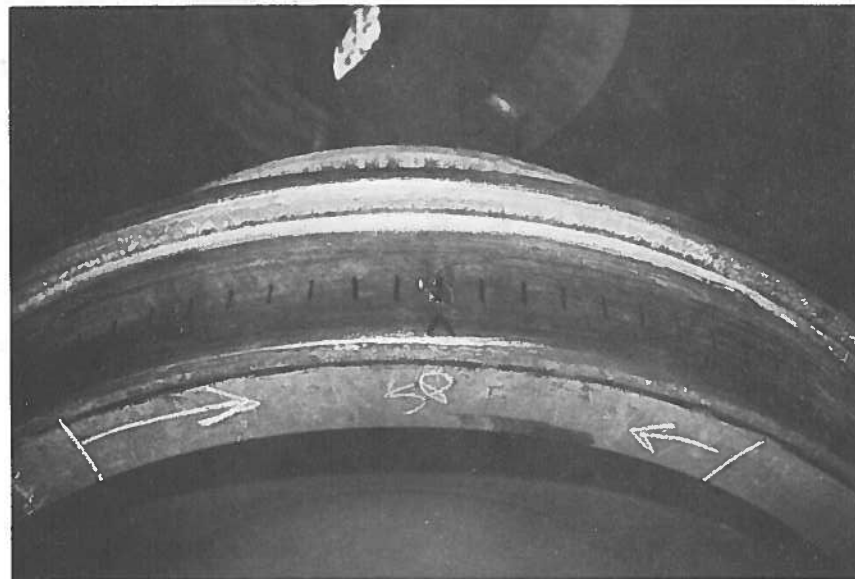
FIGURE 5-15. WHEEL CONDITIONS IDENTIFIED BY TRACK LOADING MEASUREMENTS

(a) Typical Spalled Wheel Tread

(b) Worst-Case Flattened Wheel Condition
